Product Name	BMW
Part Name	DAPING ELEMENT
Part Number	1459501
Department	METROLOGIA
Inspector	LEYDA TREJO
Date	Sep 12, 2024
Unit	mm

Datos de resultado - 1: Datos medidos - 1459501-B_CAV_10_OK

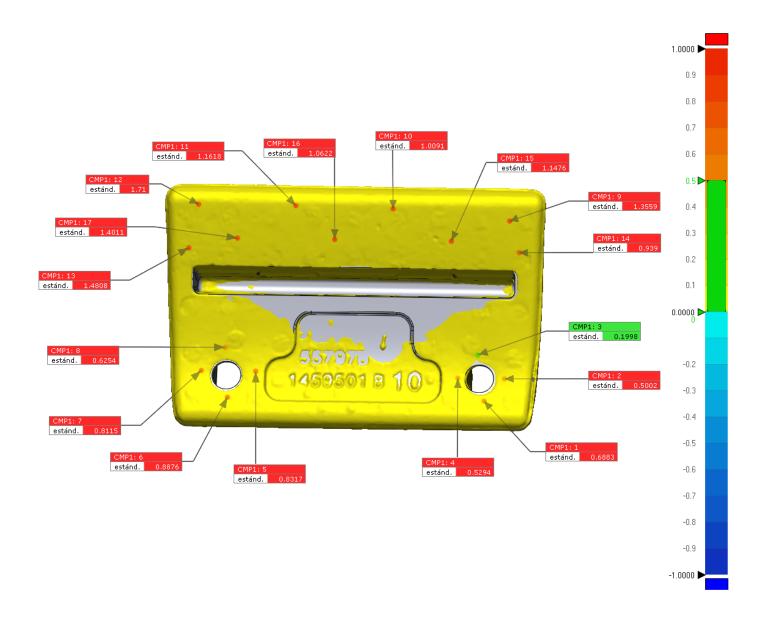
Nombre del corte	Mín.	Máx.	Promedio	Promedio RMS		Variación	Promedio +	Promedio -
CMP1	0.1403	1.7514	0.962	1.0441	0.4058	0.1647	0.962

Nombre del	Nombre del	T.1		Posición de referencia			Medida Posición			
corte	resultado	Tol.	estánd.	Х	Y	Z	X	Υ	Z	
CMP1: 1	Datos de resultado - 1	0 ~ 0.5	0.6883	2984.0002	-68	921.7472	2983.9564	-68	921.0603	
CMP1: 2	Datos de resultado - 1	0 ~ 0.5	0.5002	2972.0004	-78	921.8865	2972.0271	-78	921.387	
CMP1: 3	Datos de resultado - 1	0 ~ 0.5	0.1998	2960.0004	-64	920.4744	2960.0363	-64	920.2778	
CMP1: 4	Datos de resultado - 1	0 ~ 0.5	0.5294	2972.0004	-54	921.8865	2972.0287	-54	921.3579	
CMP1: 5	Datos de resultado - 1	0 ~ 0.5	0.8317	2970.0006	50	921.7685	2970.0592	50	920.9389	
CMP1: 6	Datos de resultado - 1	0 ~ 0.5	0.8876	2984.0002	64	921.7472	2983.9437	64	920.8614	
CMP1: 7	Datos de resultado - 1	0 ~ 0.5	0.8115	2970.0006	78	921.7685	2970.0578	78	920.959	
CMP1: 8	Datos de resultado - 1	0 ~ 0.5	0.6254	2958.001	66	920.0628	2958.1354	66	919.4519	
CMP1: 9	Datos de resultado - 1	0 ~ 0.5	1.3559	2895.0001	-80	896.5015	2895.5341	-80	895.2552

CMP1: 10	Datos de resultado - 1	0 ~ 0.5	1.0091	2890.0001	-20	894.34	2890.4031	-20	893.4148	
CMP1: 11	Datos de resultado - 1	0 ~ 0.5	1.1618	2889.1985	30	893.9908	2889.642	30	892.917	
CMP1: 12	Datos de resultado - 1	0 ~ 0.5	1.71	2889.1985	80	893.9908	2889.8513	80	892.4103	
CMP1: 13	Datos de resultado - 1	0 ~ 0.5	1.4808	2910.0001	85	902.7969	2910.5626	85	901.4272	
CMP1: 14	Datos de resultado - 1	0 ~ 0.5	0.939	2910.0001	-85	902.7969	2910.3568	-85	901.9283	
CMP1: 15	Datos de resultado - 1	0 ~ 0.5	1.1476	2905.0001	-50	900.7297	2905.4408	-50	899.6701	
CMP1: 16	Datos de resultado - 1	0 ~ 0.5	1.0622	2905.0001	10	900.7297	2905.408	10	899.749	
CMP1: 17	Datos de resultado - 1	0 ~ 0.5	1.4011	2905.0001	60	900.7297	2905.5382	60	899.4361

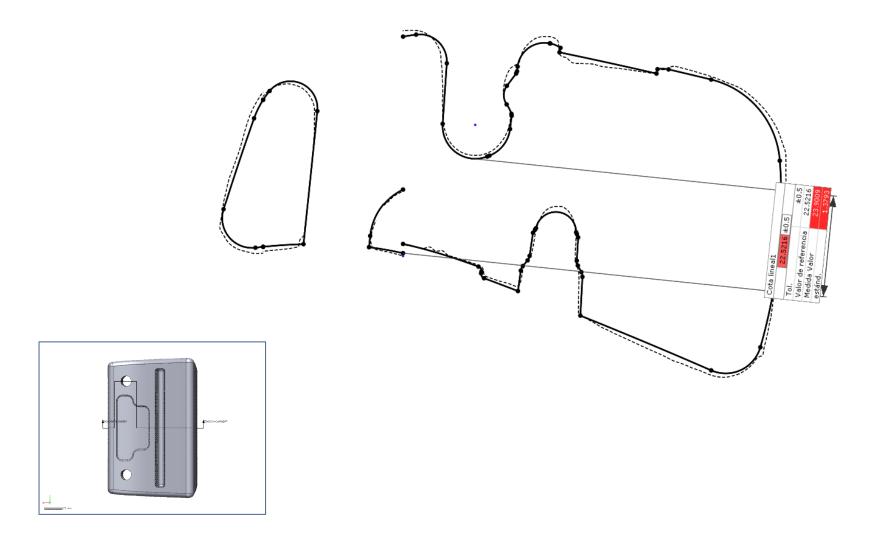
Nombre del corte	Nombre del resultado	Valor de referencia	Tol.	Medida Valor	estánd.
Cota lineal1	Datos de resultado - 1	22.5216	±0.5	23.9009	1.3793

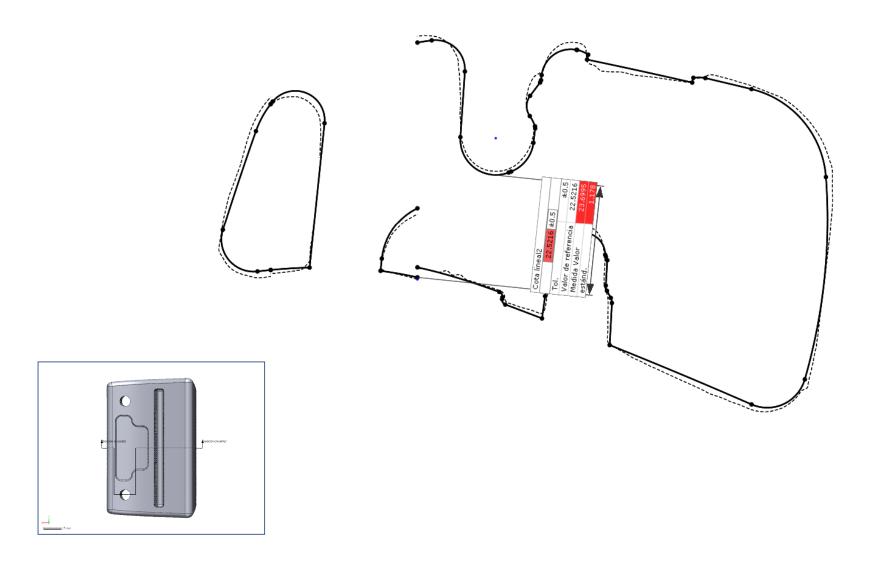
Nombre del corte	Nombre del resultado	Valor de referencia	Tol.	Medida Valor	estánd.
Cota lineal2	Datos de resultado - 1	22.5216	±0.5	23.6995	1.178
