**MTL/NDT/2026**

**REPORT ON AN IN-SITU INTEGRITY TEST  
(NON-DESTRUCTIVE) OF COMPRESSIVE  
STRENGTH OF STRUCTURAL ELEMENTS**

Botanical Garden Road, Ebute Metta

DATE OF REPORT: 05/09/2026

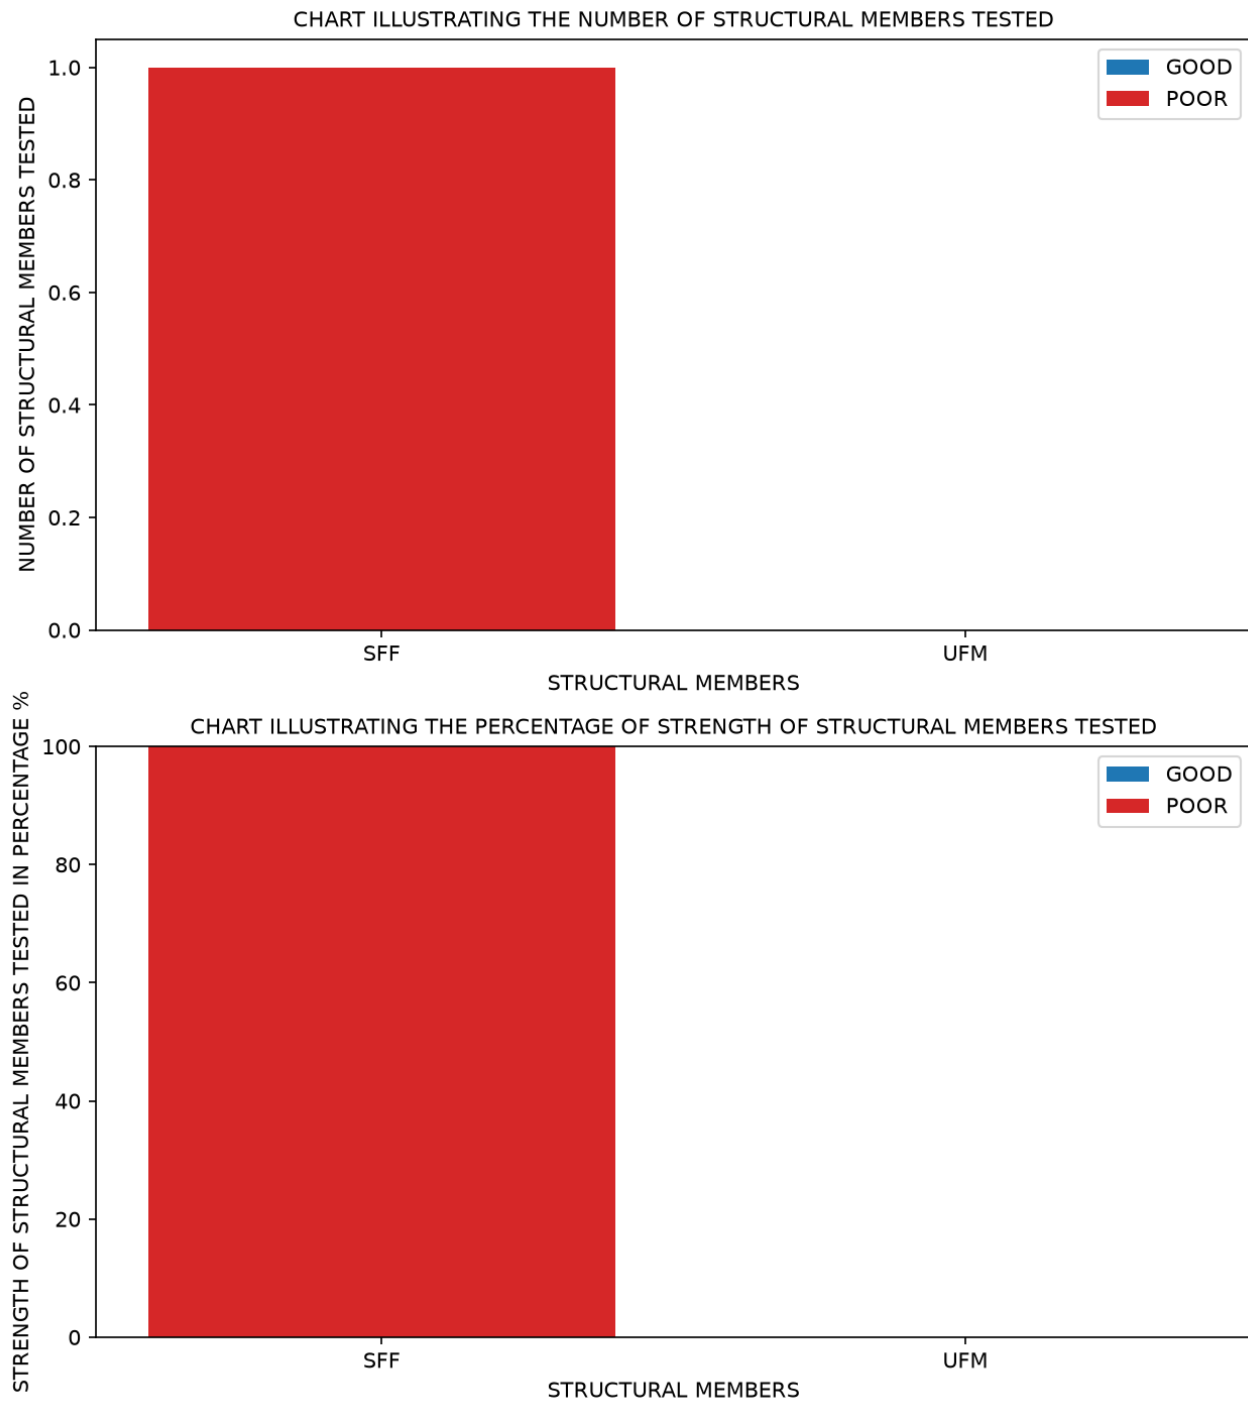
## BAR CHART SHOWING SUMMARY OF TEST RESULTS

1. The Non-Destructive Test analysis as shown in the summary of test result (Section 5.0) shows the percentage of strength for the structural elements tested in the building: 0 of 2 elements (0.0%) attained the assumed 25 N/mm<sup>2</sup> strength at the time of test, while 1 element (50.0%) fell below it.
2. However, it is imperative to state clearly that non-adherence to the recommendation excludes the testing laboratory of any responsibility.

- [URGENT] Structural review of 2 element(s) graded poor or very poor by pulse velocity.
- [HIGH] Map and monitor 1 element(s) with crack depth above 25 mm; engage a structural engineer.
- [HIGH] Map crack extent and monitor; engage structural engineer for crack-depth exceedance.
- [URGENT] Immediate structural engineering review - pulse velocity indicates compromised
