**MTL/NDT/2026**

**REPORT ON AN IN-SITU INTEGRITY TEST  
(NON-DESTRUCTIVE) OF COMPRESSIVE  
STRENGTH OF STRUCTURAL ELEMENTS**

**LAGOS STATE MATERIALS TESTING LABORATORY  
OJODU BERGER, LAGOS.**

Botanical Garden Road, Ebute Metta

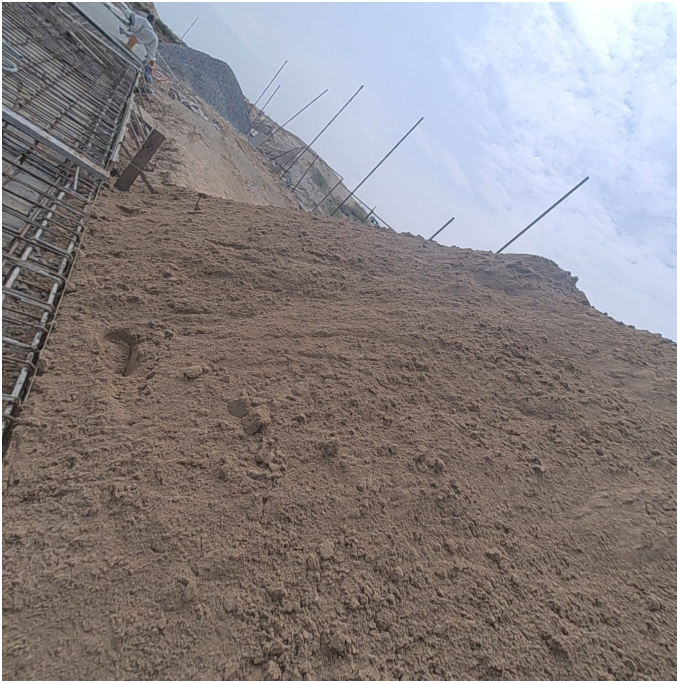
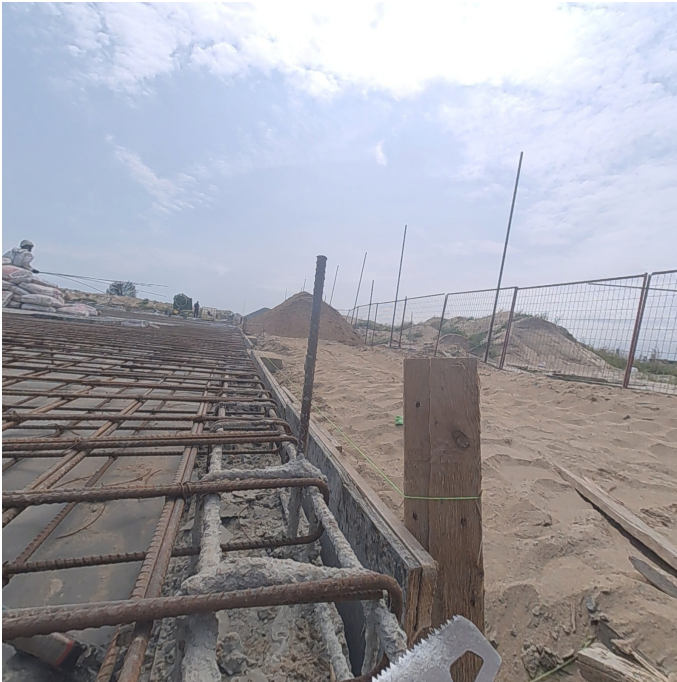
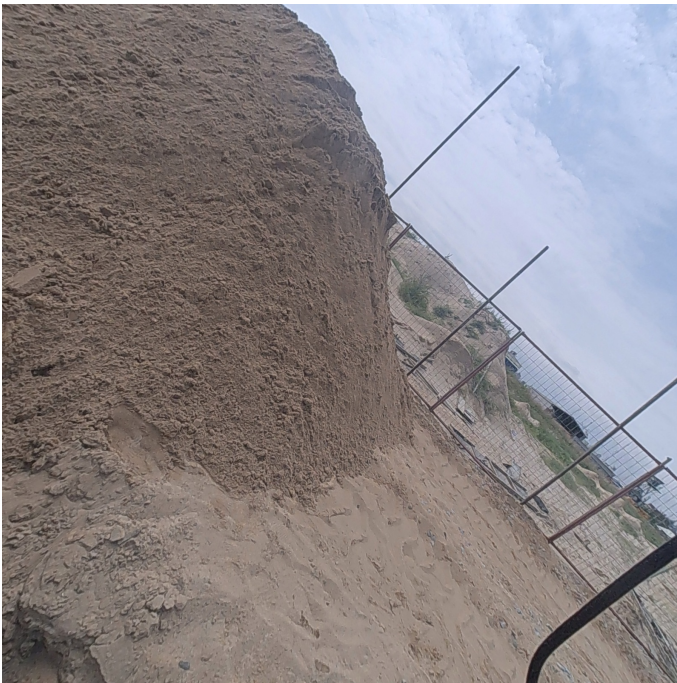
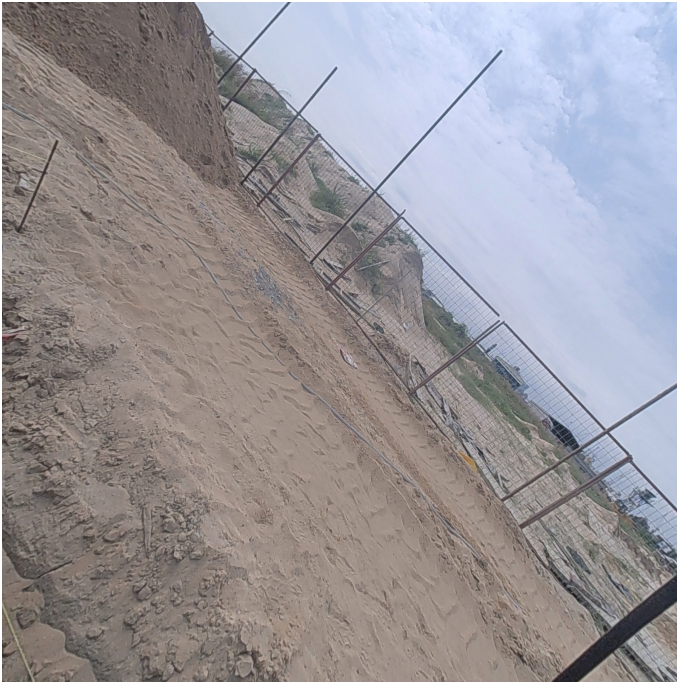
- Floor:200THK RC SLAB:780904: [MANUAL\_FIELD\_ENTRY - Station UPV-FLD-2026-002] tacky floor
- M\_Footing-Rectangular:900 x 900 x 200mm:803711: [MANUAL\_FIELD\_ENTRY - Station fghjkjhg] helllo

| ELEMENT | PATH (MM) | T CRACKED<br>(US) | T<br>UNCRACKED<br>(US) | CRACK DEPTH<br>(MM) | REMARK |
|---|---|---|---|---|---|
| Floor:200THK RC<br>SLAB:780904 | 300.0 | 70.0 | 62.5 | 75.7 | Depth exceeds 25 mm -<br>structural review<br>required |

Photo 1: 1786628996237056000.jpg (Floor:200THK RC SLAB:780904)

Photo 2: 1786628911732759040.jpg (Floor:200THK RC SLAB:780904)

Photo 3: 1786628988736631808.jpg (Floor:200THK RC SLAB:780904)

Photo 4: 1786628977736079872.jpg (Floor:200THK RC SLAB:780904)

- [HIGH] Map crack extent and monitor; engage structural engineer for crack-depth exceedance.
- [URGENT] Immediate structural engineering review - pulse velocity indicates compromised concrete.

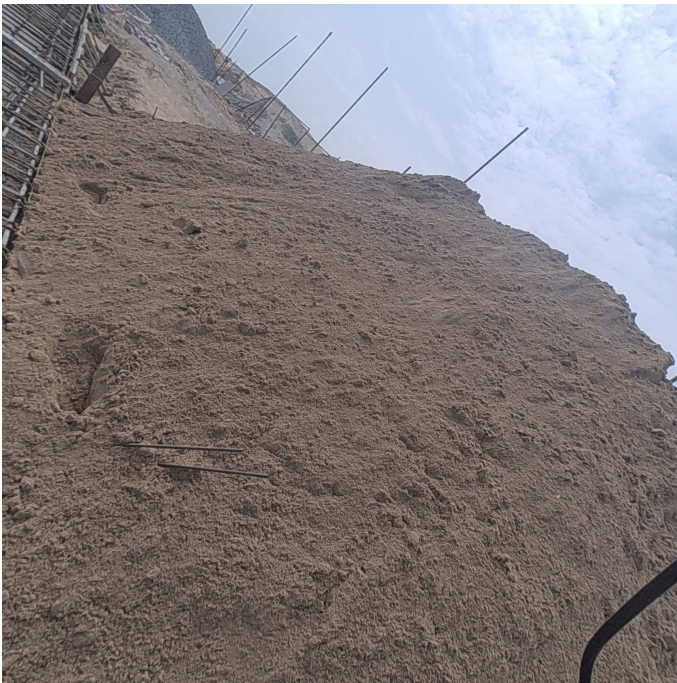
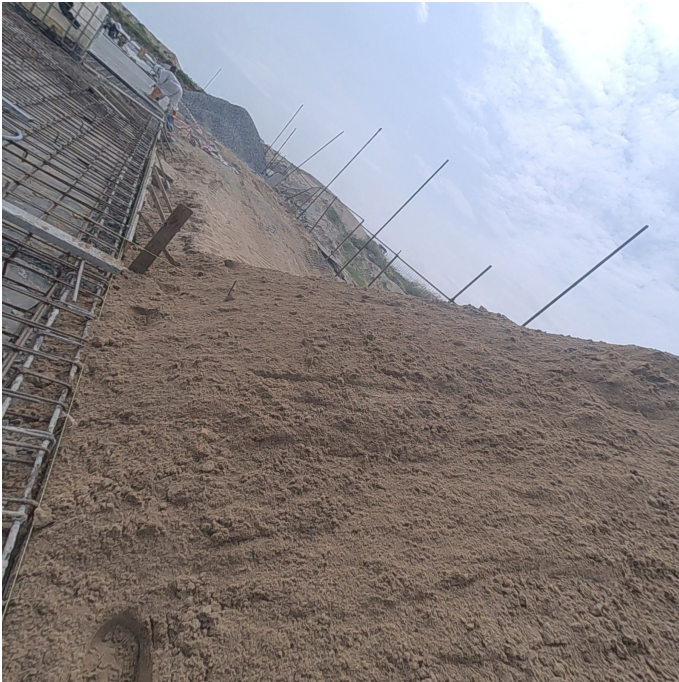
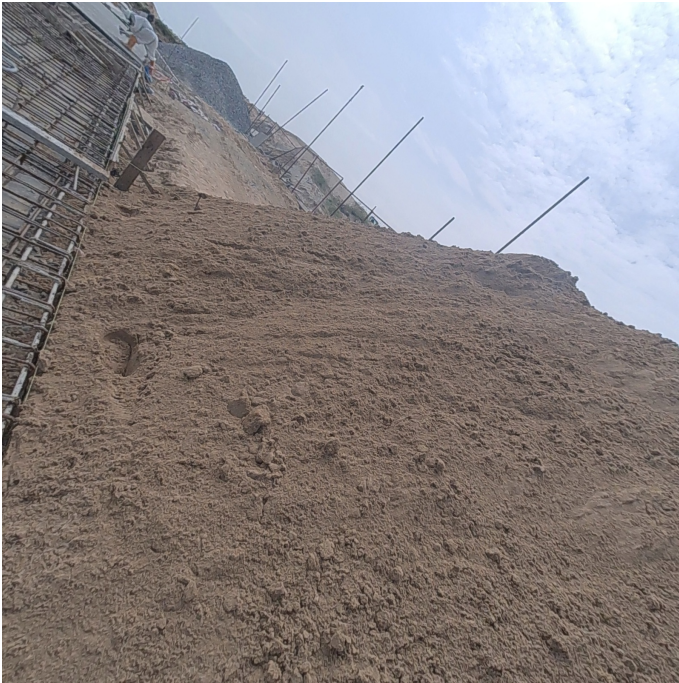
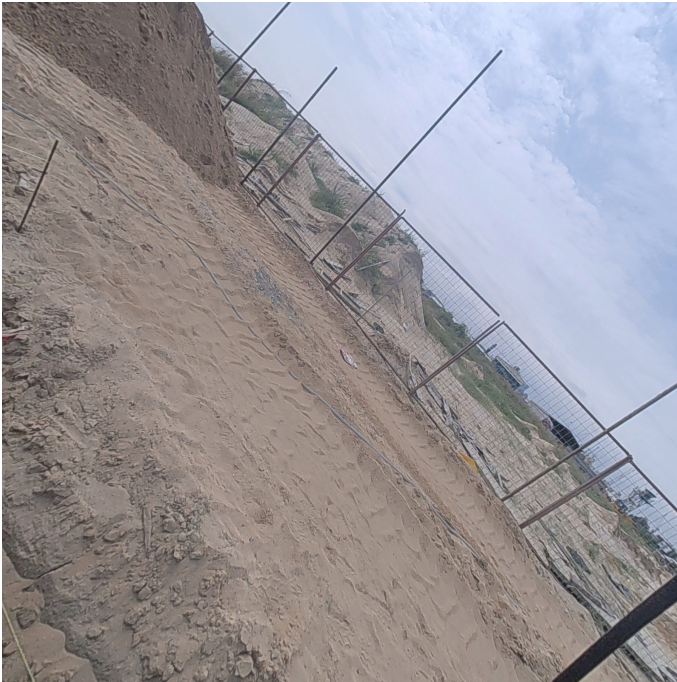
AVERAGE PULSE VELOCITY: 5.36 KM/S      AVERAGE E.C.S: - N/MM2      REMARK: EXCELLENT

Photo 5: 1786628993736943872.jpg (M\_Footing-Rectangular:900 x 900 x 200mm:803711)

Photo 6: 1786628998237142784.jpg (M\_Footing-Rectangular:900 x 900 x 200mm:803711)

Photo 7: 1786628996237056000.jpg (M\_Footing-Rectangular:900 x 900 x 200mm:803711)

Photo 8: 1786628977736079872.jpg (M\_Footing-Rectangular:900 x 900 x 200mm:803711)
