# Embedded Heritage: A Study of Venetian Church Floors

An Interdisciplinary Qualifying Project  
submitted to the faculty of  
**Worcester Polytechnic Institute**  
in partial fulfillment of the requirements for the  
Degree of Bachelor of Science

*Soprintendenza all'Archeologia*

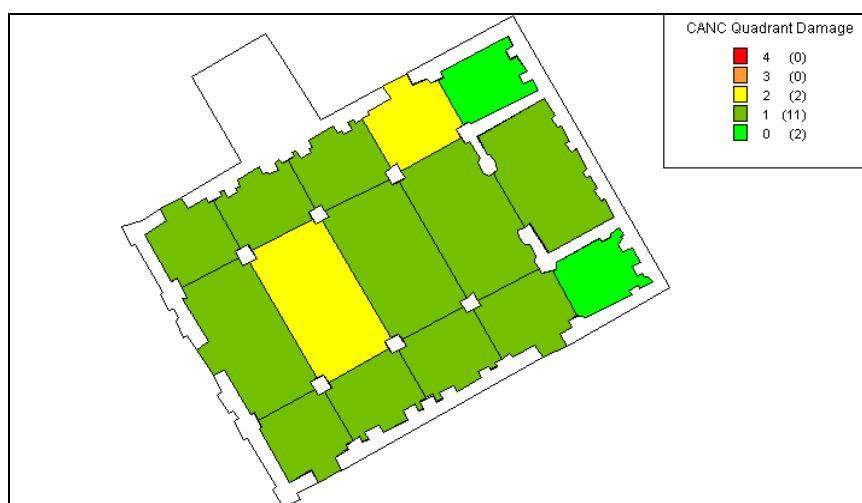
Figure 35: Quadrant Damage in San Canciano

Through the use of the damage assessment tables shown in Appendix C: Damage Assessment Tables, our group was able to determine the damage rating of each quadrant on the 0 to 4 scale. On this scale a score of 0 indicated the least possible damage to the quadrant while a score of 4 indicated the highest severity of damage. The most prevalent average damage score for the quadrants of San Canciano was a 1, with 11 out of the 15 quadrants receiving that score. The group collected individual quadrant damage information from every church in the study. To save space we have included a MapInfo image of the quadrant damage in San Canciano, shown in Figure 35. The quadrant damage for the remaining churches can be viewed in Appendix I: Church Information.

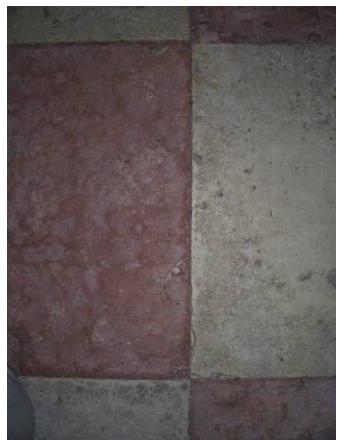
Figure 57: Joint Gap Severity 0

Scale	Description
0	Minimal or no joint gaps present
1	Low severity of joint gaps Few joint gaps that present no danger to the floor structure
2	Intermediate level of joint gaps Multiple joint gaps potentially endangering the floor structure
3	High level of joint gaps Many joint gaps that threaten damage to the floor structure
4	Severe level of joint gaps Majority or area contains joint gaps damaging the floor structure

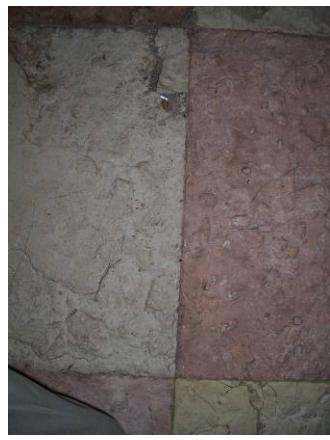
Figure 58: Joint Gap Severity 1

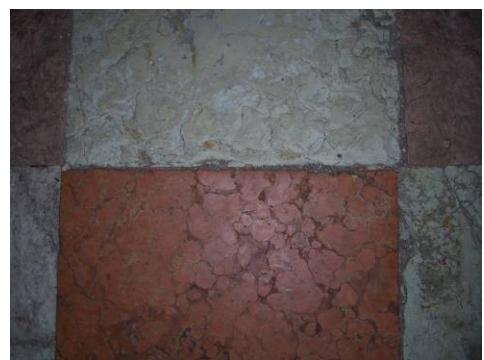
Figure 59: Joint Gap Severity 2

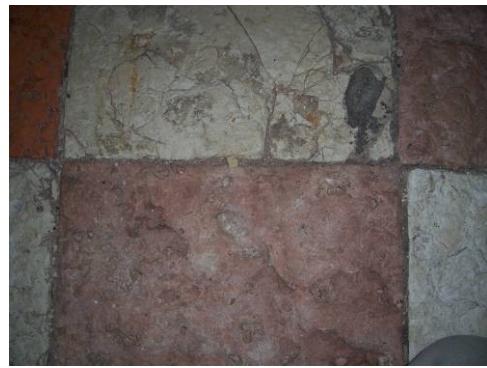
Figure 60: Joint Gap Severity 3

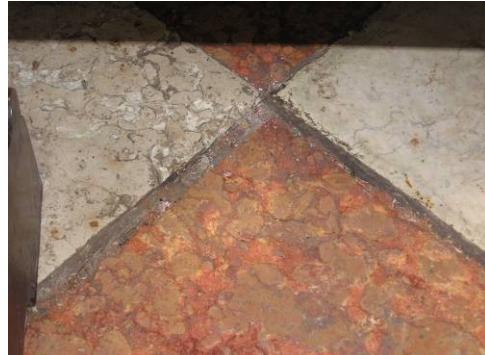
Figure 61: Joint Gap Severity 4

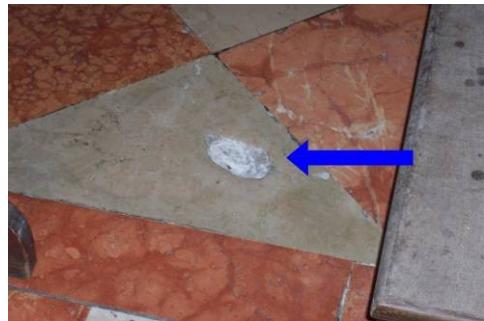
Figure 62: Example of a Hole

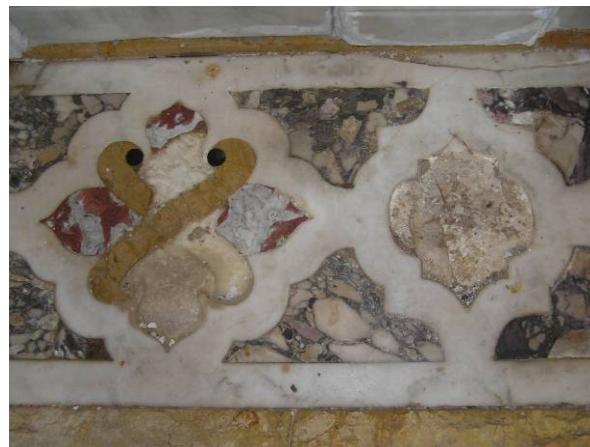
Figure 63: Example of Floor Detachment

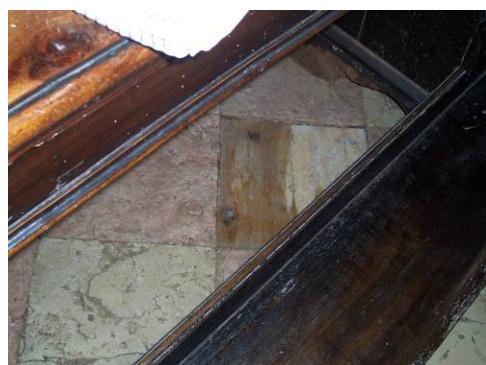
Figure 64: Floor Tile Replaced by Wood

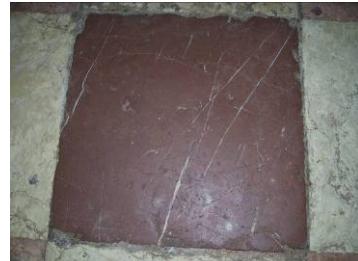
Figure 66: Surface Damage  
Severity 1

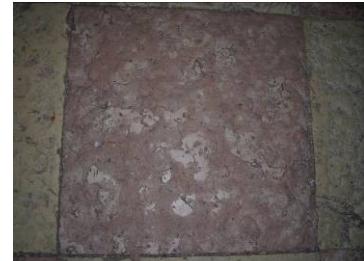
Figure 67: Surface Damage  
Severity 2

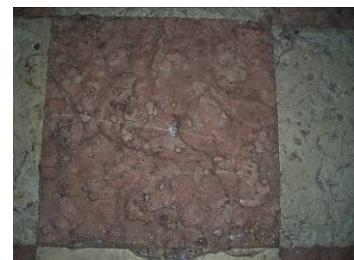
Figure 68: Surface Damage  
Severity 4
