Quantification of Sediment Sources in the City of Venice, Italy

An Interactive Qualifying Project

Date: July 31, 1999

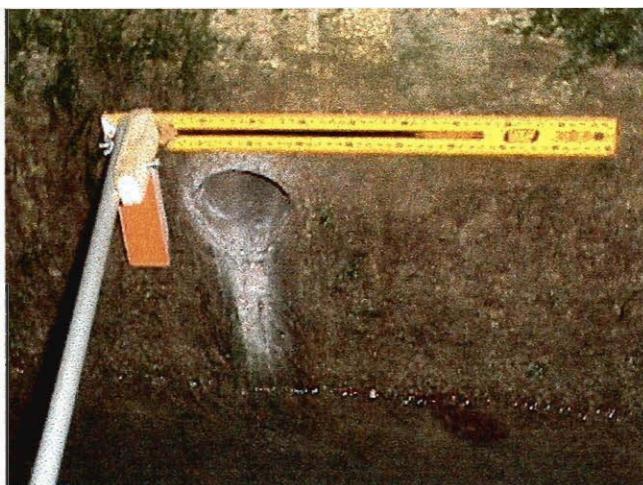
Figure 5-1 Sewer outlet with primary signs of activity

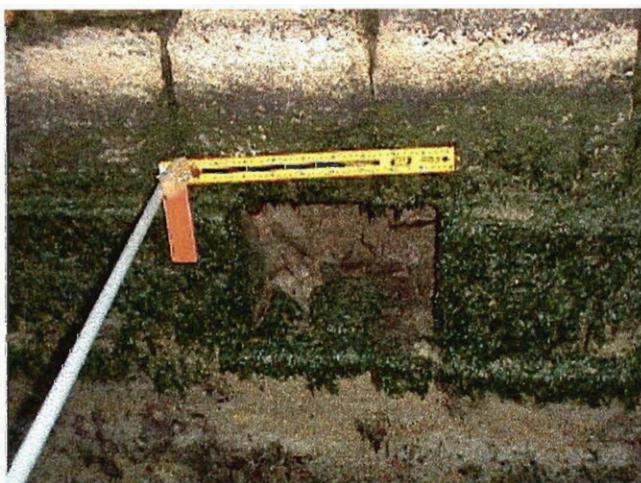
Figure 5-2 Sewage outlet with seaweed inside, a sign that it is inactive

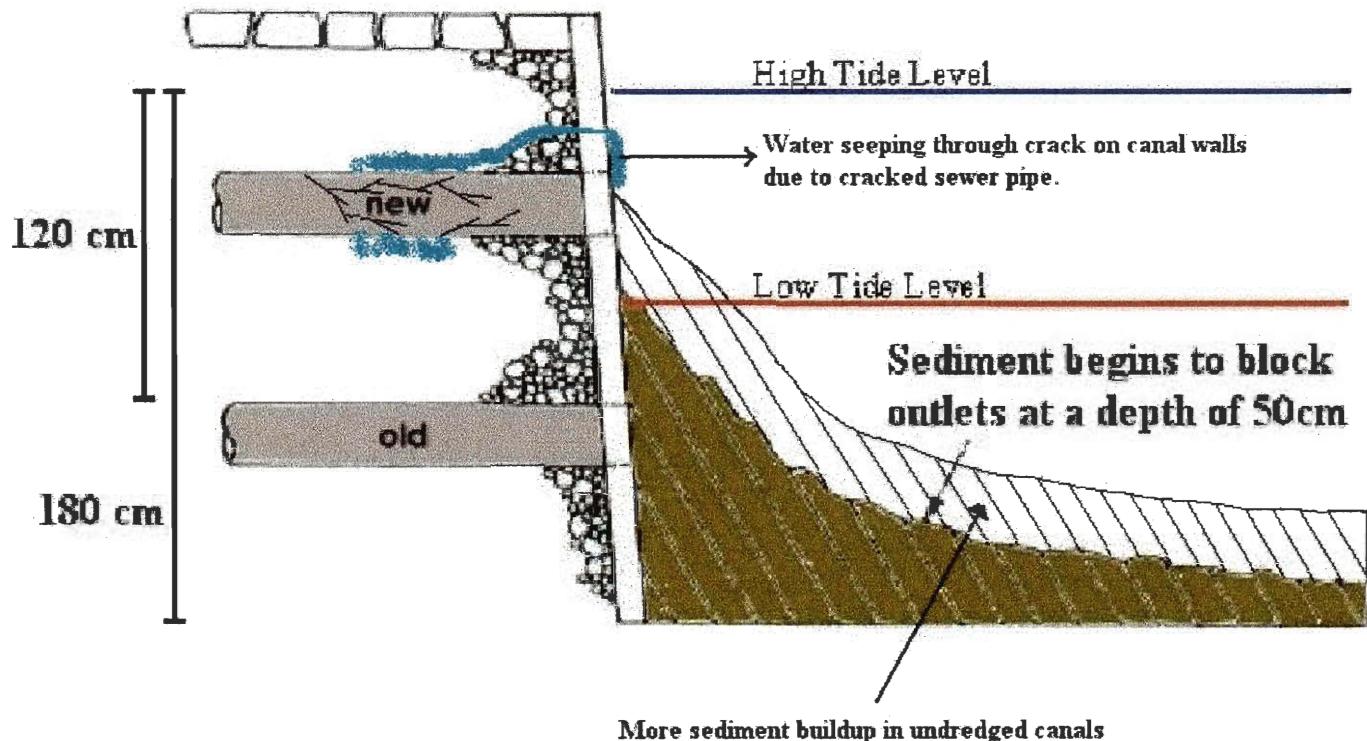
A damaged outlet can be readily identified by increased occurrences of structural damage around it because the pipe is clogged or cracked. When a pipe bursts or cracks, the escaping sewage deteriorates the surrounding structure (On several occasions the sewage from an inactive, damaged sewer outlet was observed to exit through small crevices in the canal wall nearby (Figure 5-3 & Figure 5-4). This process

greatly diminishes the integrity of the canal wall and eventually causes structural failure.

Figure 5-3 Diagram showing the formation of structural damage caused by ruptured sewage outlets

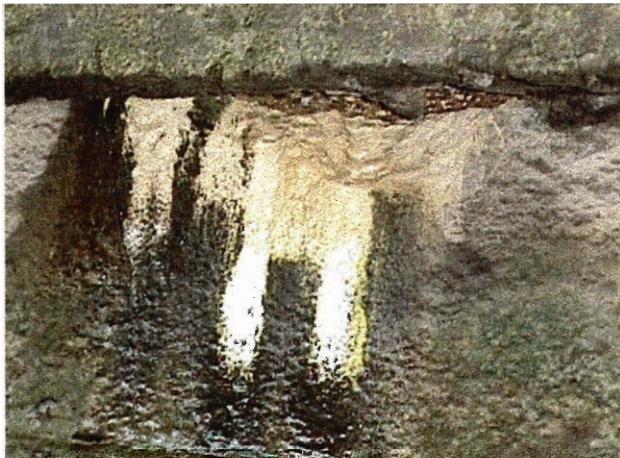
Figure 5-4 Beginning of a structural damage caused by leaking sewage pipes

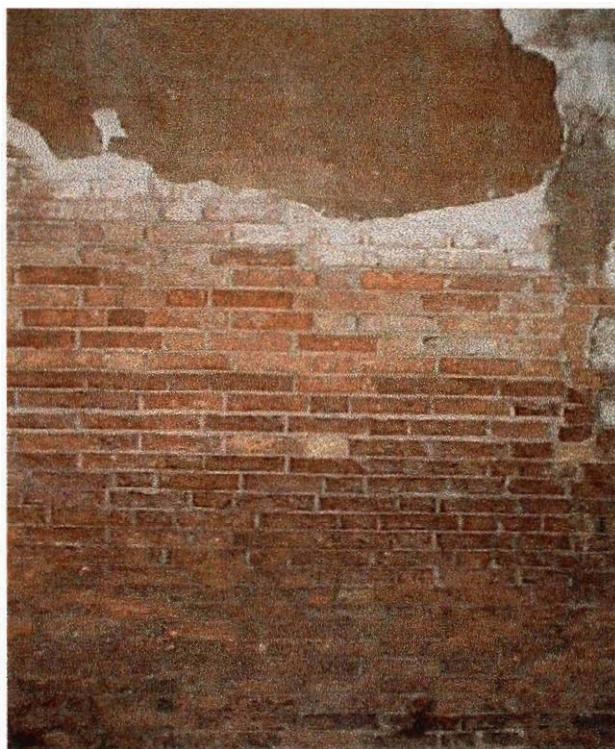
Figure 5-1 Wall segment showing partial plaster erosion

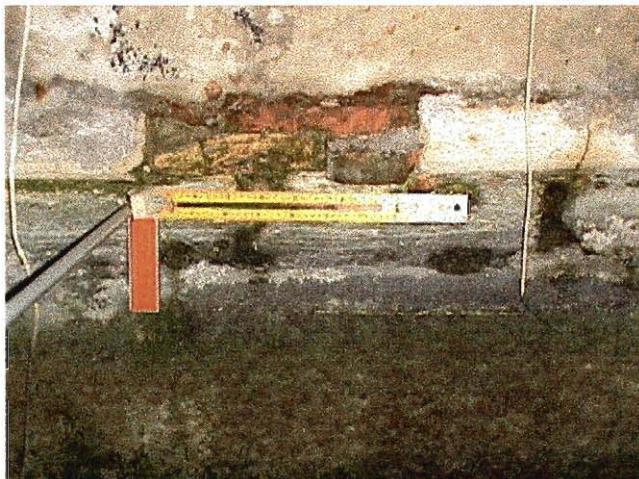
Figure 5-1 Image showing damage to istrian stone which is structural in origin and ruler used for reference

due to an object, most likely a boat, colliding with the area. Such a collision can cause cracking and displacement of the stone. Structural damage occurs in the middle of canal segments and may be due to ruptured sewer pipes or the effects of motorboat wakes.

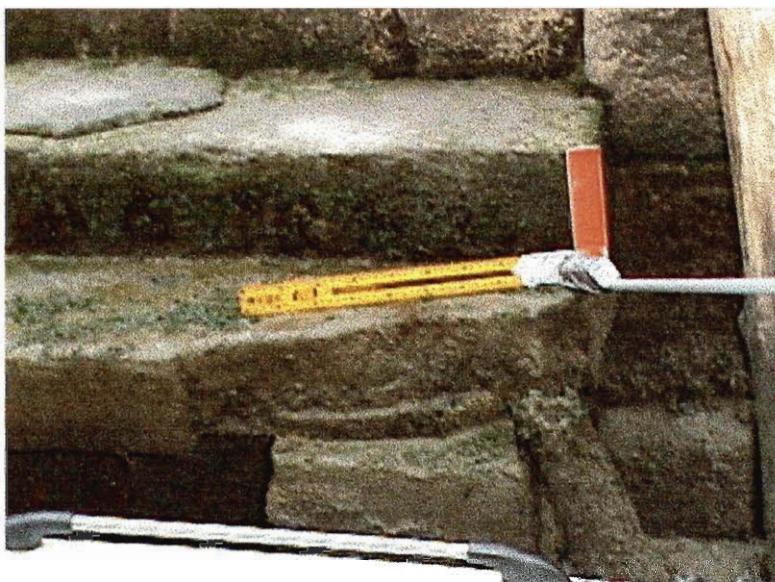
Figure 5-2 Picture showing impact damage on stairs

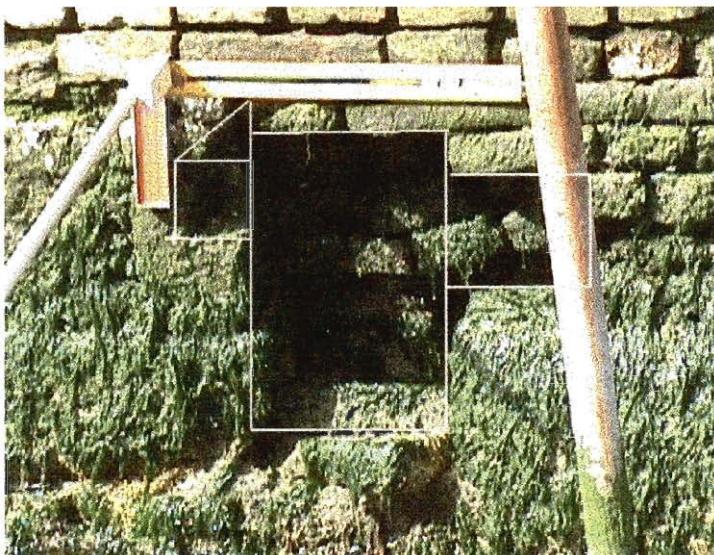
Figure 5-1 Damage on canal wall partitioned into basic geometric shapes for area calculation

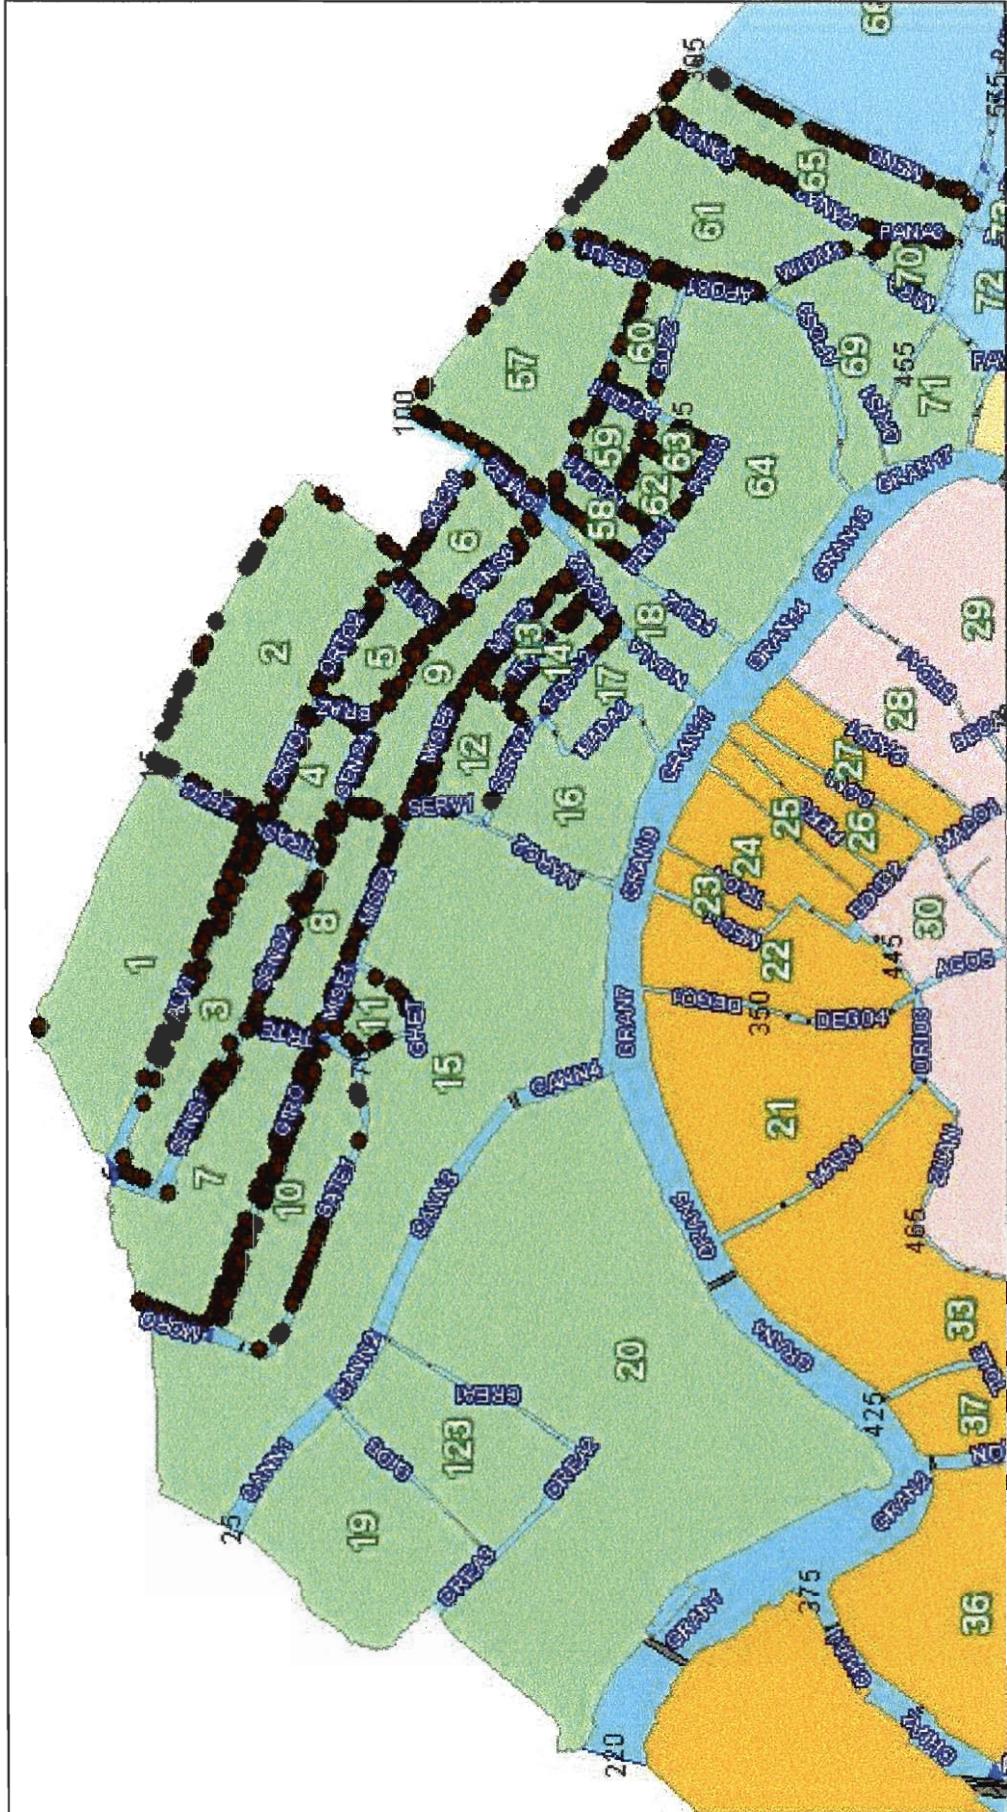
The following subheadings contain the data from our study of the sewer outlets in Cannaregio. Table 6-1 lists the number of outlets found on islands that have been surveyed and gives percentages for each type. As can be seen from this table, 84.1% of the sewer outlets surveyed are active. Of these, 82.8% are also undamaged. Inactive outlets accounted for 15.9% of those documented. Of these outlets 64.1% are damaged as well as inactive. The majority of the outlets surveyed have been found to be in working order. Figure 6-1 shows a map with the positions of all documented sewer outlets in Cannaregio.

Figure 6-1 Map showing the positions of recorded sewer outlets in Cannaregio

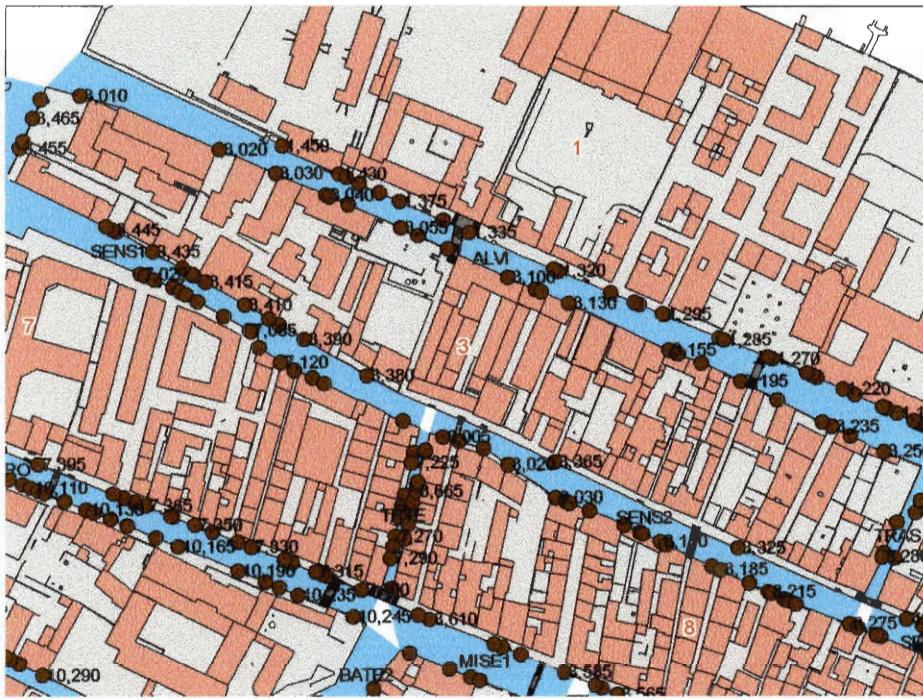
Figure 6-2 Example of sewage outlets located around island 3

Table 6-2 shows a breakdown of the data for island three. As can be seen, 55.6% of the outlets on island three are active and undamaged while 4.4% of them are active but damaged. Of all the outlets 60% are active. The inactive outlets are almost equally divided between damaged and undamaged.

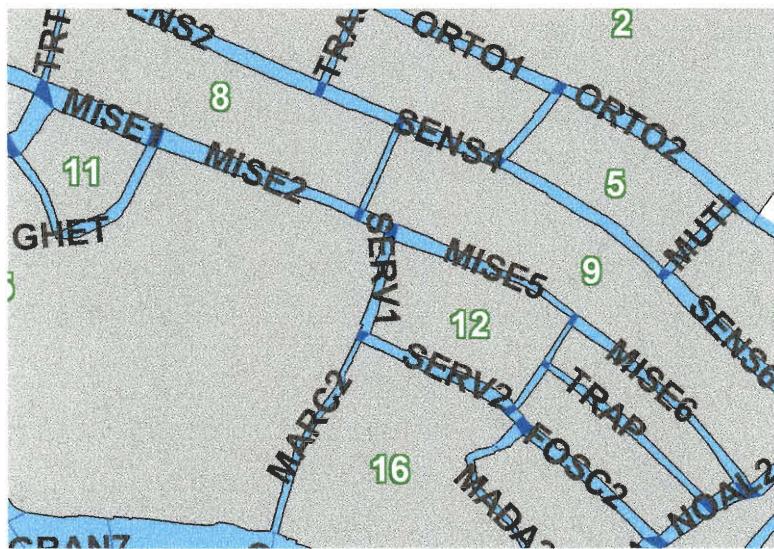
During our fieldwork we had an opportunity to recheck data taken by a previous IQP team in 1992 along the Misericordia canal (segments MISE 1 – MISE 6 in Figure 6-1). We found that, for the most part, these previous data are correct and reliable for the sewer outlets. However, the data for island 11,

Figure 6-1 Map showing the "Misericordia" canal which is bordered by islands 8 and 9 on the north and by 11, 12, 13 and 15 on the south

the side of the island bordering canal segment MISE 1 were blocked at the time of dredging as found by a previous WPI team. The canal wall damage data showed major inconsistencies as well. This is also most likely due to the fact that the canal walls were repaired during the recent dredging.

the "Ghetto" of Venice (Figure 6-2), showed major discrepancies. All of the outlets recorded by the 1992 team are not currently visible. This may be due to the fact that the Misericordia canal was recently dredged. During that process the holes may have been closed off during wall repairs. This supposition is rendered very probable by the observation that seven of the ten holes on

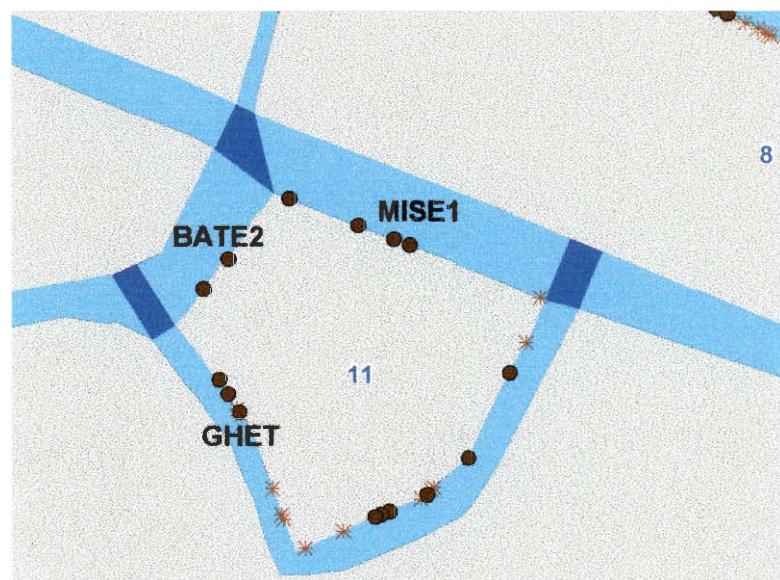
Figure 6-2 Island 11 with the position of current sewer outlets and canal wall damage

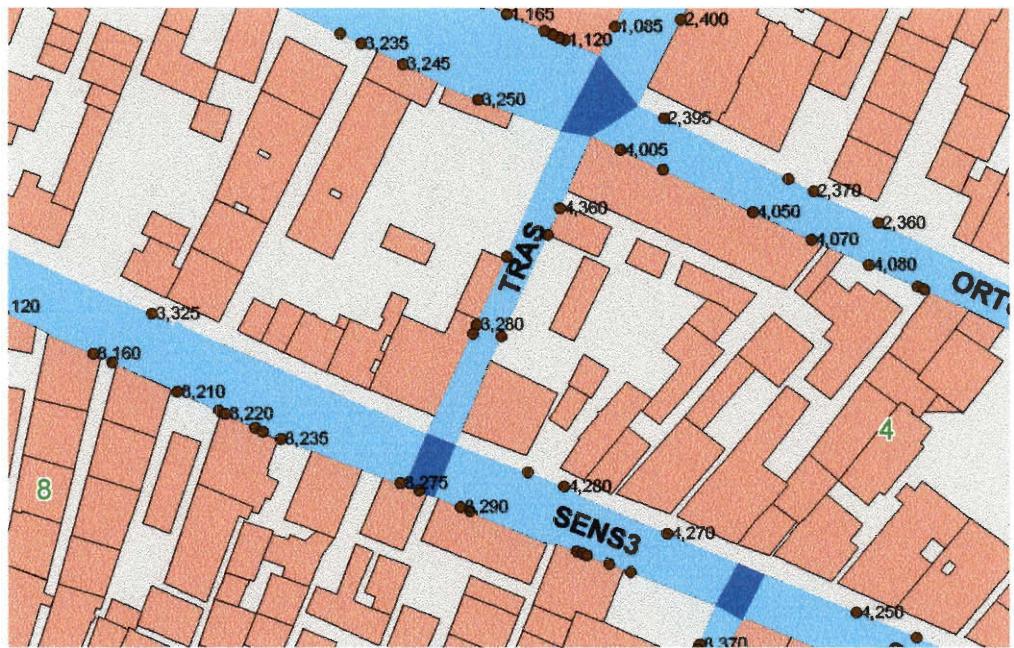
Figure 6-1 Canal segment (TRAS) with sewage outlets located on two bordering islands

Segment TRAS is situated between islands 3 and 4. Table 6-1 shows the calculations necessary for determining the total yearly inflow of sewage into this segment. As can be seen from this table, TRAS receives an annual input of 3274 m³ of sewage every year.

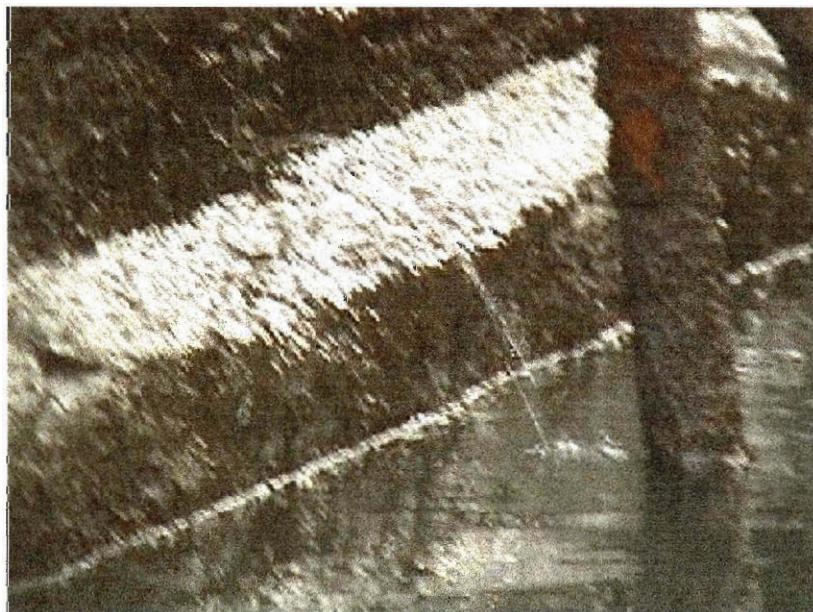
Figure 7-1 Image showing wastewater flowing from a crack in the canal wall which will cause further deterioration if not repaired
