Preserving the Bell Towers of Venice

Bells 2019

An Interactive Qualifying Project
submitted to the Faculty of
WORCESTER POLYTECHNIC INSTITUTE
in partial fulfilment of the requirements for the degree of Bachelor of
Science
Matt Adiletta,
Isabel Bowman,
Connor Bruneau,
Ian Casciola

Advisors: Professors Fabio Carrera and William Michaelson
Date: 11 December 2019

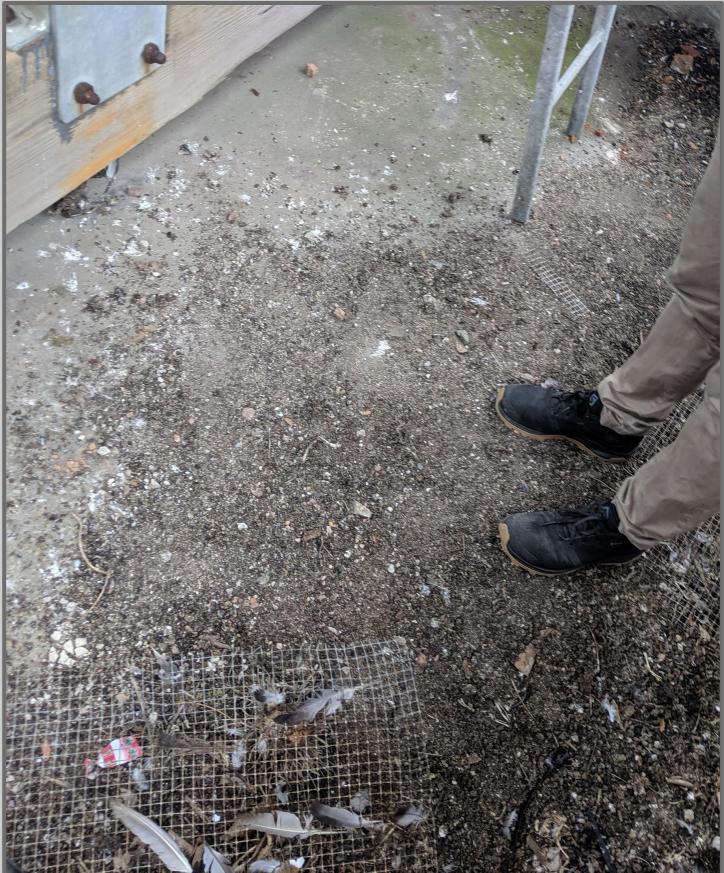
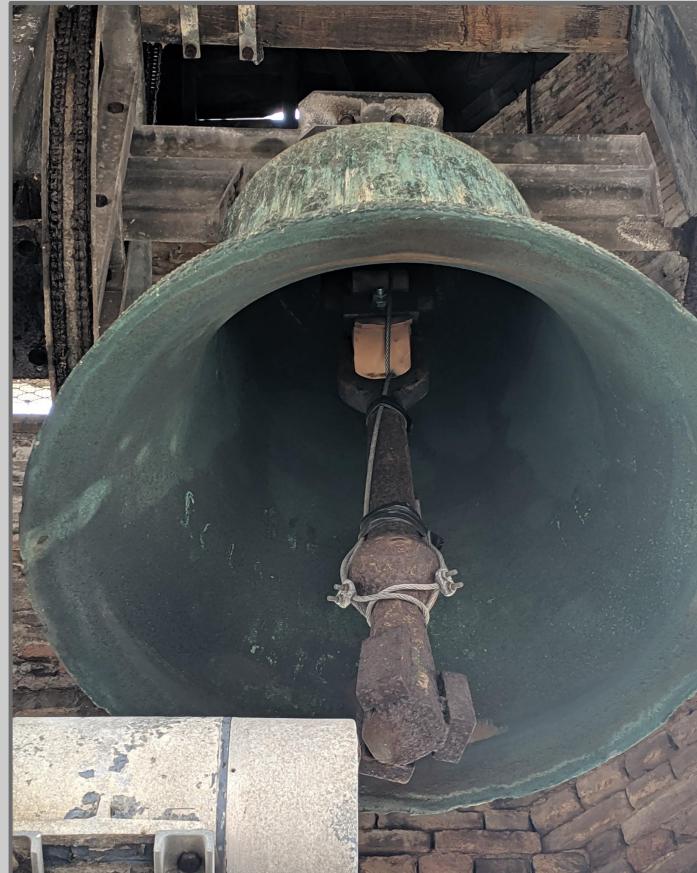
After visiting these towers, there were a few problems we observed that should be monitored and fixed if possible. A common issue we saw was dirtiness, there was often dust, dirt, and random debris build up throughout every tower. The most significant was San Giuseppe, with several inches of dirt buildup throughout the shaft and in the belfry, as well as two bird carcasses, one in the belfry, and one at the bottom of the shaft.

Also at San Giuseppe, one of the bells was incorrectly repaired. Several thick metal blocks were attached to the bottom of a damaged clapper. This caused significant damage to the bell every time it was rung, and needs be repair, or the bell should not be rung.

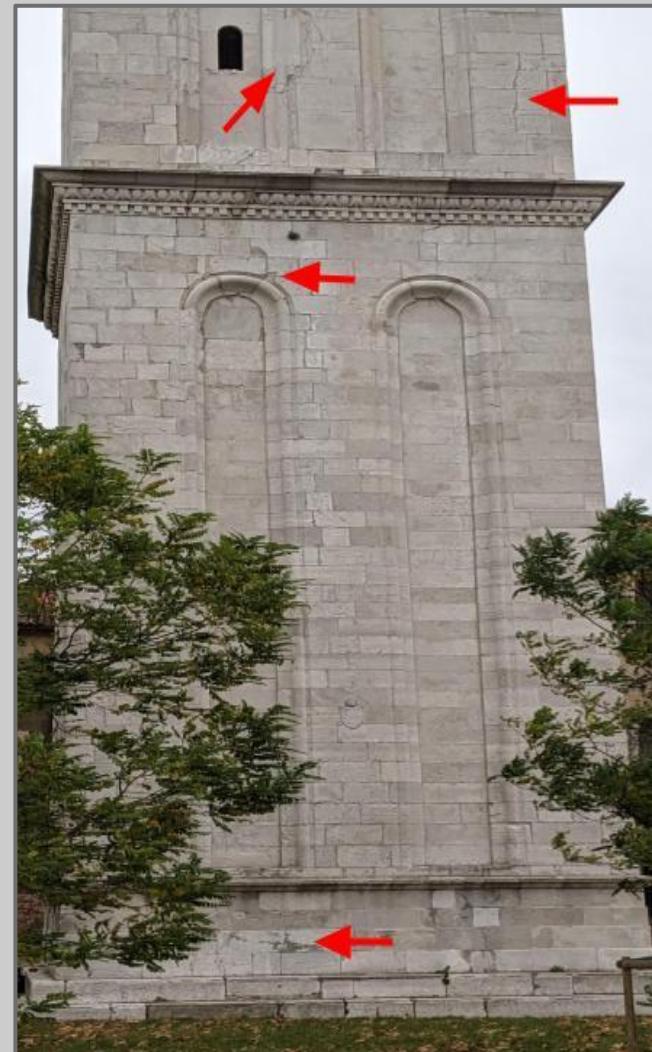
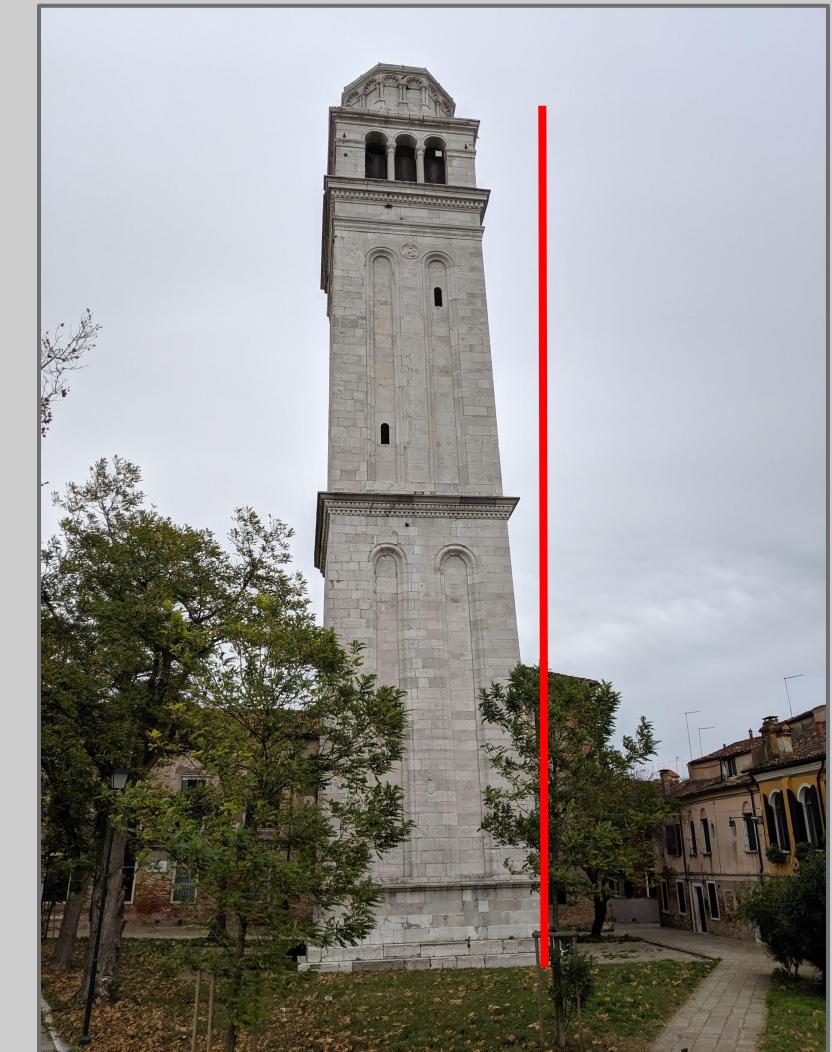
The tower also had a large number of long cracks on the foundation and the shaft of the tower. These can be addressed in the short term via the use of tie bands, but none were present at the time of recording this data.
