## VENICE FROM ABOVE: An Effort to Preserve Venice's Bell Towers

An Interactive Qualifying Project Report Submitted to the faculty of

WORCESTER POLYTECHNIC INSTITUTE

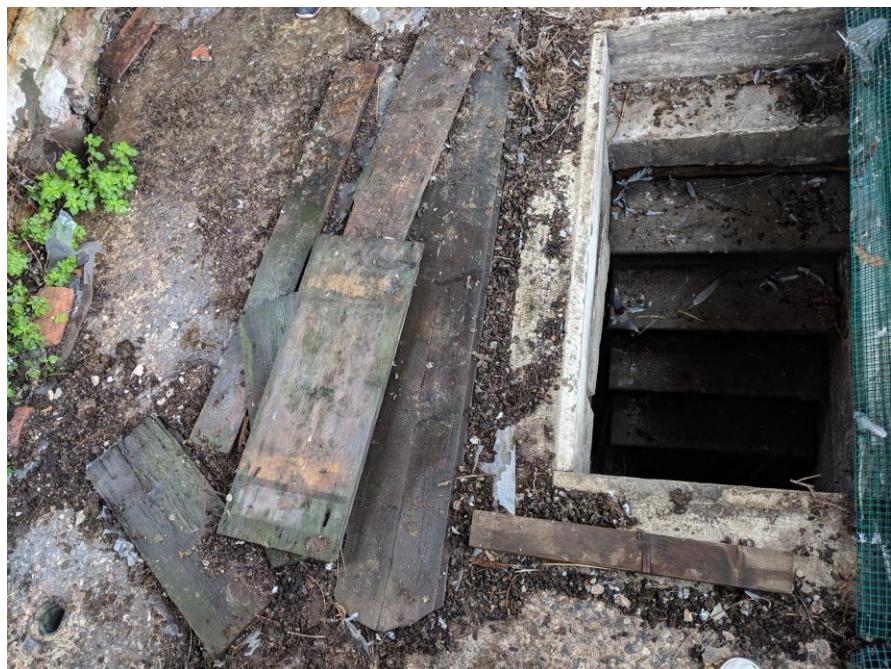
To help in the preservation of Sant'Andrea we suggest that there be a major cleanup of the tower. This was by far the worst tower in terms of cleanliness and should have not reached that condition. After the cleanup the bird nets would need to be replaced and any holes in the roof would need to be patched. The stairs and structure of the tower were very sound and are not in need of repair.

**Figure 5.1:** Unclean Conditions in Sant'Andrea Belfry

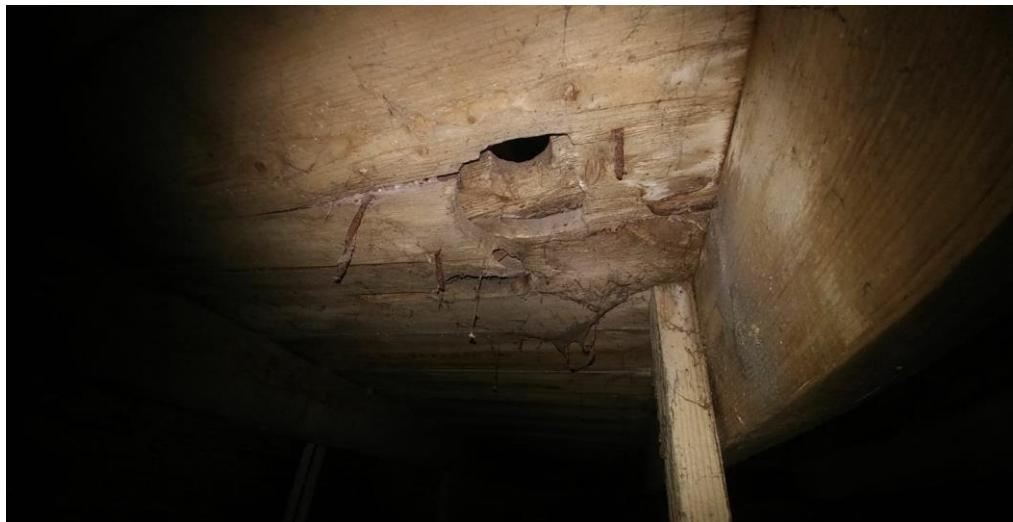
**Figure 5.2:** Hole in Top Landing of San Polo

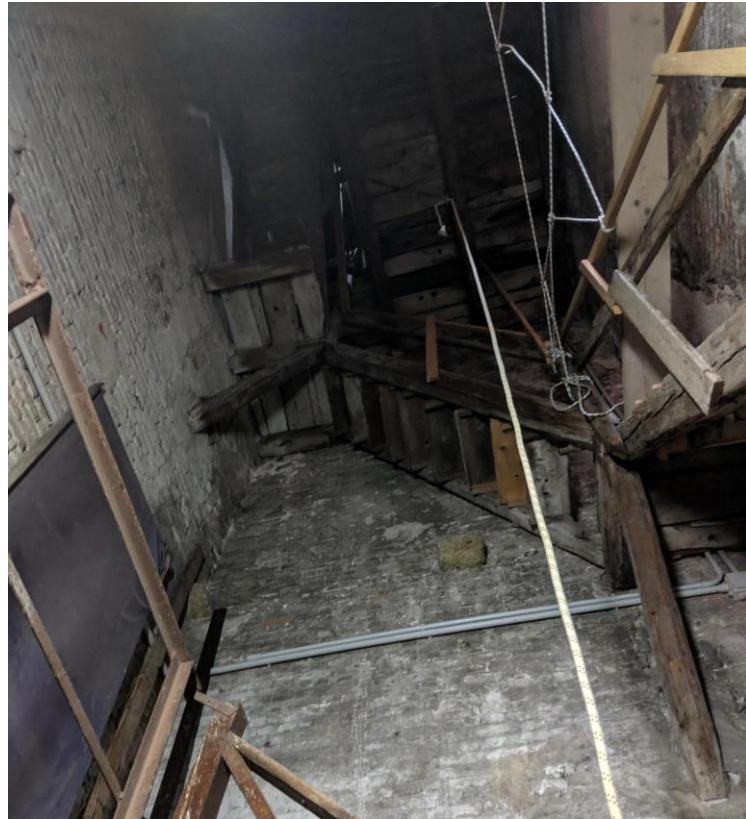
**Figure 5.3:** Staircase of Sant'Eufemia
