# Car Inspection Report

## MARUTI SUZUKI BREZZA

VXI | 2025 | MT | Petrol

Report generated on: 04 Oct, 2025

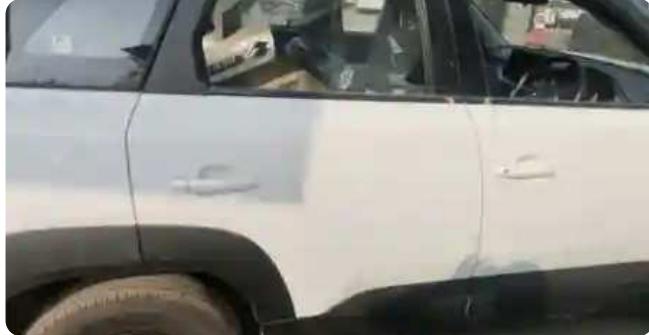
- The car's AC, heater, climate control, power windows, airbags, music system, and steering mounted controls are functional.
- Engine, transmission, steering, suspension, and brakes are in good condition. No blow-by or unusual engine sounds were detected.
- The car has surface rust on the right rear door, damaged headlights and taillights, and a scratched right side mirror.

Okay, here's a summary of your car's exterior and tyre condition: Most of the exterior parts are in good shape. However, there's some surface rust on the right rear door, one headlight is damaged, ORVM has scratches, and tyres are in good condition.

Door RHS Rear: Surface Rust

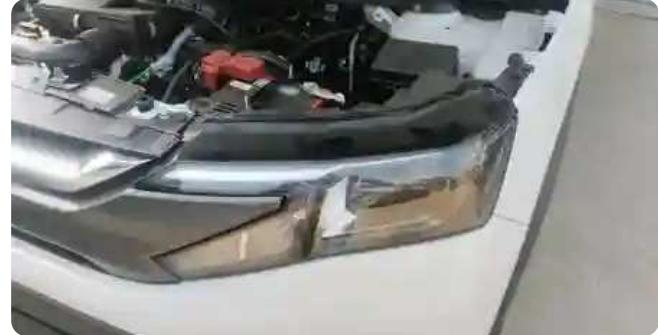
Light LHS Headlight: Damaged

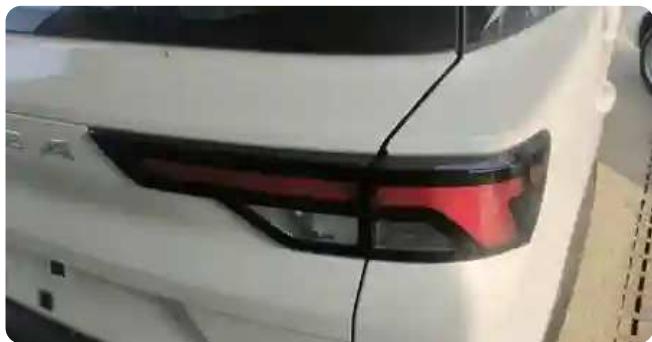
Light RHS Taillight: Damaged

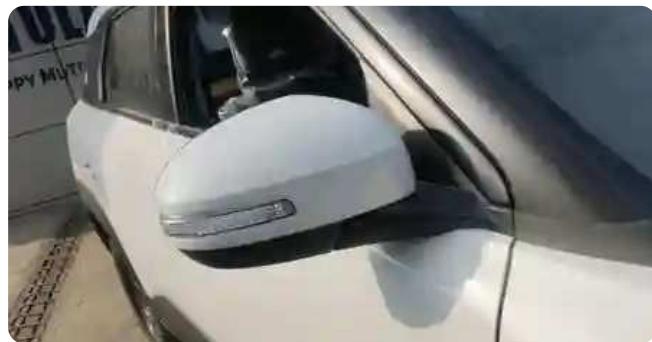
ORVM - Manual / Electrical RHS: Scratched

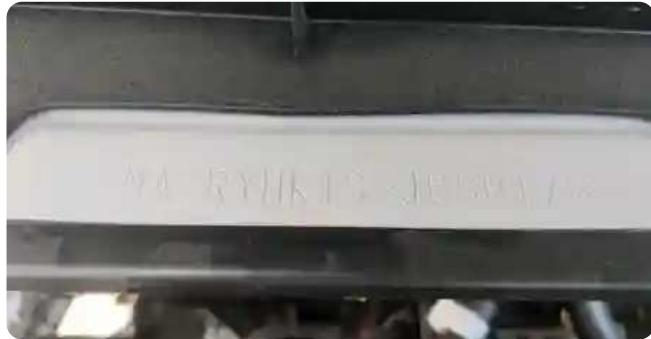
Chassis Embossing: Ok

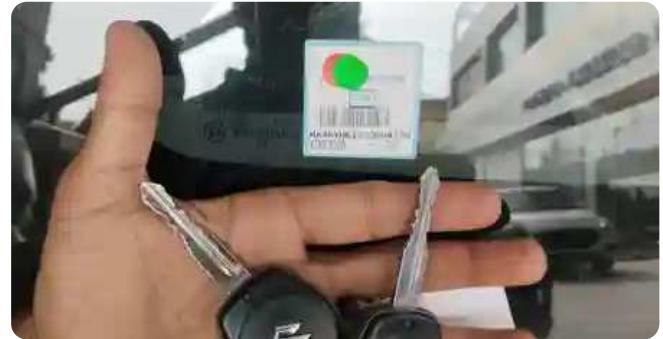
Duplicate Key: Yes
