# 2023 Turkey Earthquake Virtual Report on Geotechnical Impacts

Report Date: 2/9/2023

Geotechnical Extreme Events Reconnaissance (GEER) Association

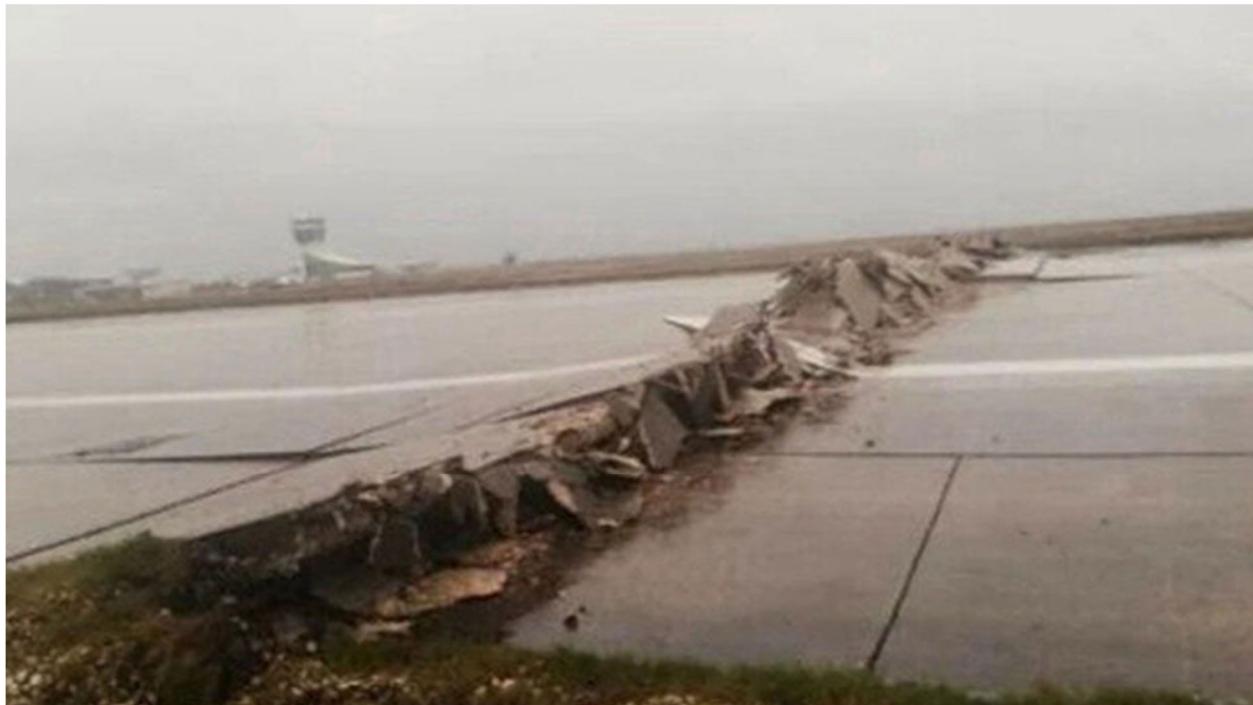
Critical infrastructures such as roads, viaducts, airports, railways, and hospitals were reported as collapsed or heavily damaged.

**Figure 2:** Damage to Hatay Airport runway  
[\(<https://www.ozgurkocaeli.com.tr/haber/13964829/hatayda-deprem-sonrasi-havaalanı-pistiyikildi>\)](https://www.ozgurkocaeli.com.tr/haber/13964829/hatayda-deprem-sonrasi-havaalanı-pistiyikildi)

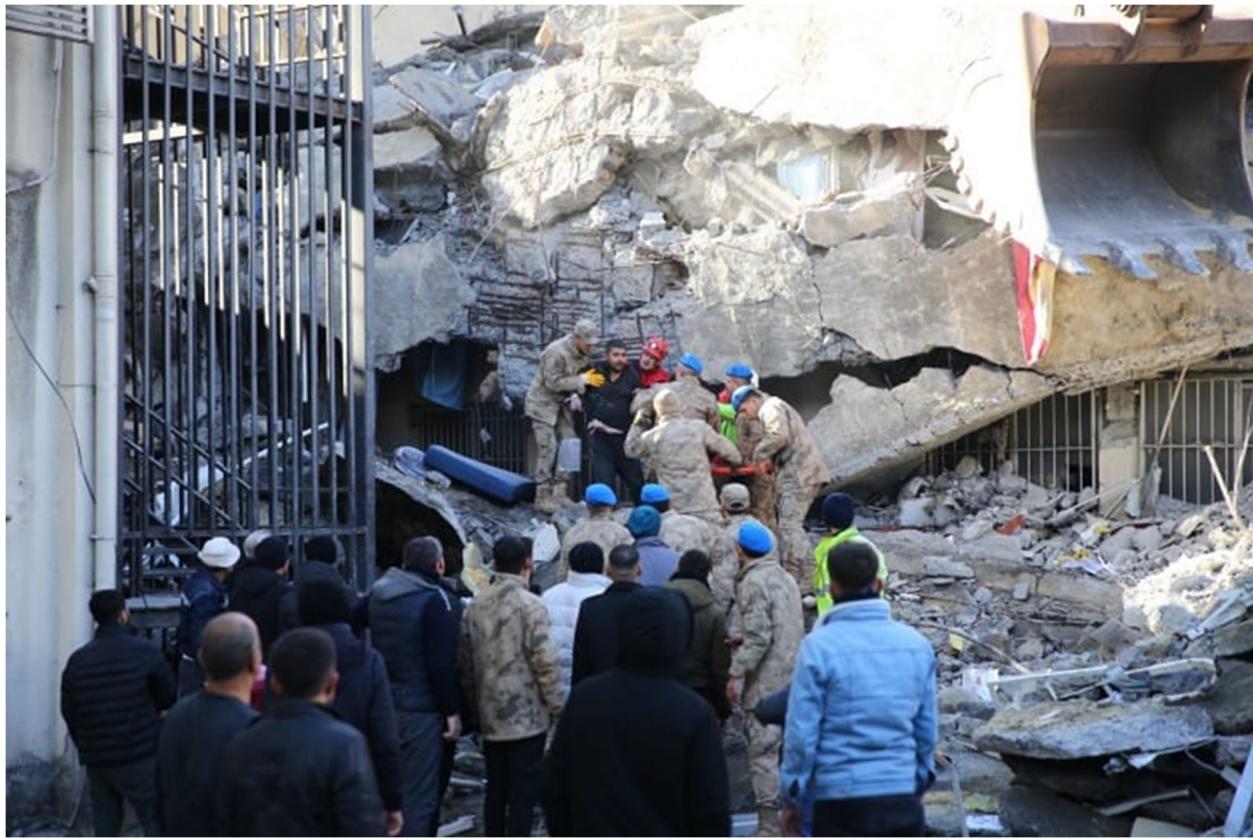
**Figure 3:** Collapsed state hospital in İskenderun, Hatay (<https://www.diken.com.tr/hastane-nasil-yikilir/>)

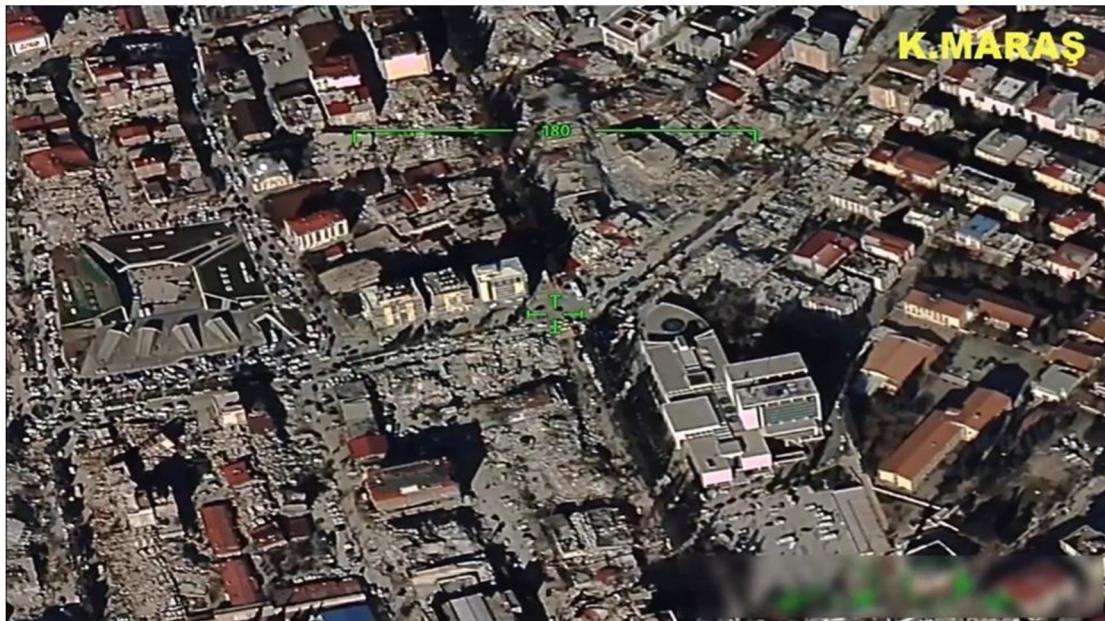
**Figure 4:** An image taken by UAV from Kahramanmaraş  
(<https://www.milliyet.com.tr/galeri/buyuk-afette-ucuncu-gun-deprem-bolgesinde-zamana-karsi-yaris-6900343/1>)

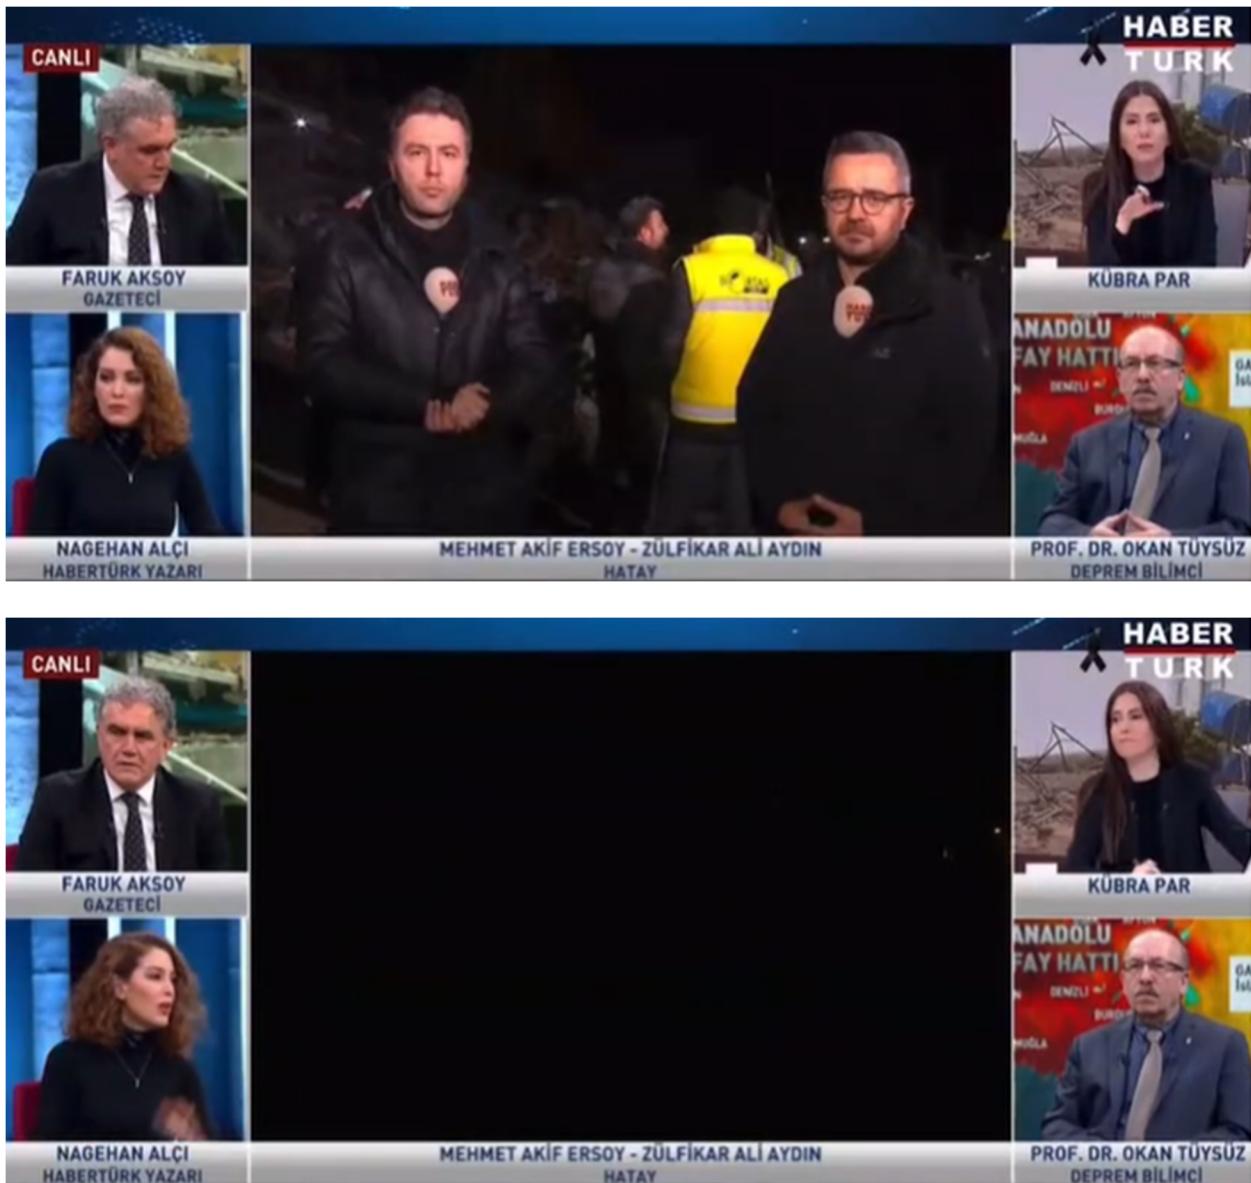
One reporter showed the lack of lighting during the search and rescue on the second day of the earthquake in Hatay. The only lighting rescuers had in the field was the lighting of the camera crew.

**Figure 5:** A live Turkish news broadcast showing no lighting in the field (February 7)

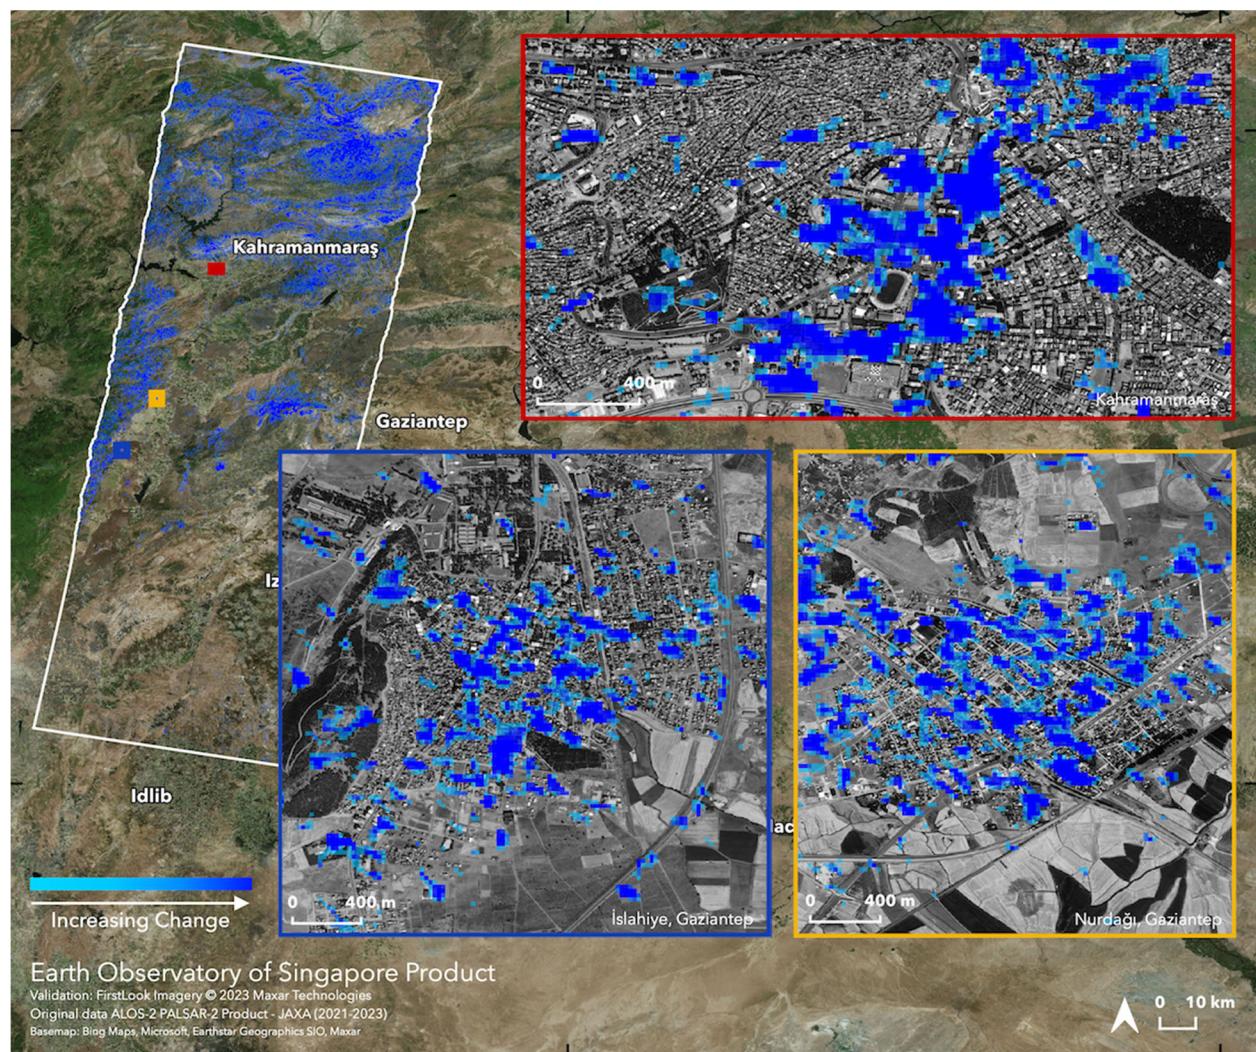
One of these products is the Damage Proxy Map (DPM), which highlights the areas that likely suffered damage after the earthquake. This dataset was computed using synthetic aperture radar (SAR) images captured by the ALOS-2 satellite before the event (from April 2021 to April 2022), and after the event (February 8 2023).

**Figure 11:** Damage Proxy Map (Source: Earth observatory of Singapore)

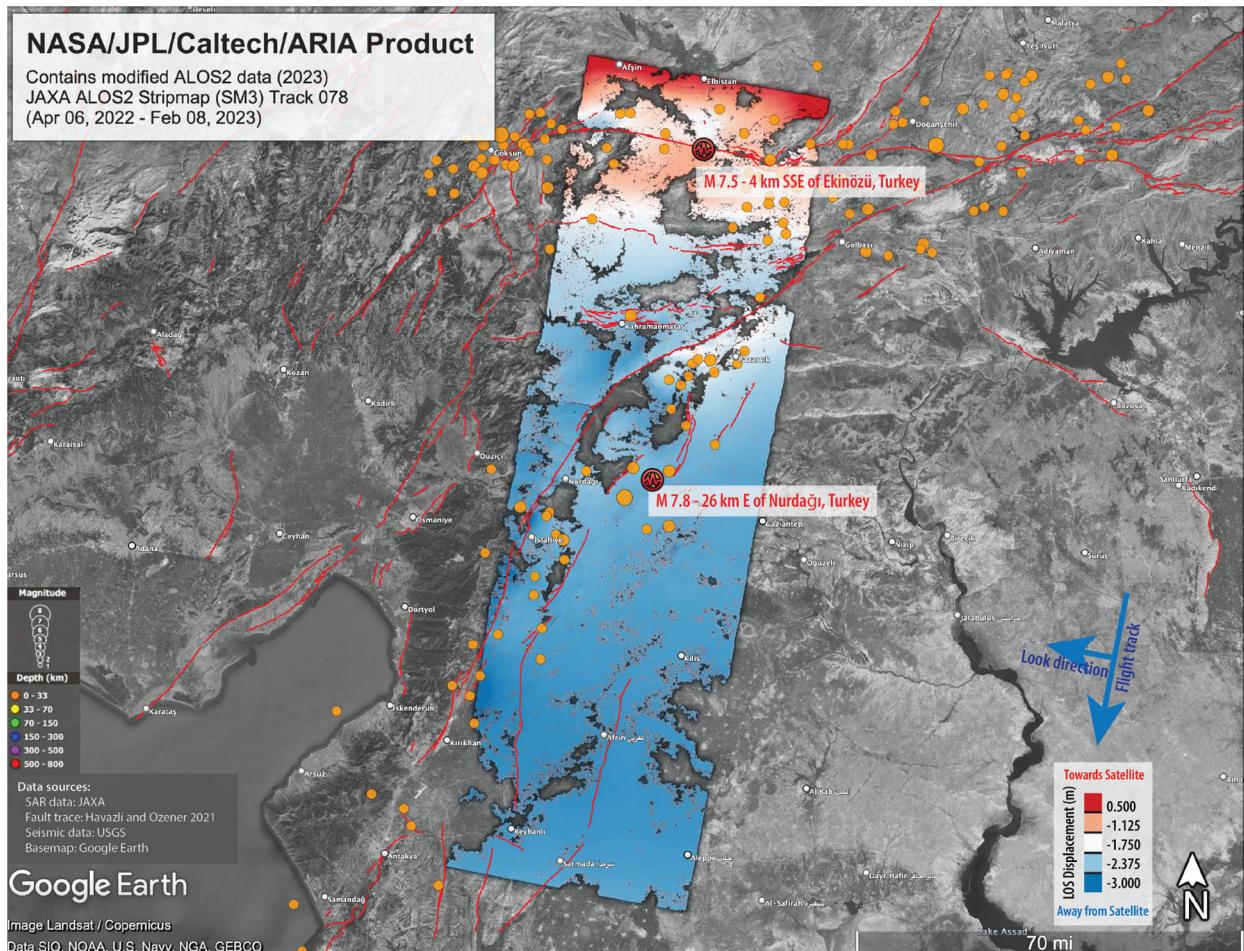
NASA JPL Laboratory has generated Stripmap displacement maps by computing the interferometric difference (interferogram or interferometric SAR) and pixel offset tracking between the post-event image acquired on February 8, 2023 with a pre-event image acquired on April 6, 2022, on the ALOS-2 descending (satellite moving south) track 78.

**Figure 12:** Preliminary dataset on surface displacement (Source: NASA JPL)

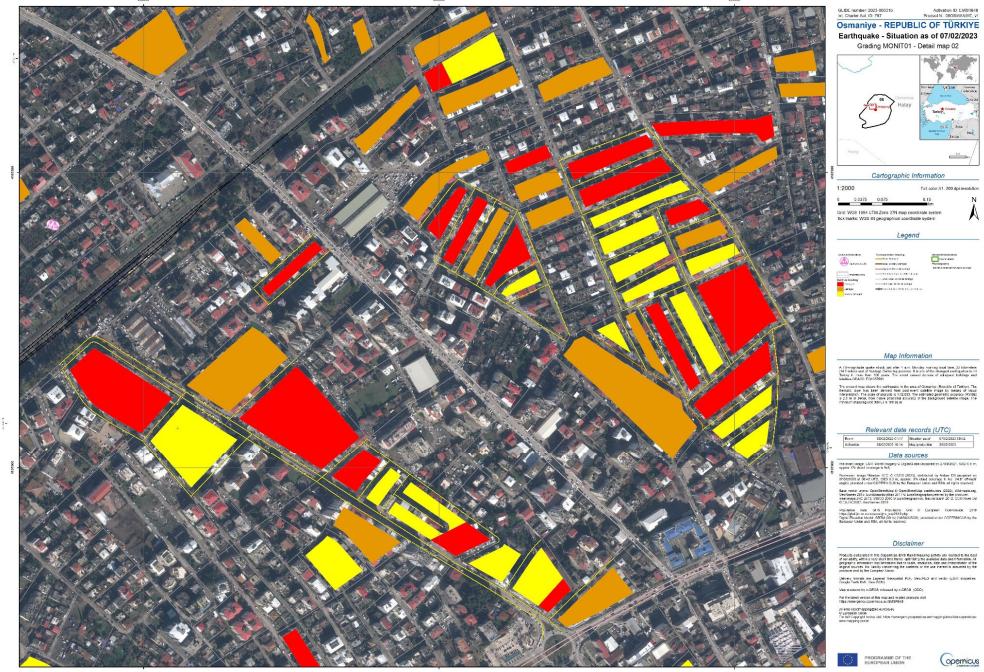
For each of these areas, satellite imagery is used to manually identify damage to infrastructure. The next figure shows the damage grading product for Osmaniye (Turkey) where red areas represent Destroyed, orange Damaged, and yellow Possibly Damaged. A larger grading product was released for the city of Kahramanmaraş.

**Figure 14:** Damage grading in Osmaniye (Source: Copernicus EMS)  
[https://emergency.copernicus.eu/mapping/ems-product-component/EMSR648\\_AOI06\\_GRA\\_MONIT01\\_r1\\_RTP02/1](https://emergency.copernicus.eu/mapping/ems-product-component/EMSR648_AOI06_GRA_MONIT01_r1_RTP02/1)

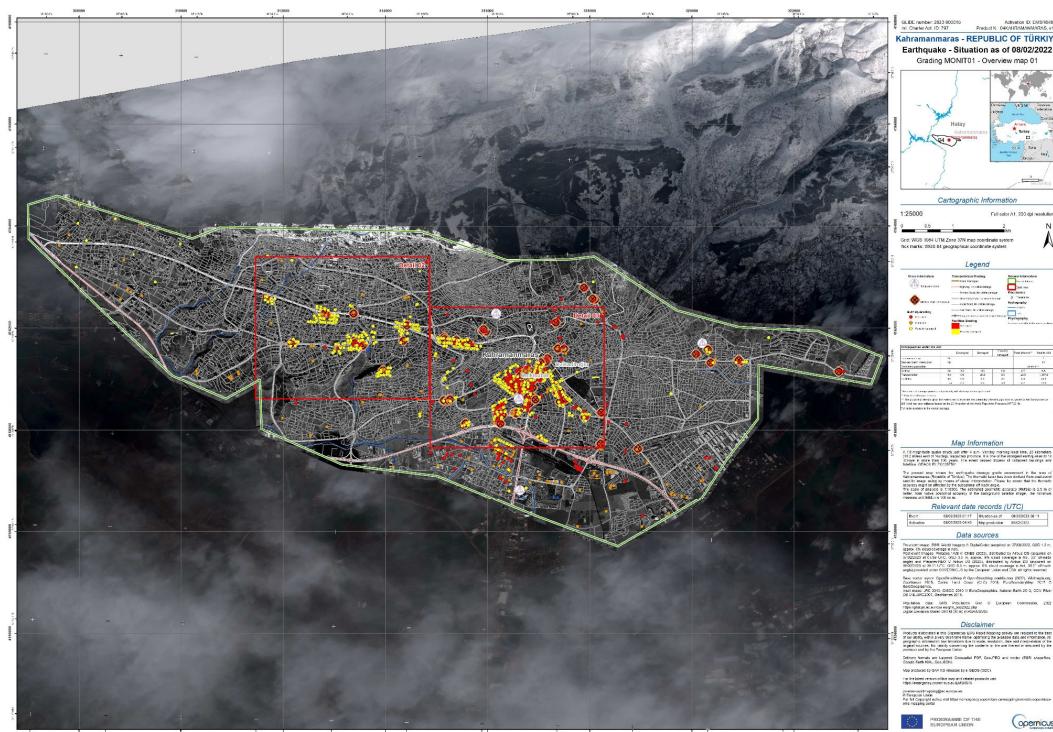
**Figure 15:** Damage grading in Kahramanmaraş (Source: Copernicus EMS)  
[https://emergency.copernicus.eu/mapping/ems-product-component/EMSR648\\_AOI04\\_GRA\\_MONIT01\\_r1\\_RTP01/1](https://emergency.copernicus.eu/mapping/ems-product-component/EMSR648_AOI04_GRA_MONIT01_r1_RTP01/1)

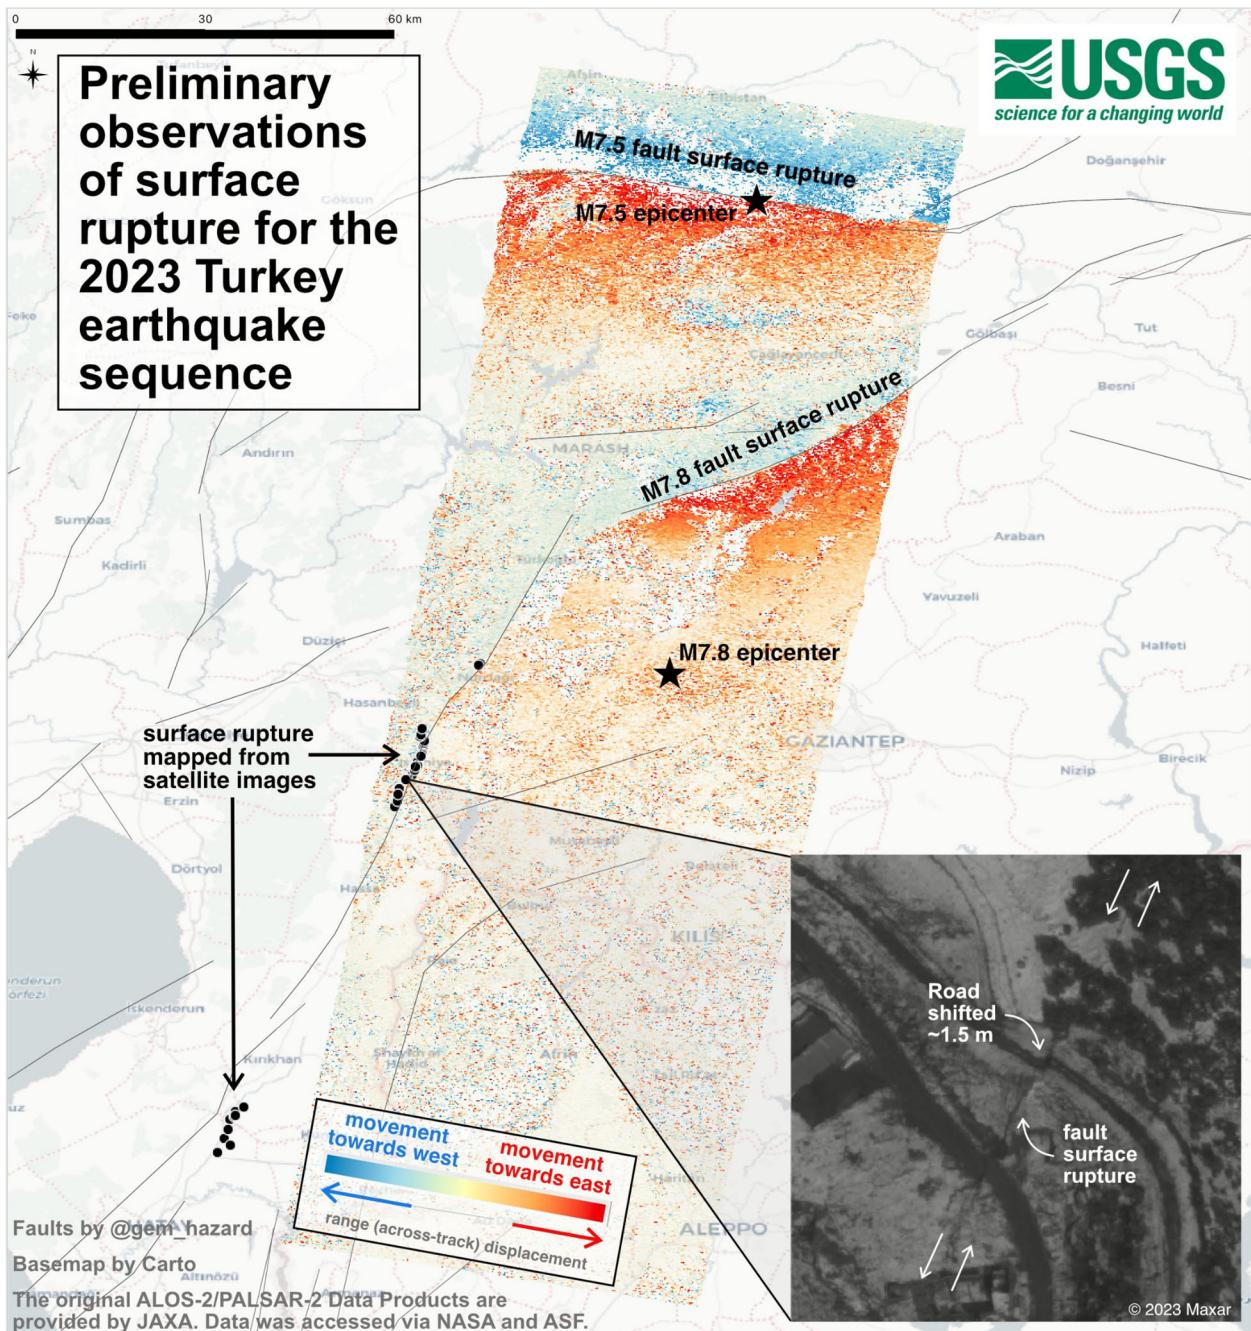
**Figure 16:** Surface Rupture estimation from satellite imagery (Source: @USGS\_Quakes on Twitter)

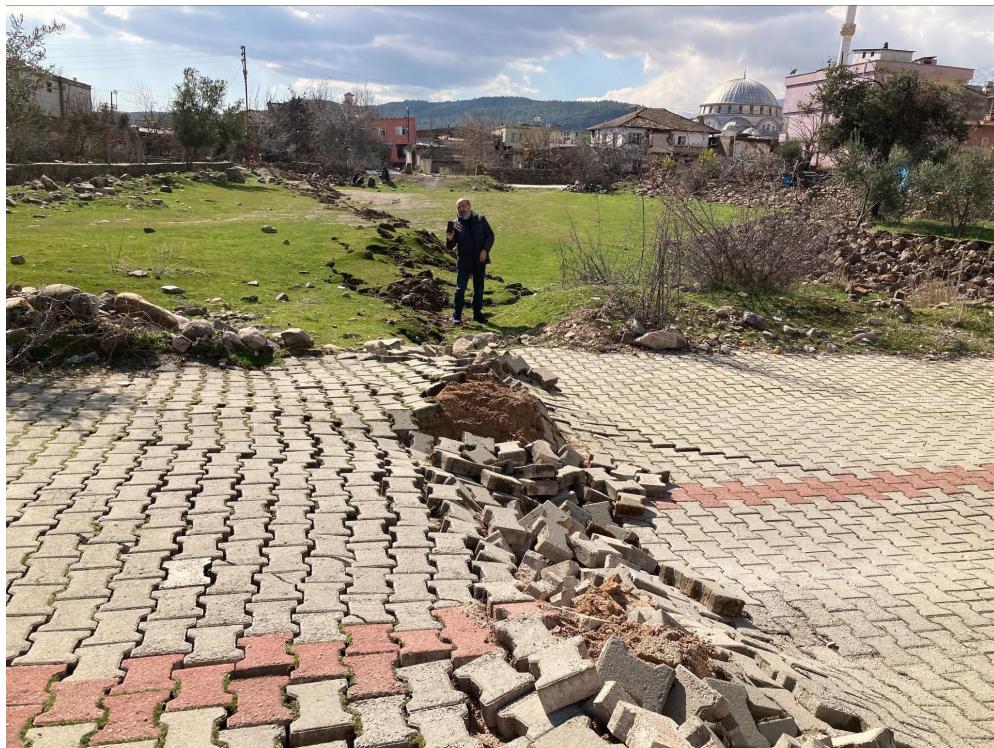
**Figure 17:** Surface rupture observed in residential neighborhood near Hessa (Source: <https://twitter.com/ziyadin/status/1623288689894871046/photo/1>)

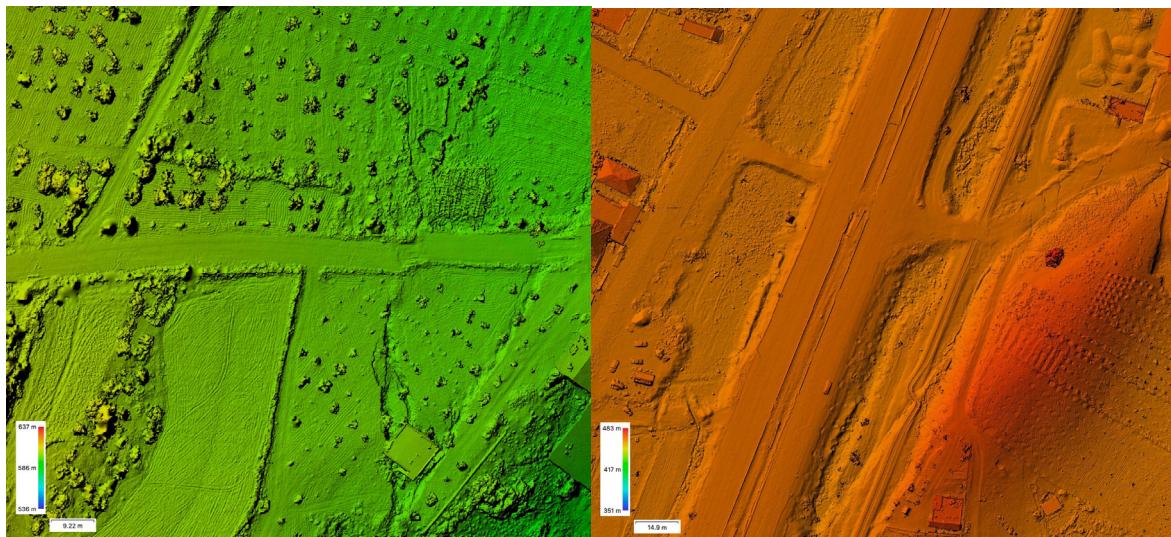
Professor Cengiz Zabcı from Istanbul Technical University (ITU) generated some of the first UAV-based digital Surface Models (DSMs) of the surface rupture.

**Figure 18:** UAV-based Digital Surface Model in Şekeroba, Turkey (Source: Twitter Cengiz Zabcı <https://twitter.com/CengizZabci/status/1623569420554493953>)

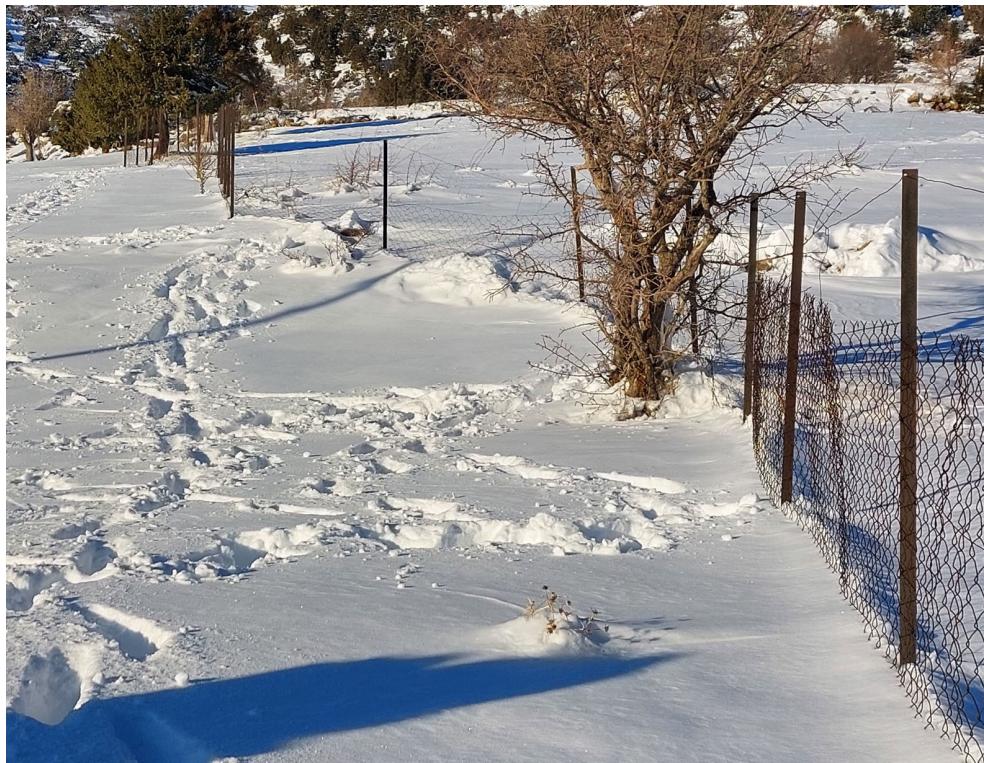
**Figure 19:** Ground displacement in Kahramanmaraş measured by fence offset of 6.7m

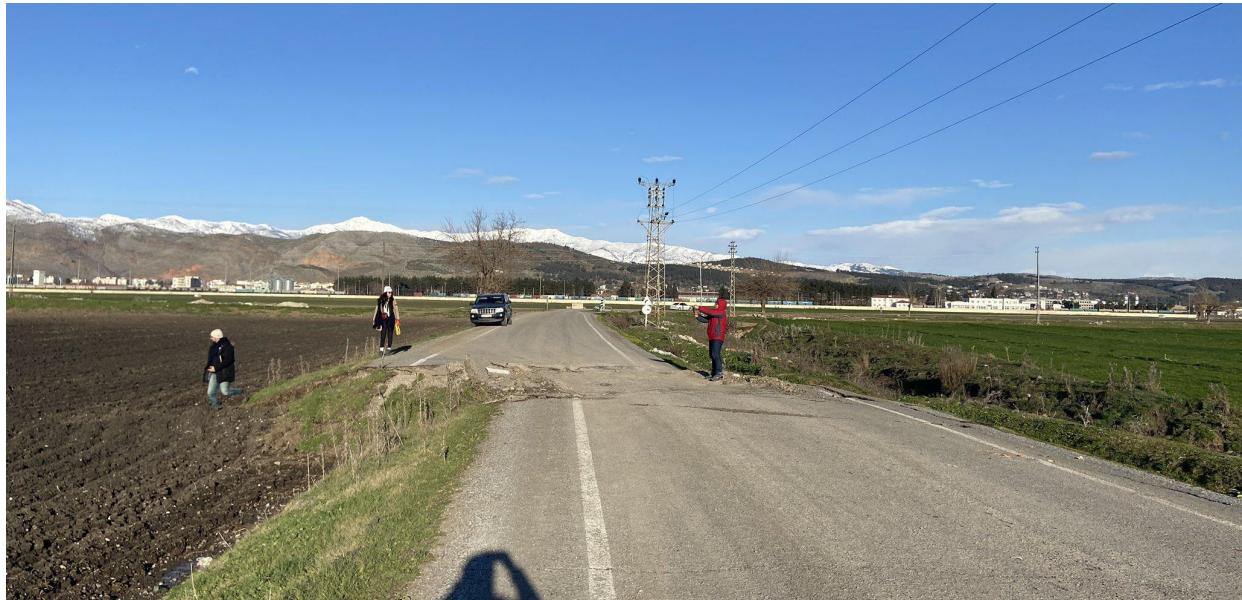
**Figure 20:** Road damage in Kahramanmaraş/Türkoğlu. 3.3m of displacement (Source: Twitter Cengiz Zabcı). <https://twitter.com/CengizZabci/status/1623236487687929857/photo/1>

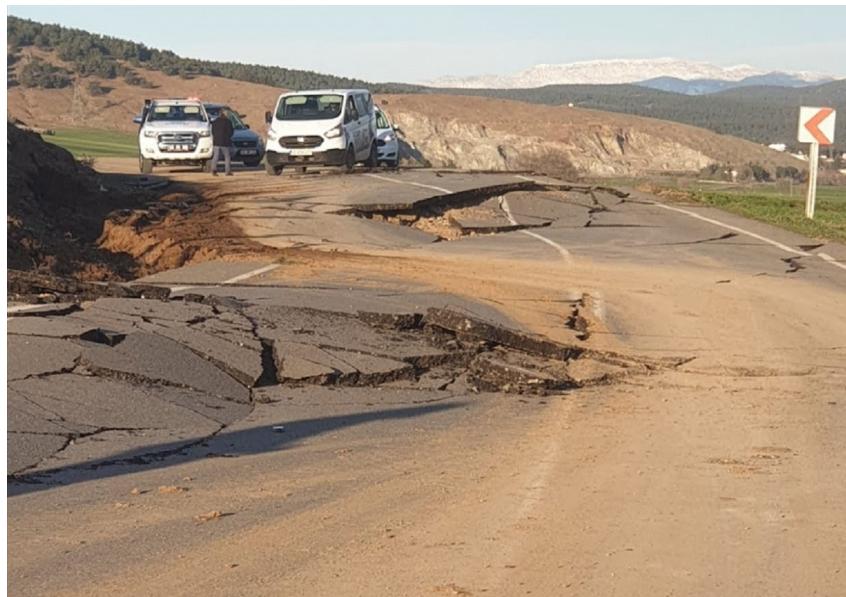
**Figure 21:** Road damage in Tevekkelli, Tevekkelli Village Road, 46090. (Source: Twitter Zeliş; [https://twitter.com/Panthalassa\\_Z/status/1623237597752352769](https://twitter.com/Panthalassa_Z/status/1623237597752352769))

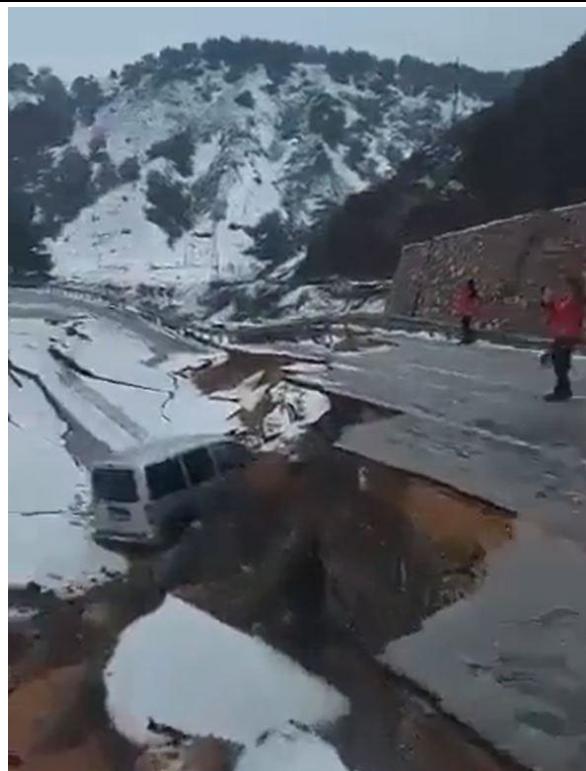
**Figure 22:** Lateral flow landslide on the road between Adana and Gaziantep (Source: Twitter video Sokagin Sesi Gazetesi; <https://twitter.com/sokaginsesigaz1/status/1622689001332215853>)

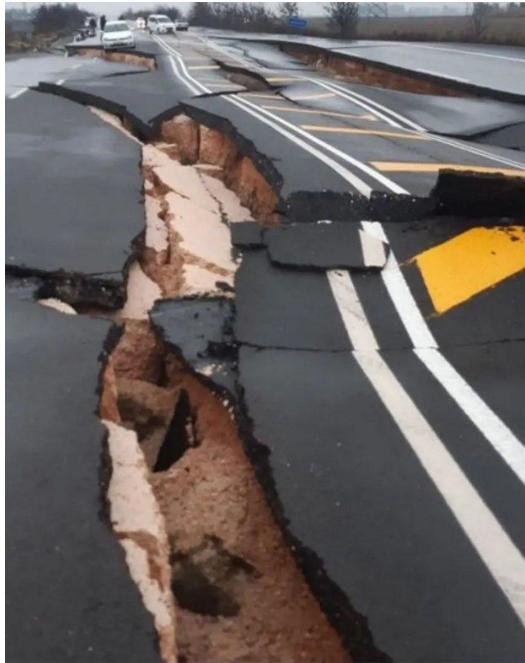
**Figure 23:** Road in Hatay, Turkey completely split open. (Source Video: Video <https://twitter.com/porcumali/status/1622594257176469506>)

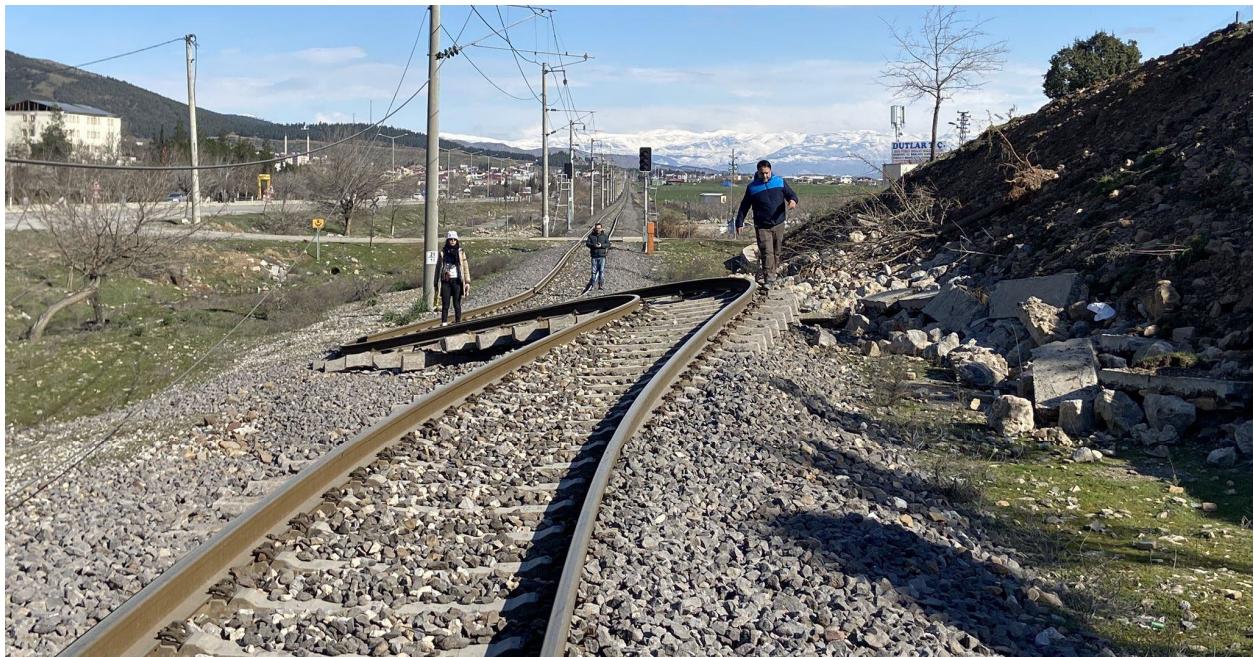
**Figure 24:** Surface displacement in Şekeroba highlighted by rail displacement (Source: Twitter Cengiz Zabci <https://twitter.com/CengizZabci/status/1623236454926229504/photo/1>)

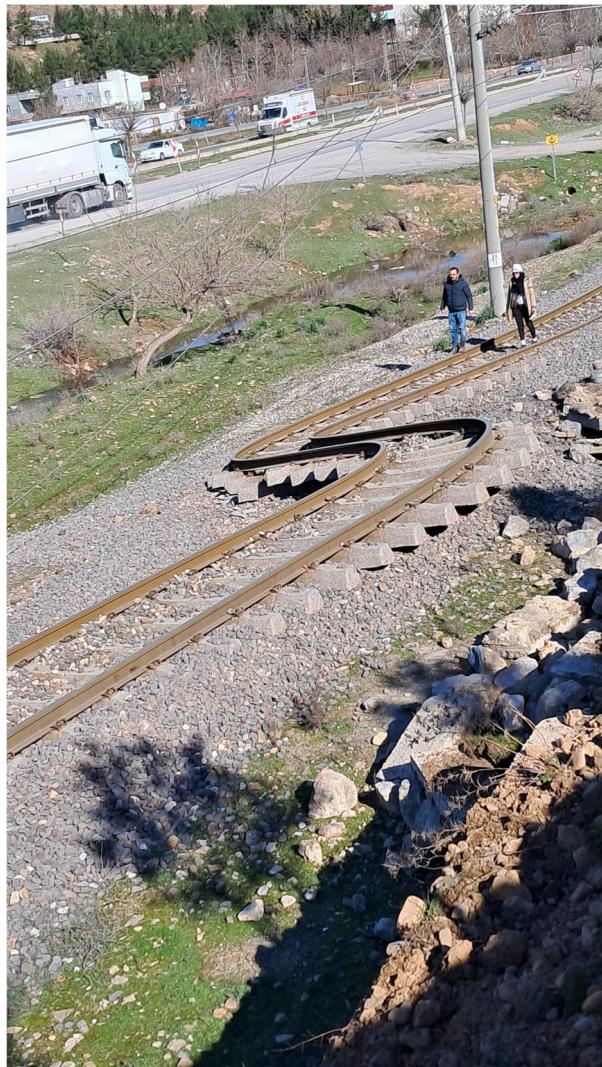
**Figure 25:** Surface displacement in Şekeroba highlighted by rail displacement (Source: @akyuz24 on Twitter)

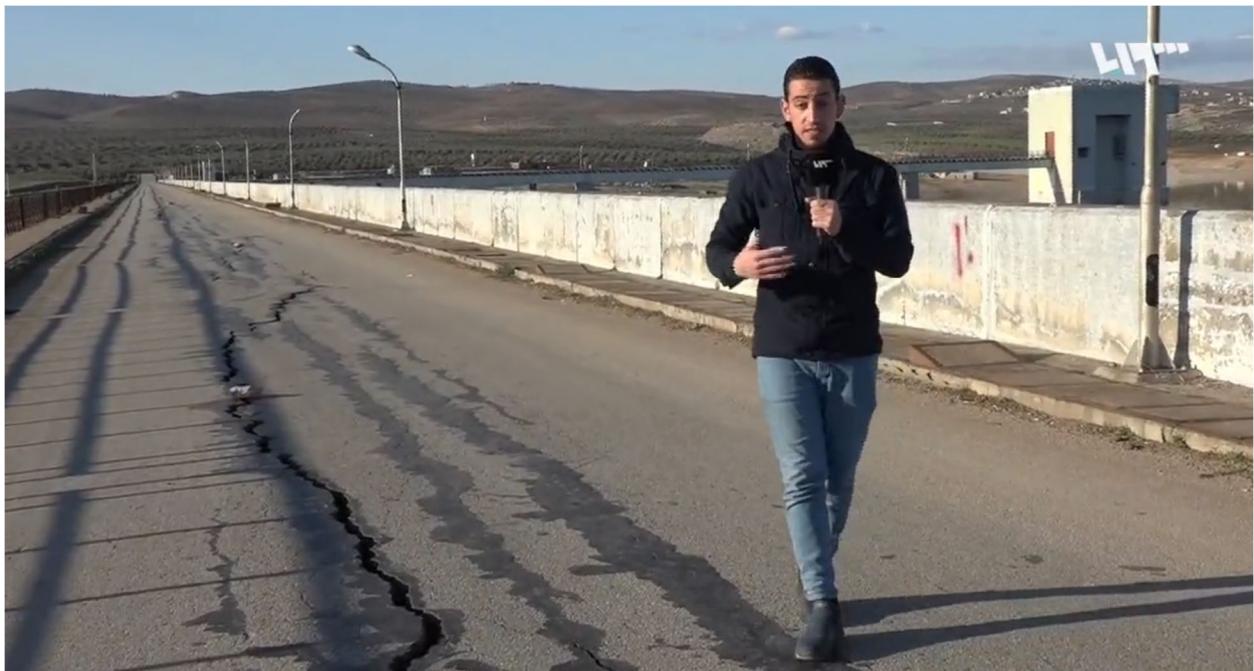
**Figure 27:** Cracking in the Afrin Dam (Source:  
<https://twitter.com/Hibakarm/status/1623723294686838784>)

The earthquake sequence resulted in the cracking of the Afrin Dam and the subsequent flooding of a downstream Syrian enclave, al-Tlul. There have been no further reports of flooding or damage, and no evacuation notices have been sent. Additionally, the Ataturk dam, the third largest dam in the world, has been cleared of any damage or impacts resulting from the earthquakes.

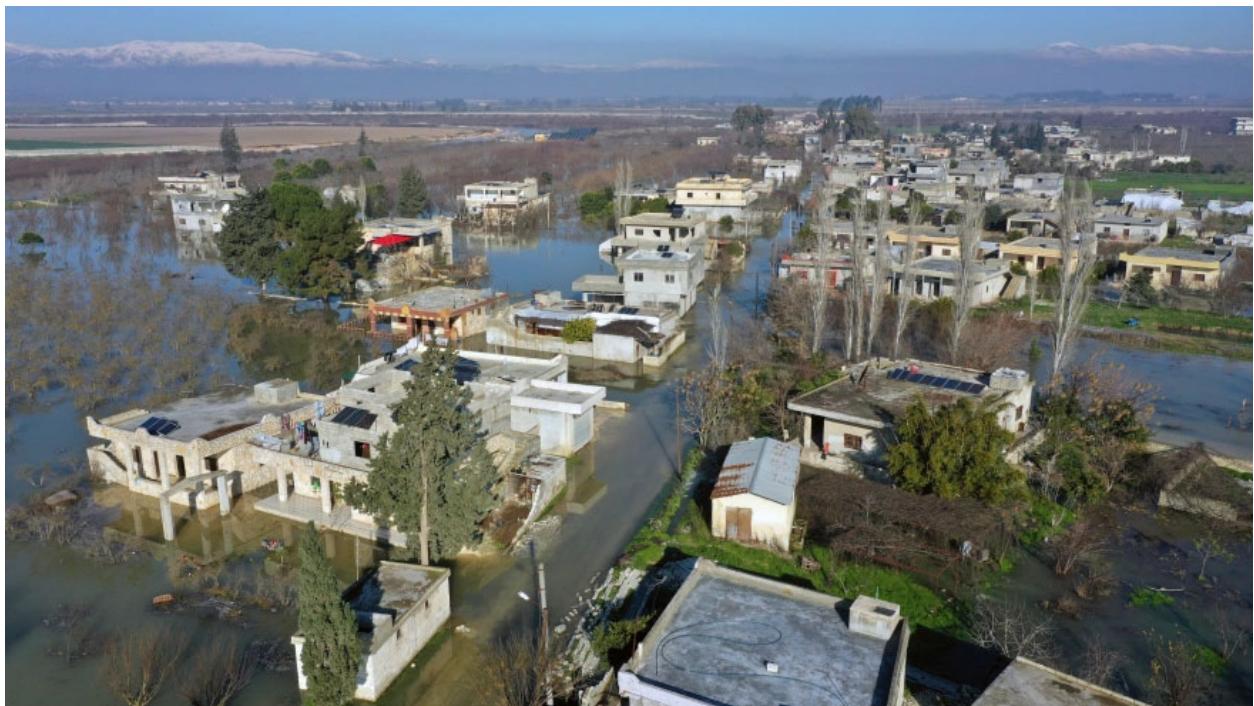
**Figure 28:** Aerial view of the al-Tlul village, where damage to the Afrin dam led to flooding  
(Photo Credit: AP Photo/Ghaith Alsayed).

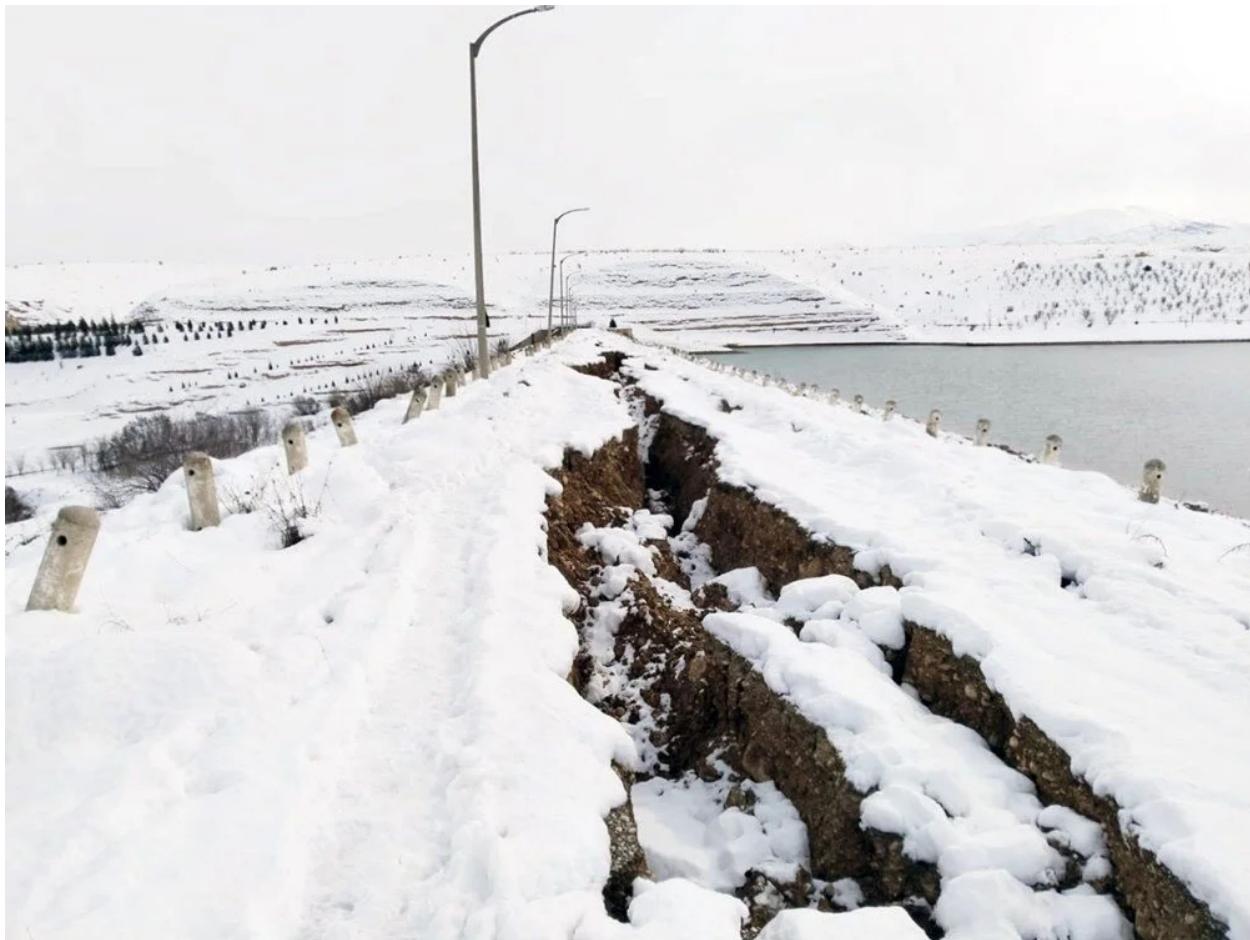
**Figure 29:** Cracking damage observed in the Sultansuyu Dam (Source:  
<https://www.ntv.com.tr/galeri/turkiye/govde-aksinda-catlaklar-olusan-malatyadaki-sultansuyu-baraji-tahliye-ediliyor,xxRN92Huy0iiG0tyCNu4fA/aimTJcX5X0egL7OUo5ez0Q>)
