# **Floods at Bengaluru City - A Technical Study**

**Dr. Sudhir Sajjan, B.E., M.B.A., Ph.D.**  
sajjan.sudhir@gmail.com

**December, 2022**

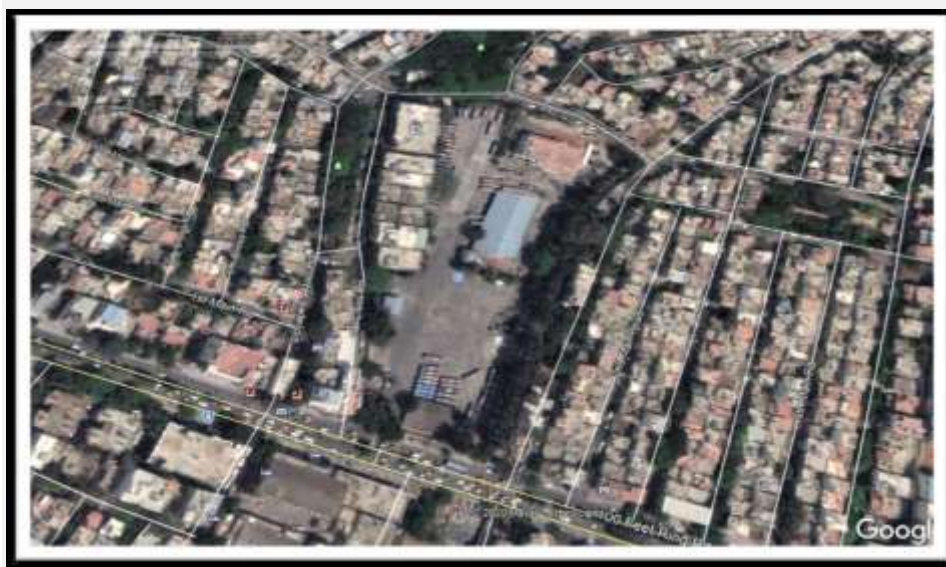
*Chennamma kere*

**Exhibit 3.2: Current status of disused lakes**

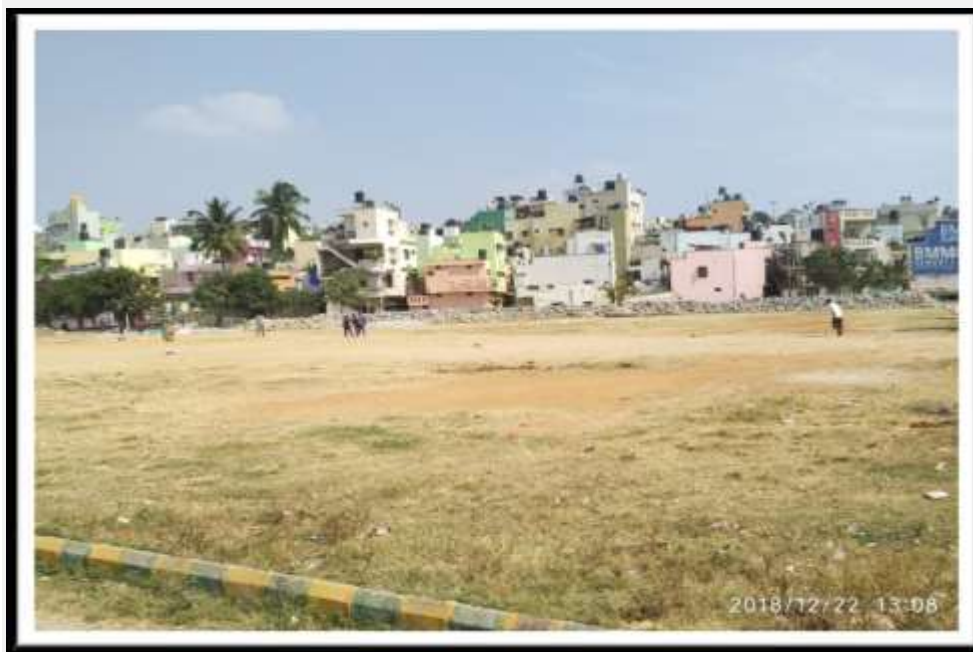
***Kamakshipalya lake converted as sports ground***

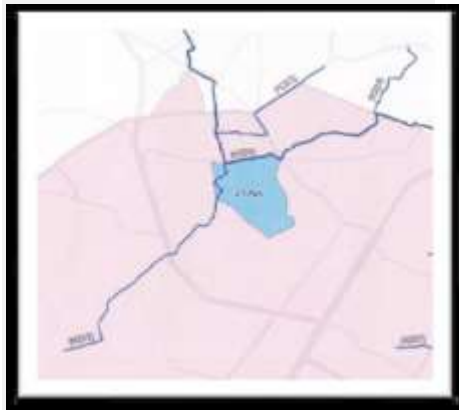
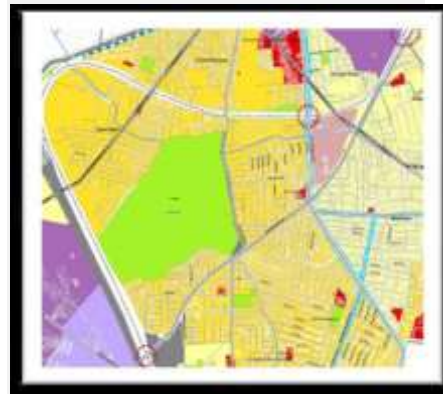
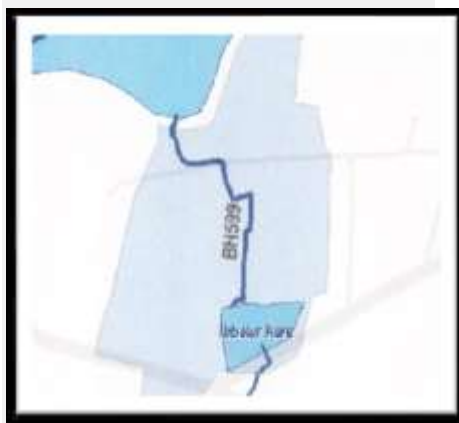
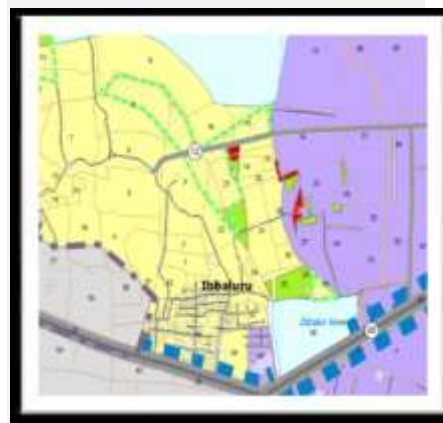
**Exhibit 4.1: Illustrative photographs showing drains/water bodies not mapped in RMP-2015 (shown in red rectangles)**

*Shown as a water body*

*Shown as a park*

*SWD shown between Bellandur and Ibbalur tanks*

*No connectivity between two tanks*

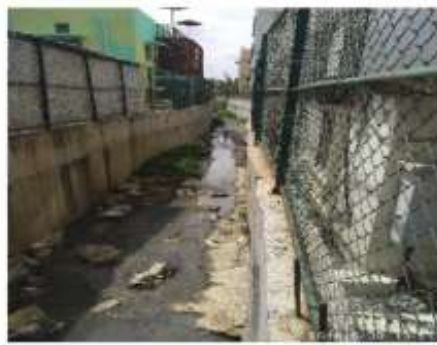
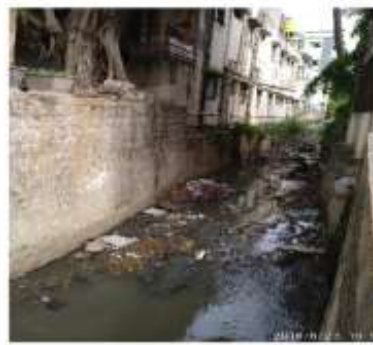
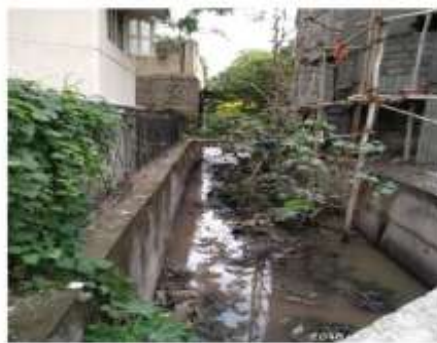
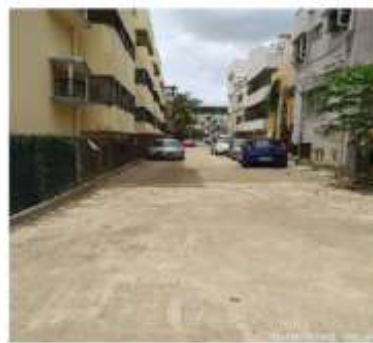
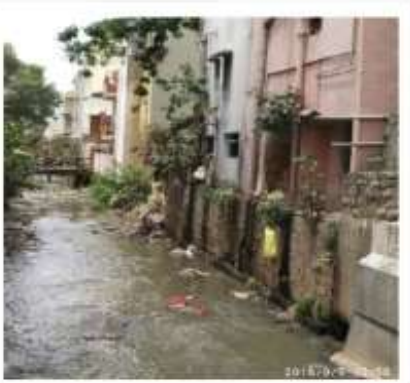
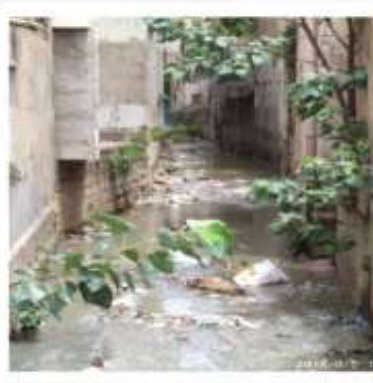
The lapses indicated above facilitated unabated construction along the drains without allowing the required buffer area. Photograph captured during joint inspection showing construction without allowing buffer area along SWDs are shown in **Exhibit 4.2**.

**Exhibit 4.2: Illustrative photographs showing construction of buildings allowed without buffer area along storm water drains**

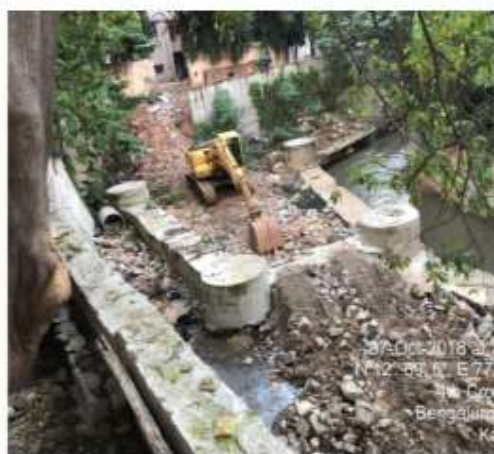
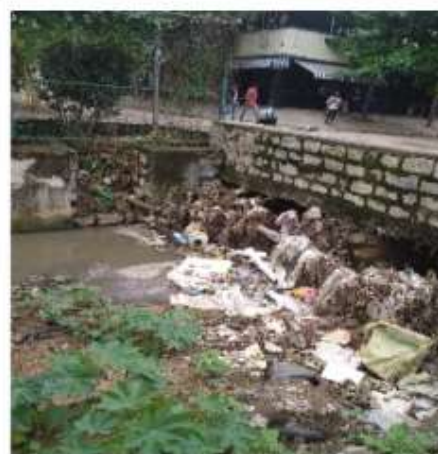
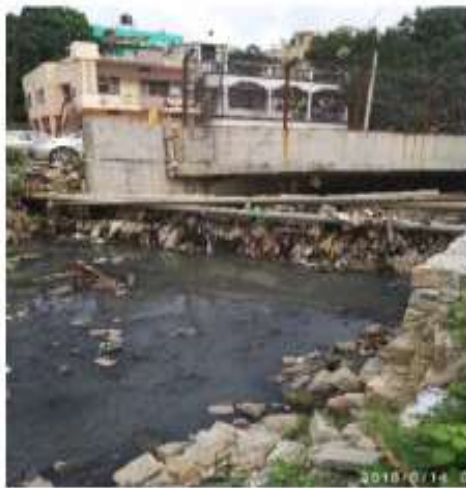
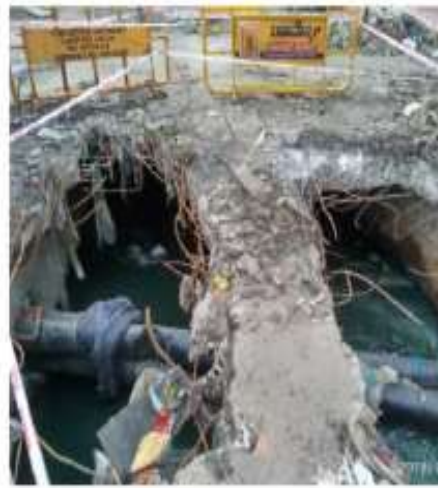
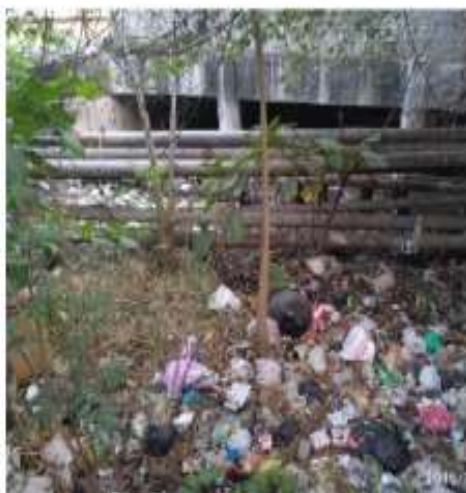
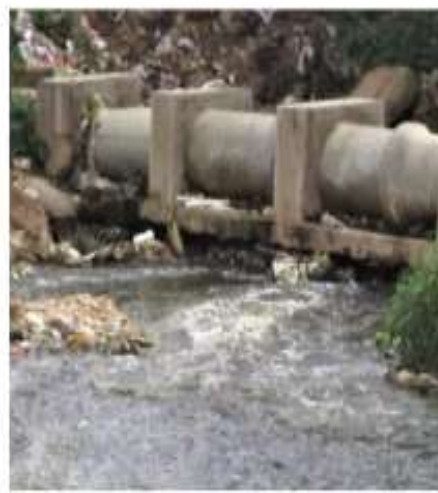
- hamper regular maintenance of the drains.
- impact one of the purposes of creating a buffer zone *i.e.*, to provide space for laying of utilities. Audit observed that many utility lines like water pipes, sanitation pipes, electrical, telephone, optical cable, *etc.*, were laid across the drains in many locations obstructing the flow in drains and overflows (**Exhibit 4.4**). The absence of buffer zone also results in encroachments as indicated in Paragraph 5.1.3.

**Exhibit 4.4: Photos showing the presence of utility lines in SWDs**

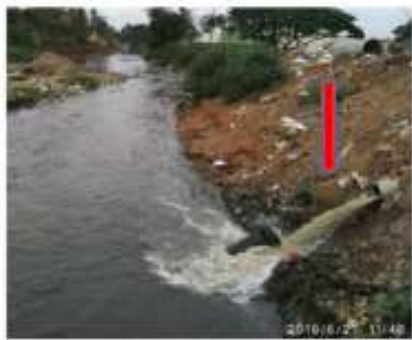
The joint inspection of drains confirmed the existence of sewerage lines within SWDs. Further, audit noticed sewage being discharged into the SWDs directly or through fractured manholes at many places (**Exhibit 5.2**). This can be attributed to the absence of regular inspections by BBMP as indicated in Paragraph 5.2.1. Consequently, none of the SWDs were dry irrespective of the rainfall.

*Direct discharge of sewage into SWD at Pattanagere, RR Nagar Zone*

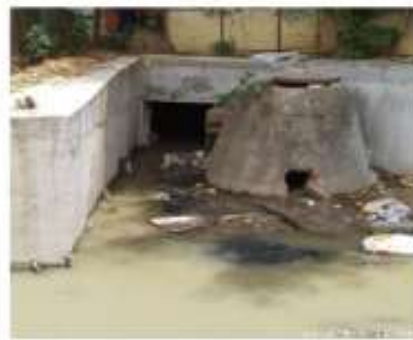
*Discharge of sewage into SWD through fractured manhole at Seshadripuram, West Zone*

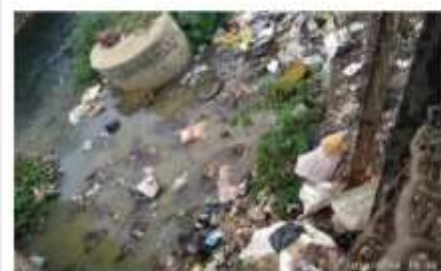
*Sewage flowing in SWD at Ejipura, Koramangala Zone*

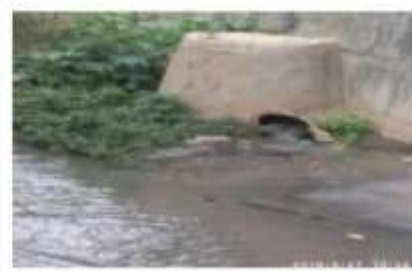
*Discharge of sewage into SWD through fractured manhole at Yeshwanthpur, RR Nagar Zone*

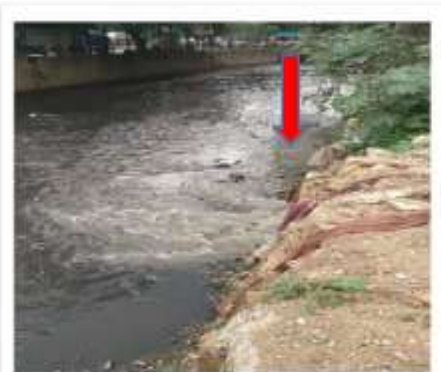
*Discharge of sewage into SWD through BWSSB pipeline at Silk Board Junction, Bommanahalli Zone*

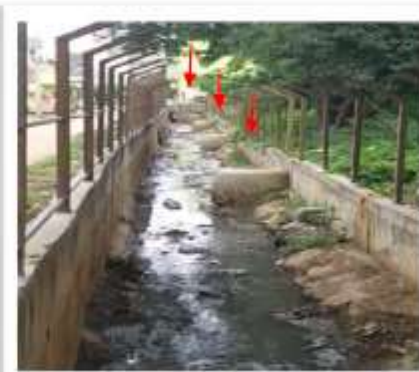
*Sewage flowing in the SWDs due to chain of fractured manholes in the drain connecting to Herohalli Lake, Dasarahalli Zone*

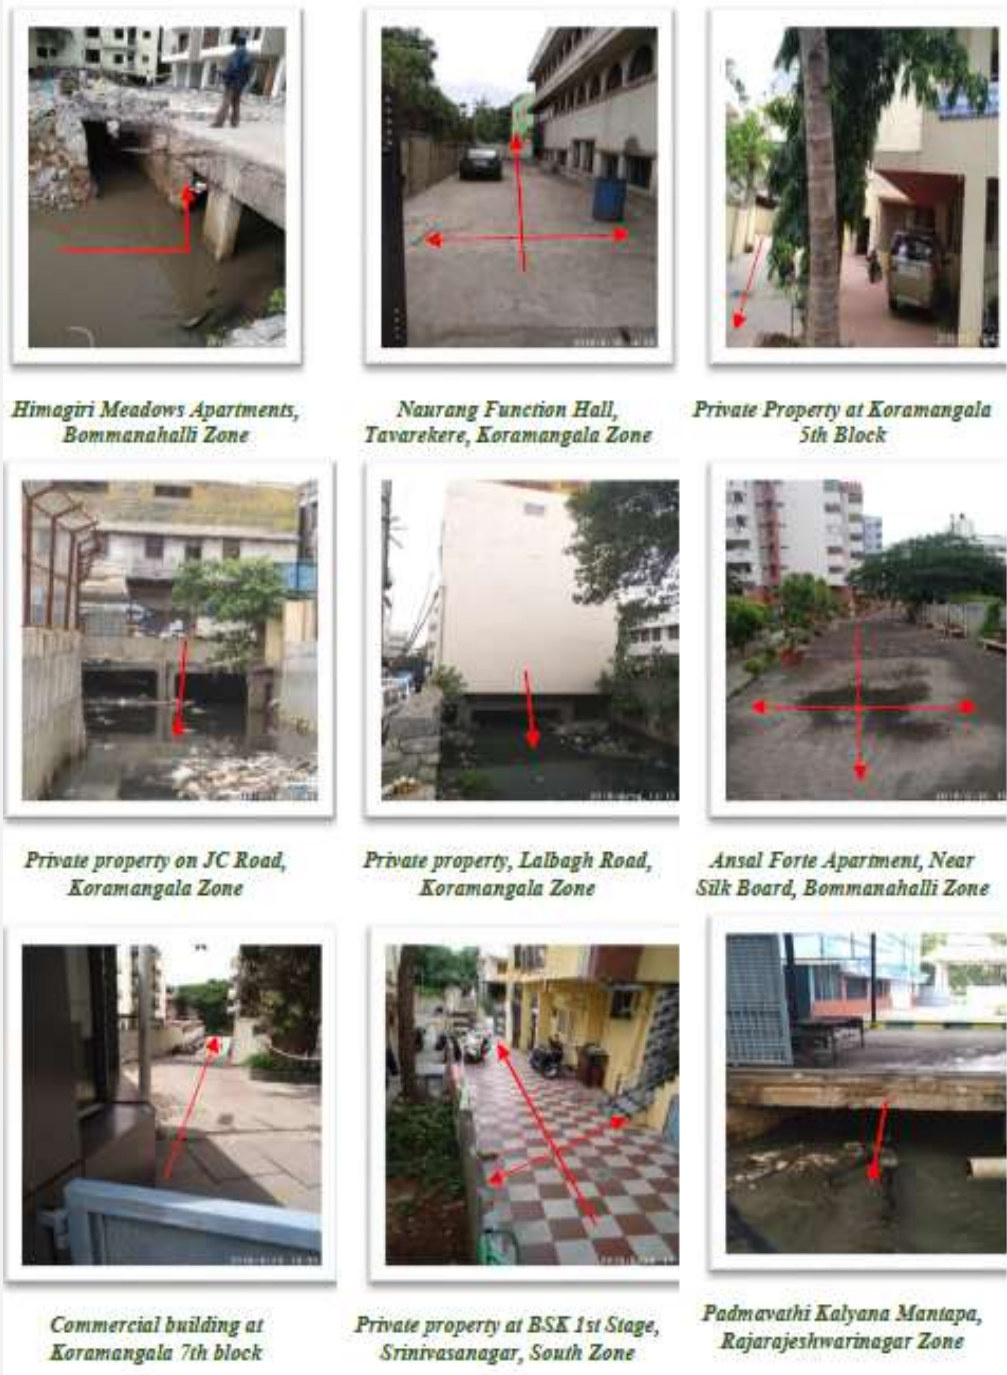
During the joint inspection of about 70 drains<sup>25</sup>, Audit observed 23 cases of significant encroachments (Exhibit 5.4) as listed in Appendix 5.1. Out of these, 16 cases were not in the list provided by BBMP. Thus, the completeness and reliability of the data on encroachments available with CE, SWD was doubtful.

**Exhibit 5.4: Photographs showing the encroachments on SWDs**

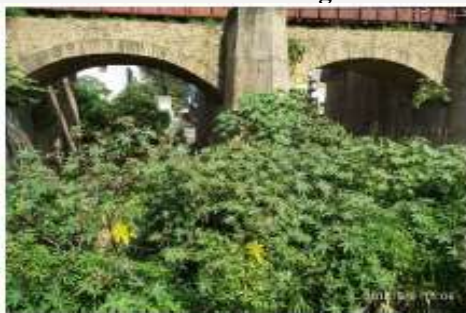
Audit observed during joint inspections of drains that SWDs were filled with debris, vegetation and were heavily silted indicating absence of regular maintenance of drains (**Exhibit 5.9**).

*Vegetation inside SWD at Magadi Road Railway Bridge, West Zone*

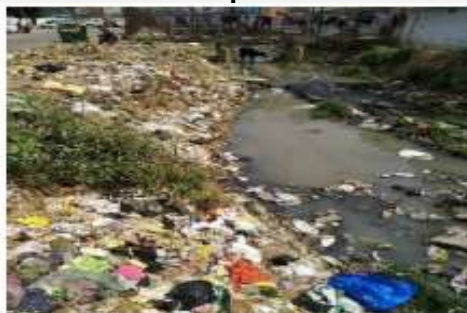
*Dumped debris/wastes and garbage inside SWD at Ejipura, Koramangala Zone*

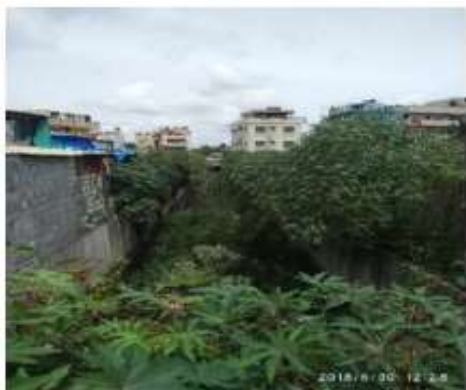
*Vegetation inside SWD Akshaya Nagar, Bommanahalli Zone*

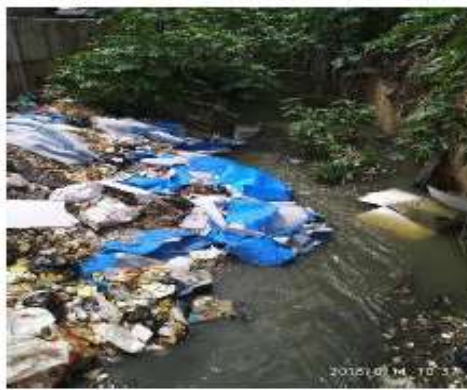
*Dumped wastes and garbage inside SWD near Football Stadium, Koramangala Zone*

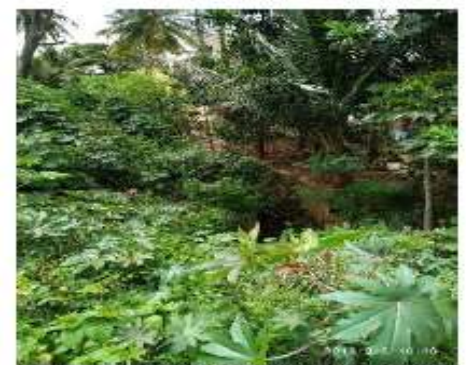
*Vegetation inside SWD at Vyalikaval, West Zone*

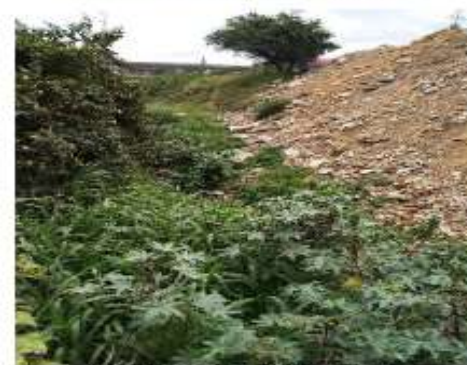
*Vegetation inside SWD at Peenya, Rajarajeshwarinagar Zone*

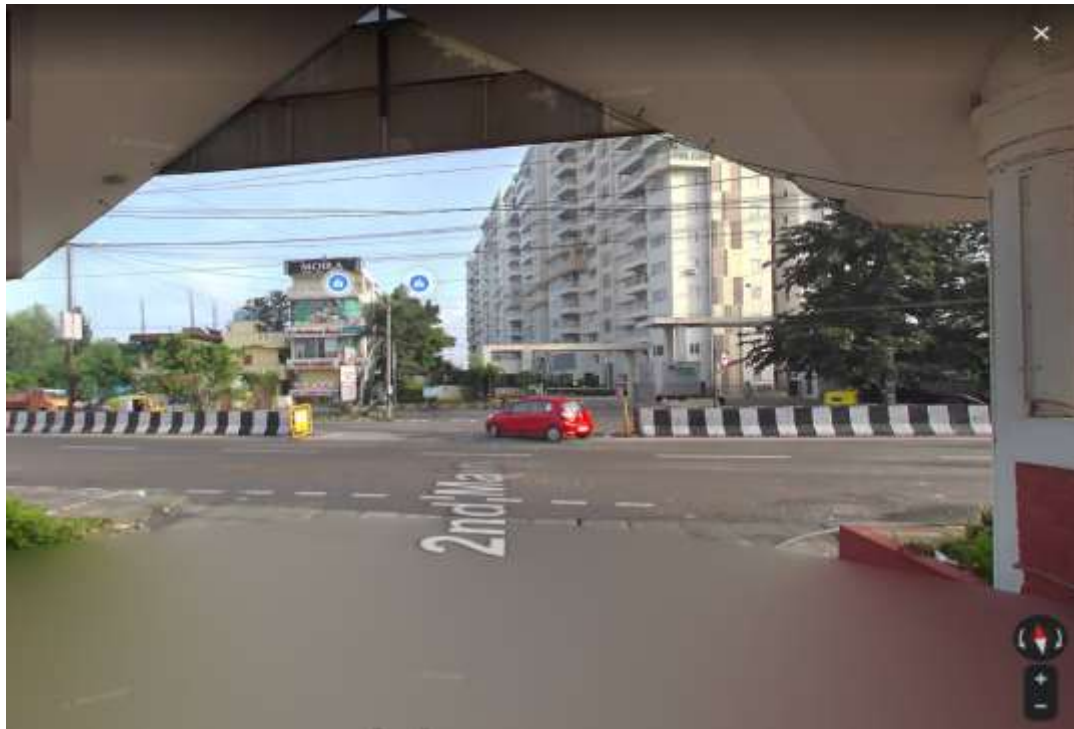
**Figure 6.5: A view of Sarjapur road from the entrance gate of RBD layout. Its level is significantly raised.**

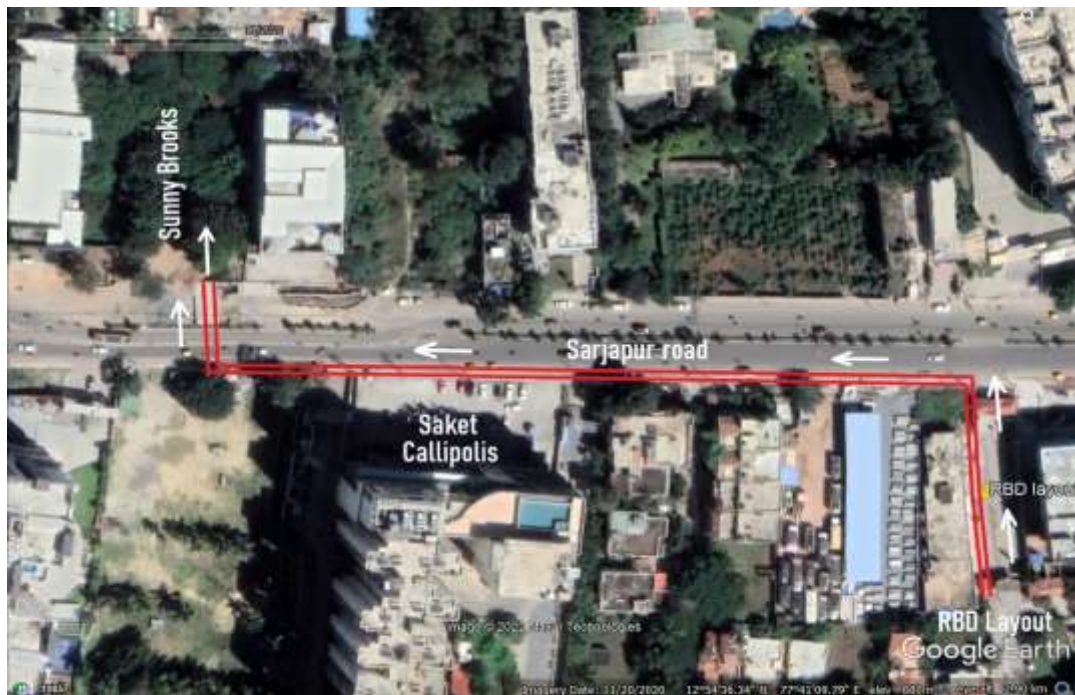
**Figure 6.6: The attempted stormwater drainage-1: In the absence of a planned stormwater drainage system, an attempt is made to regulate the discharge from Halanayakanahalli and Junnasandra lakes through sewage drain of the RBD layout, the drain on Sarjapur road and then connecting it to the culvert on it opposite to the open space between Saket Callipolis and Keerthi Regalia.**

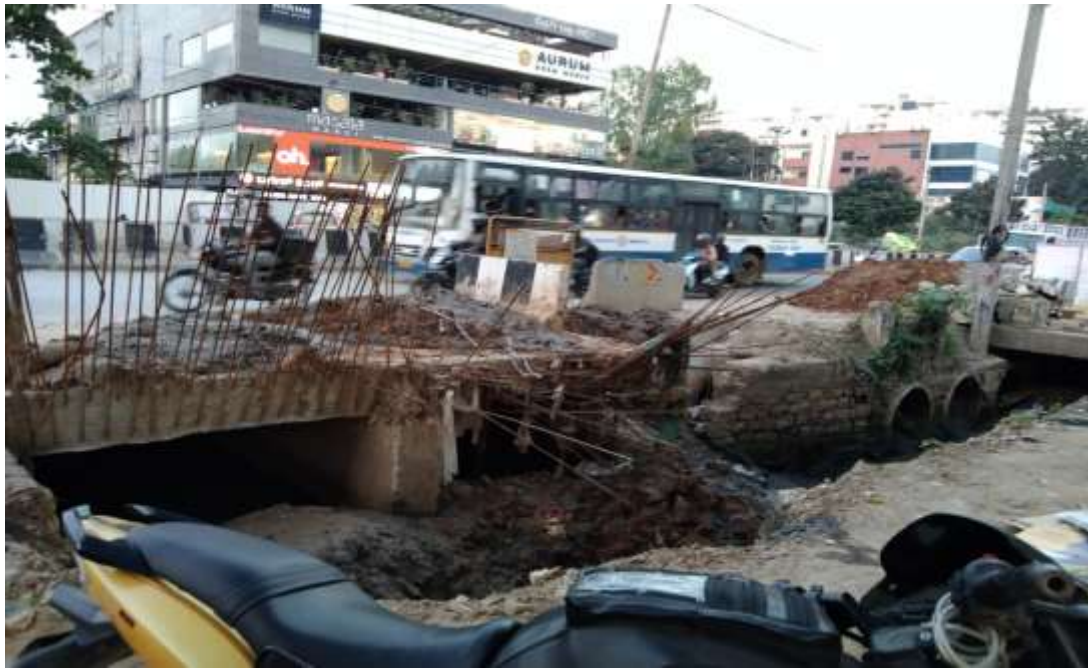
**Figure 6.7:** A view of the culvert on Sarjapur road in front of the open land between Keerthi Regalia and Saket Callipolis Apartments. There existed a pipe culvert earlier. A new one was built adjacent to it in 2020. There is no drain continued from it at the other end. It is completely filled up with soil and buried under the road.

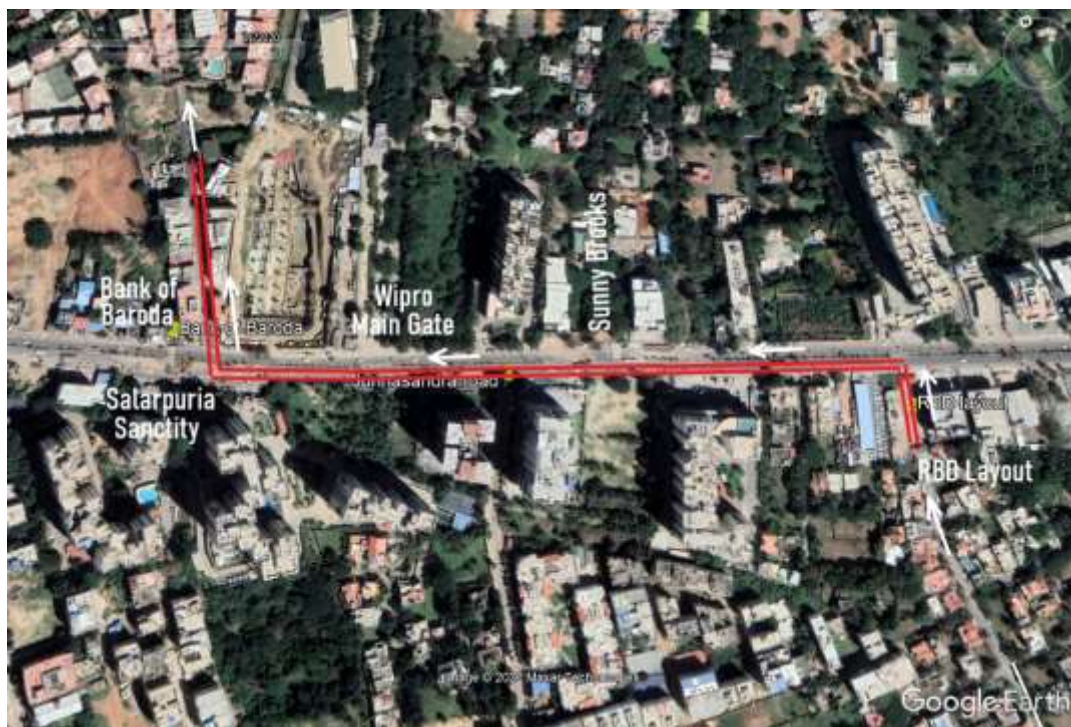
**Figure 6.8:** The attempted stormwater drainage-2: Since the Attempt-1 could not realize, an attempt is then made to continue the discharge through the side drain on the road, a culvert on it in front of Salarpuria Sanctity and then trough the sewage drain adjacent to Bank of Baroda.

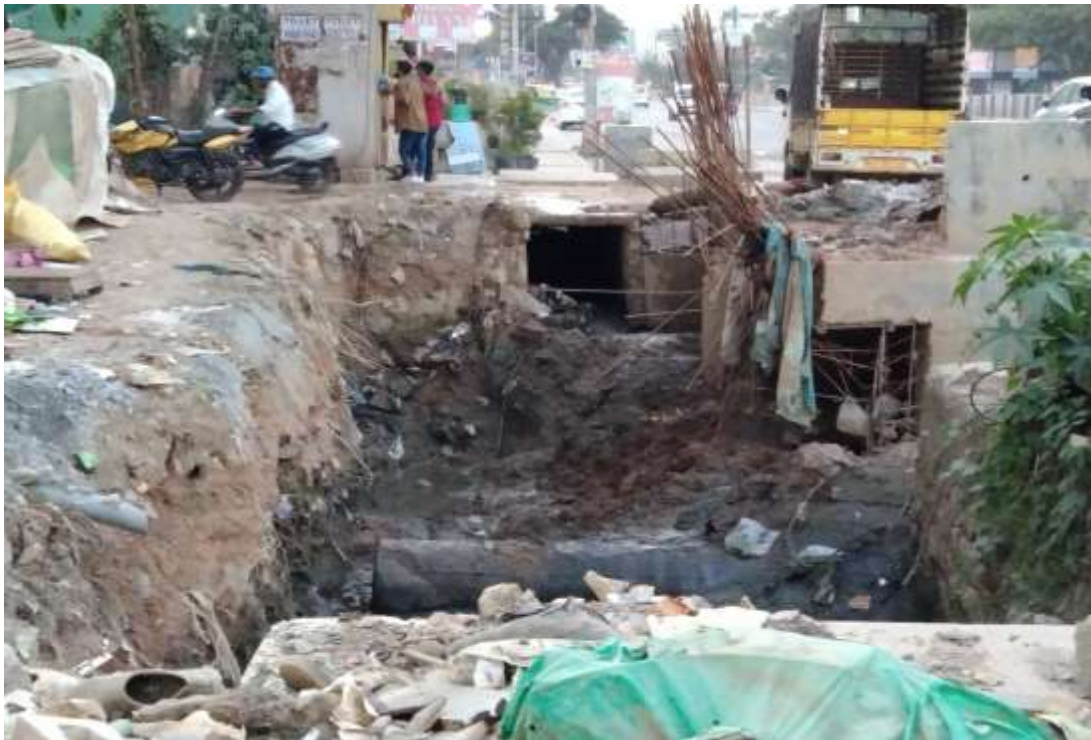
**Figure 6.9:** A view of the side drain on Sarjapur road in front of Keerthi Regalia. It is too small to carry the discharge from a catchment area of 10.1 sqkm.

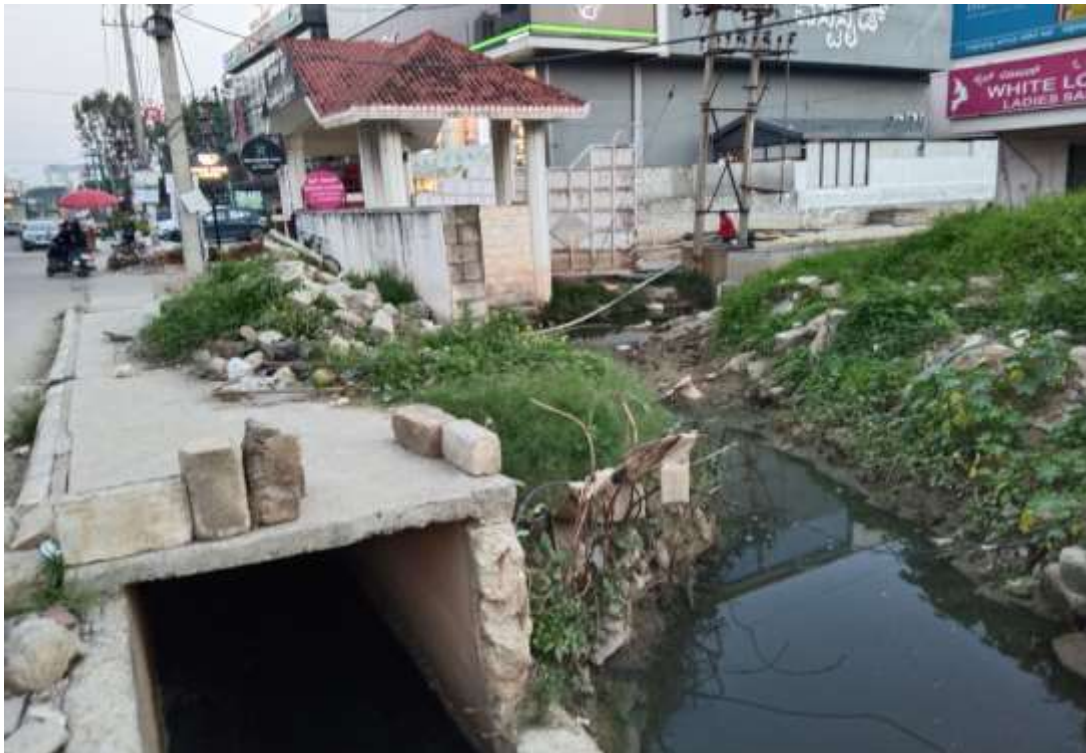
**Figure 6.11:** A view of the side drain on Sarjapur road in front of RBD layout through which attempt is made to regulate the discharge from the layout. It is at a significantly higher level than the sewage drain at the layout.

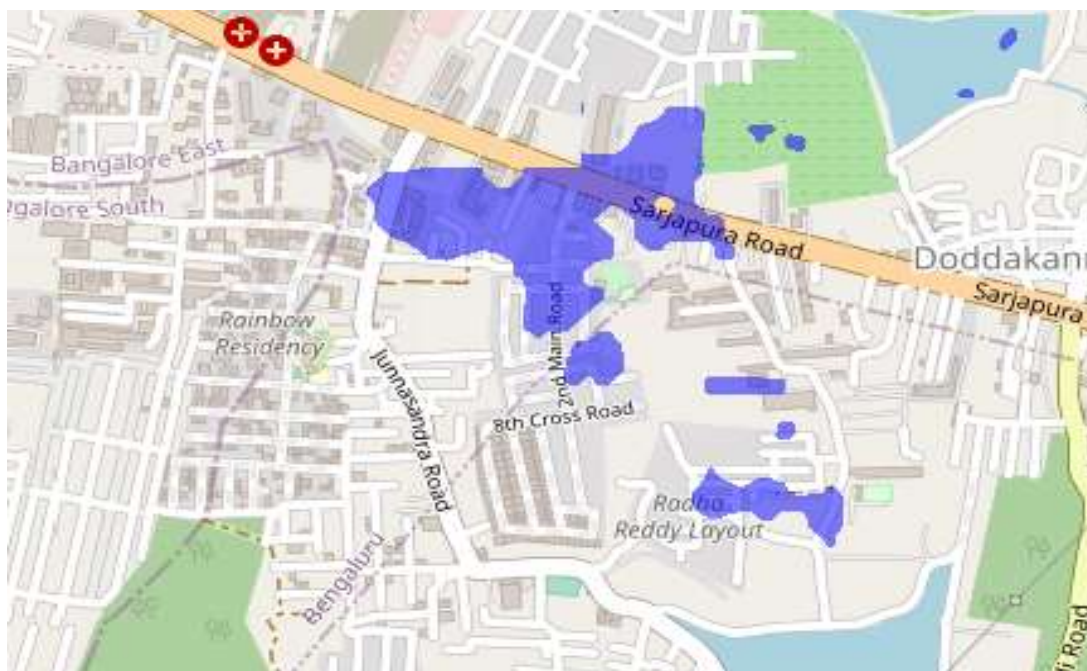
**Figure 6.12:** The pocket of low-land near RBD layout. Since it was the first layout developed at the reach and the surrounding lands were developed by filling up the area, a large area near the entrance of the layout turned into a lowland. The stormwater from the surrounding area is drained at it.

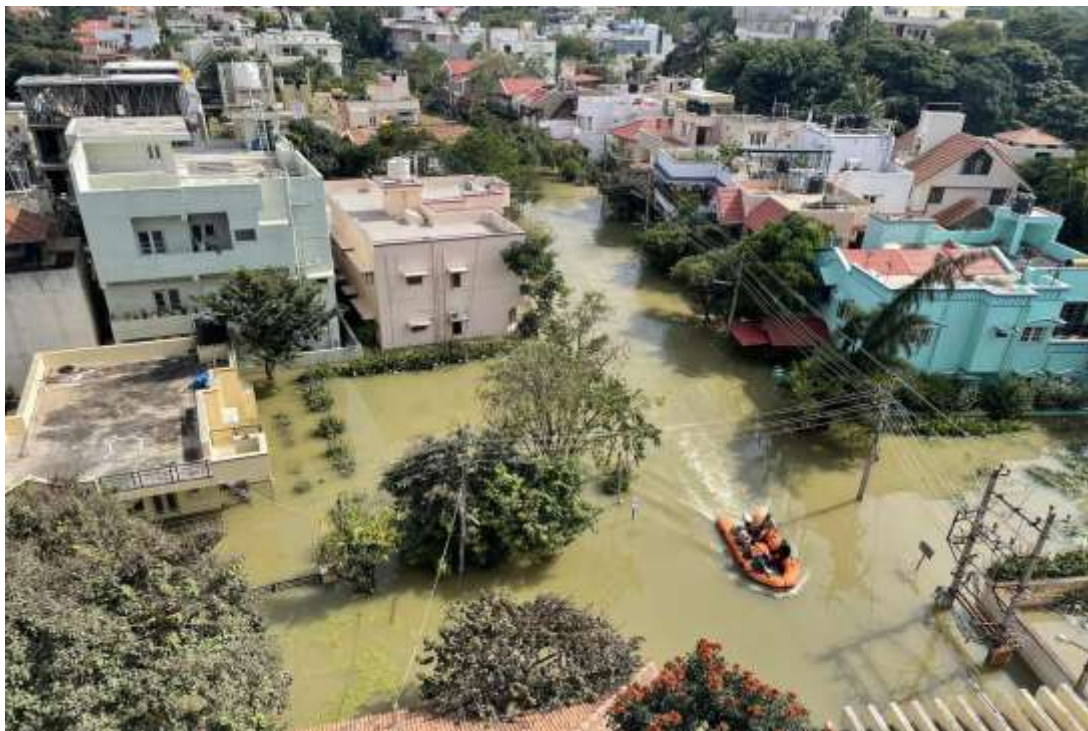
Figure 6.14: A view of the waterlogging at RBD layout on 5h September, 2022. (Photo courtesy: The Hindu)

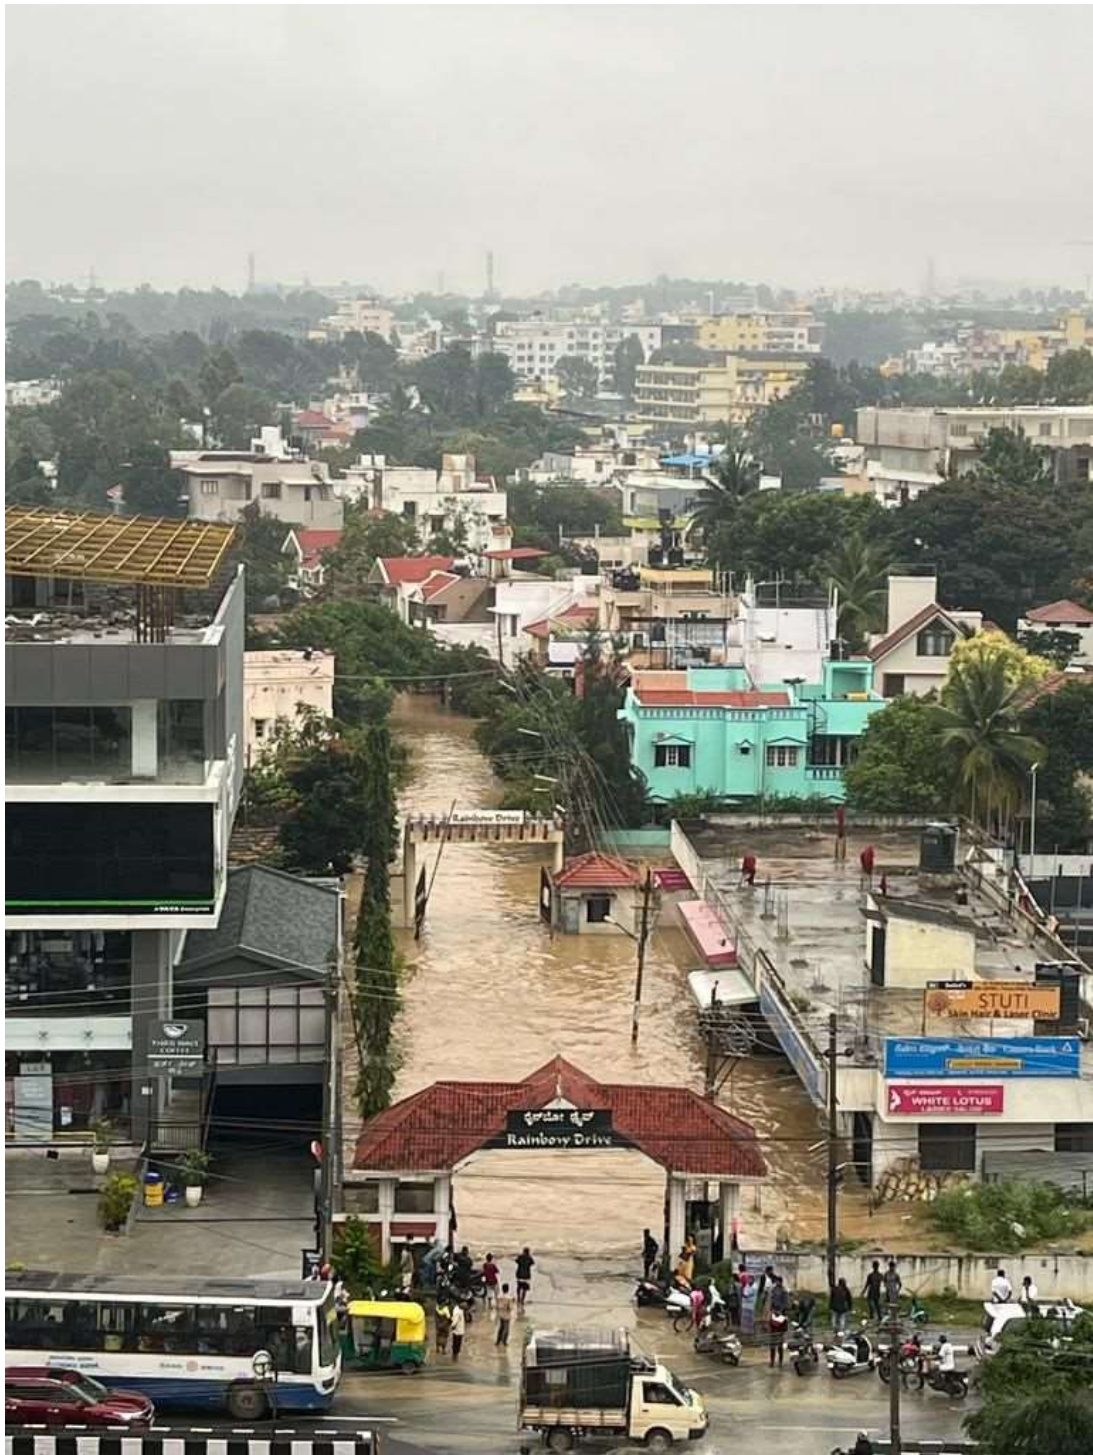
**Figure 6.15: Another view of the waterlogging at RBD layout on 5<sup>th</sup> September, 2022. It is not just the stormwater from its two neighbouring villages, viz., Halanayakanahalli and Junnasandra, but the obstructed and held back run-off from a catchment area of 10.1 sqkm at Sarjapur road, unable to find any escape route.**

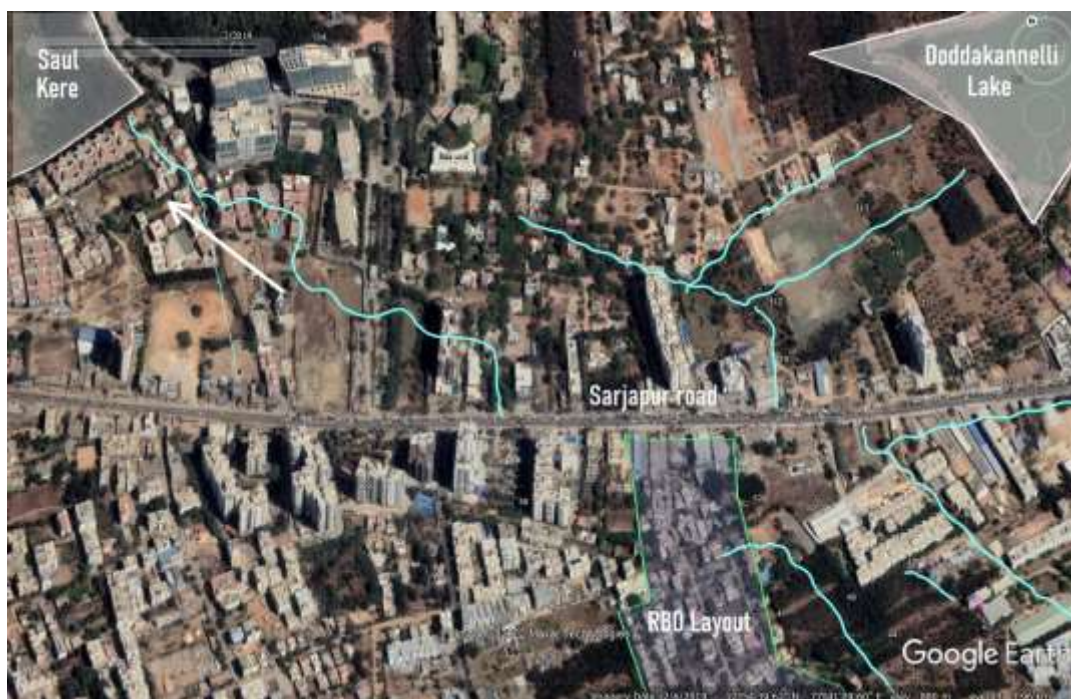
- iii. Figure 7.3 shows the Google image of the area at the reach in 2019. The entire area was developed. A large number of structures were built on the stream paths.

**Figure 7.3:** The Google image of the area in February 2019. There was development in the entire area and all along the stream paths.

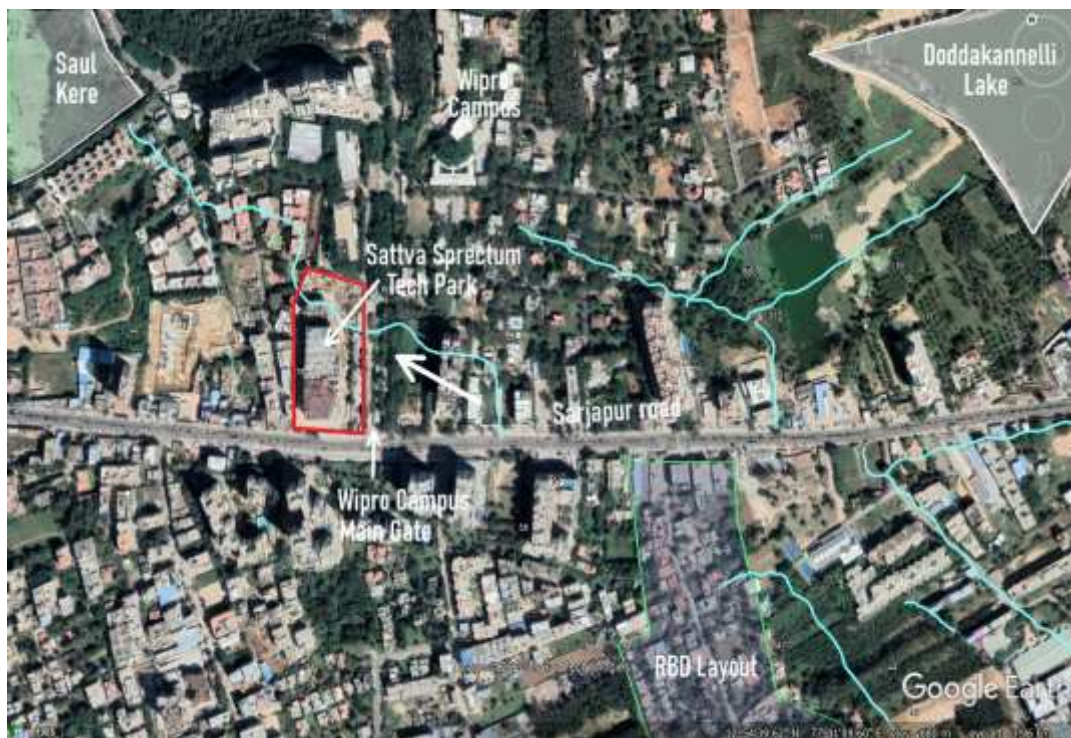
**Figure 7.6:** The Google image of the area in March 2022. Sattva Tech Park was built on the open land adjacent to Main Gate of Wipro campus. It totally obstructed the discharge from upstream lakes to Saul Kere.

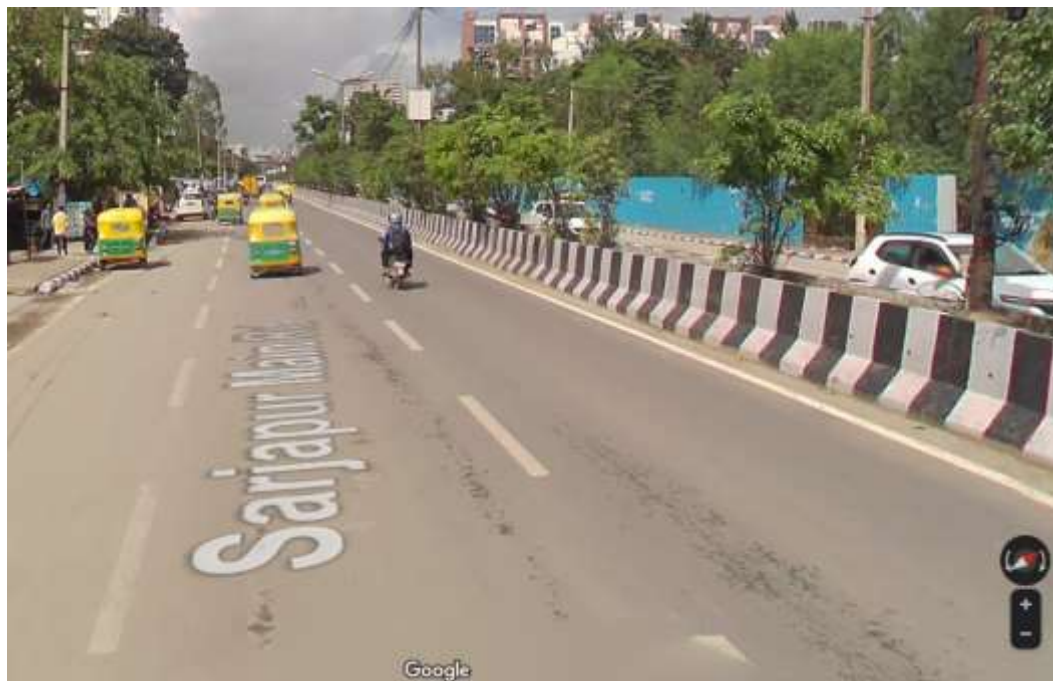
- vi. Around the same time, Sarjapur road was re-asphalted. A large camber was given for the road sloping from its centre to its edges as shown in Figure 7.7.

**Figure 7.7:** The divider on Sarjapur road in front of RBD layout. It was constructed during December 2021 replacing trees. A large camber was given for the road sloping from its centre to its edges.

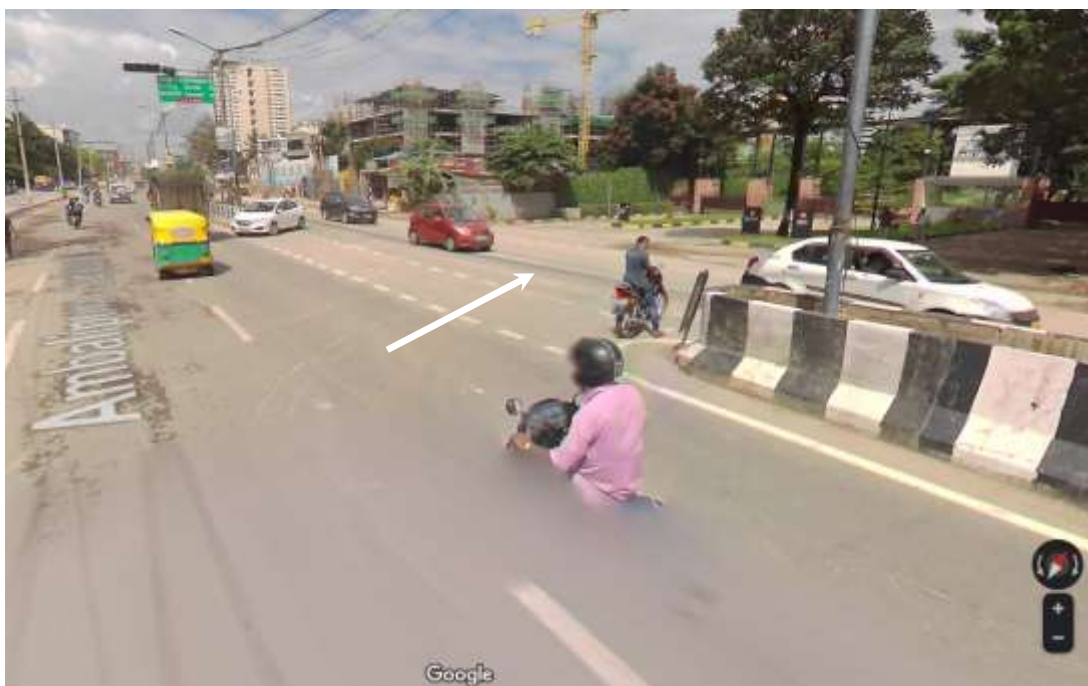
- vii. Figure 7.8 shows an ariel view of the road at the reach. The divider was laid all along the stretch of the road with an opening opposite to Main Gate of Wipro campus. The road surface at the opening was flattened and given a gentle slope towards the gate as shown in Figure 7.9..

**Figure 7.9: A close view of Sarjapur road and divider opening infront of Wipro Gate. The road surface at the divider opening is flattened and given a gentle slope towards the gate.**

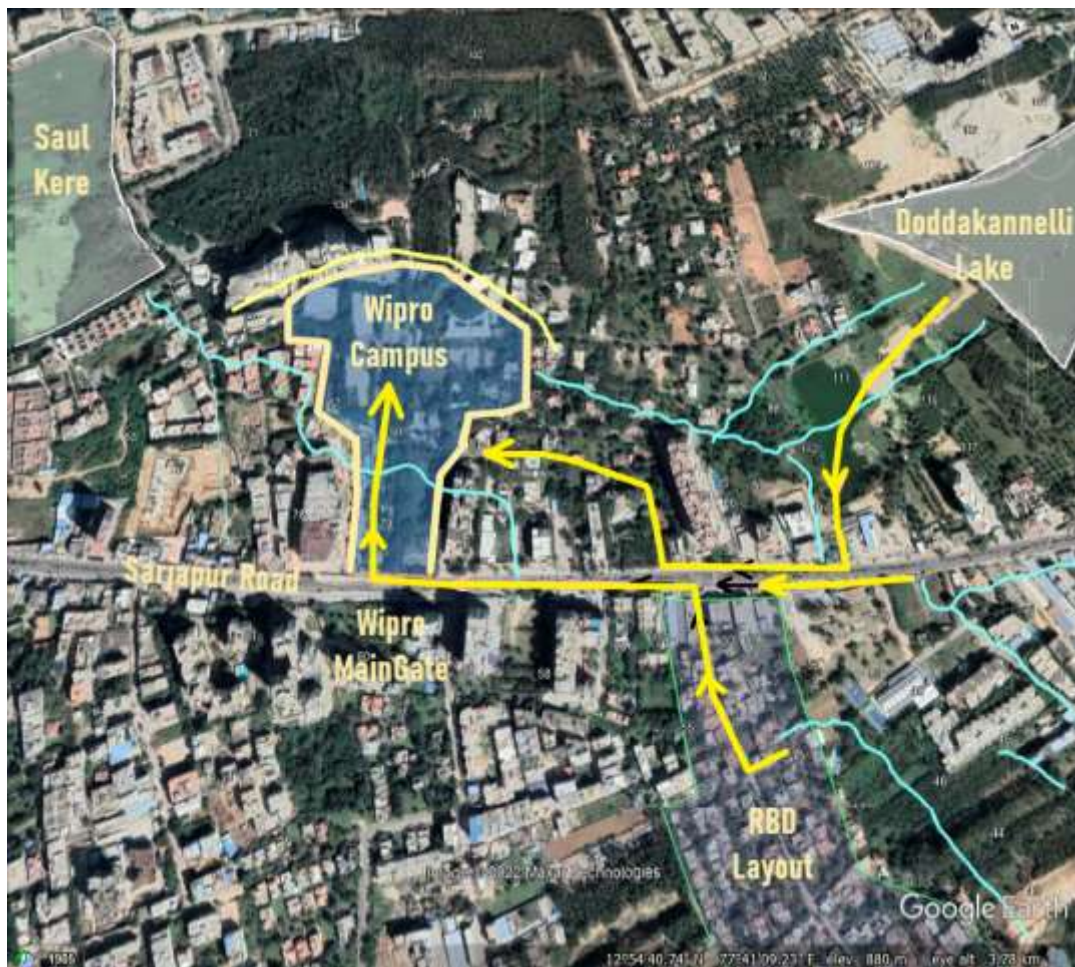
**Figure 7.10: The phenomenon of the waterlogging at Wipro campus.** There were two developments just before the rainy season of 2022, viz. (i) The Sattva Tech Park was built; it totally obstructed the discharge of the lakes at the reach (ii) The road divider was constructed on Sarjapur road. It directed all the spill over from RBD layout on the left) The track of Sarjapur road and then into the gate of Wipro campus. The spill over from Doddakannelli was directed into the campus from its right track. Both discharges were stuck at the campus, in front of its tall structures at its rare end.

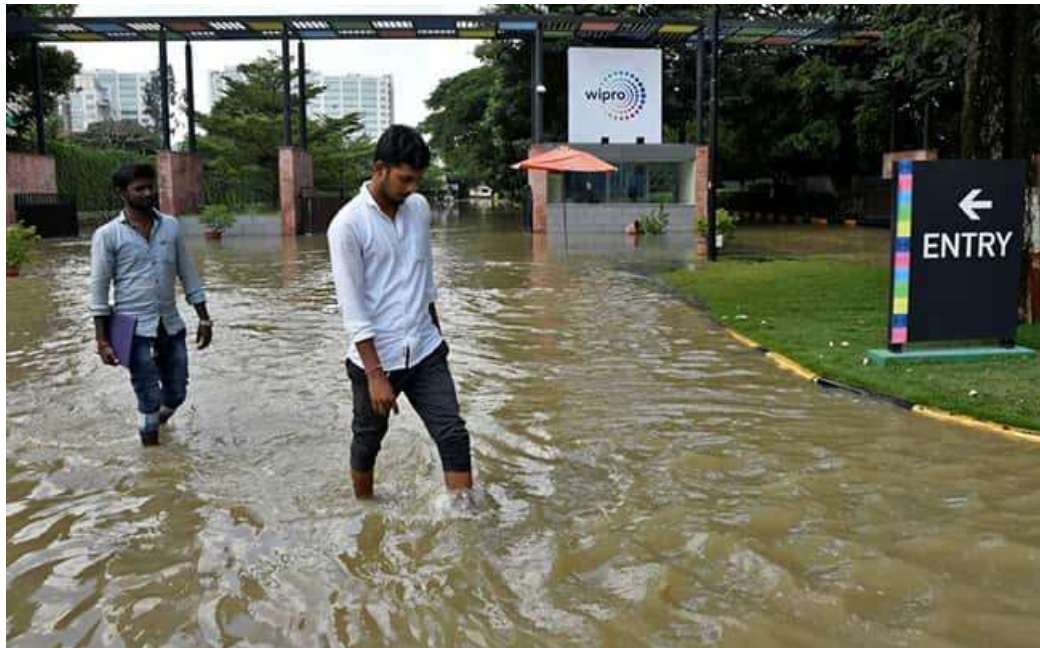
- x. From the video footages of the flood at the reach on September 5, 2022, we could clearly see the spill-over from RBD layout directed on the left track of Sarjapur road by the divider and then into Wipro Gate and accumulating at the centre of the campus. Figure 7.11 shows a still from a video footage in which the discharge on the road could be seen directed into Wipro Gate.

**Figure 7.11: A view of flood water at the Main Gate of the Wipro complex on 5<sup>th</sup> September, 2022. It clearly shows the spillover from Halanayakanahalli lake directed into it from the left track of Sarjapur road. It is then accumulated inside the campus and held back upto the road.**

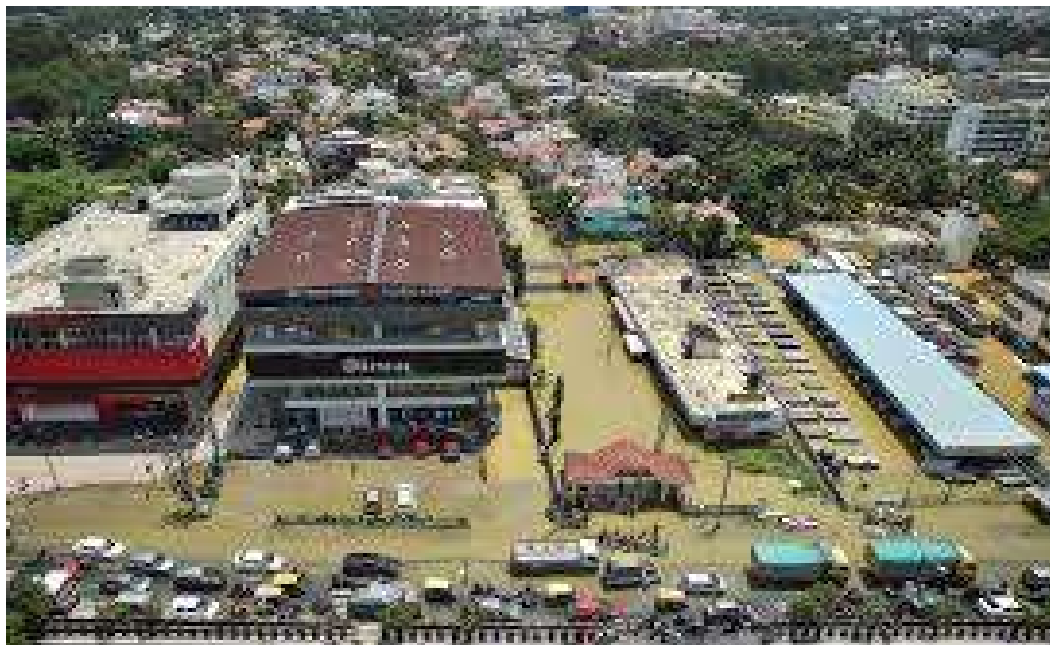
**Figure 7.12: The view of the flood water at RBD layout on 6<sup>th</sup> September, 2022. During peak flood, the discharge from three lakes viz., Halanayakanahalli, Junnasandra and Doddakannelli lakes struck at Wipro campus is held back upto the layout. Therefore, what we see in the above picture is actually the obstructed flow at Wipro campus stretched upto the layout and beyond it.**
