# **Floods at Bengaluru City - A Technical Study**

**Dr. Sudhir Sajjan, B.E., M.B.A., Ph.D.**  
sajjan.sudhir@gmail.com

**December, 2022**

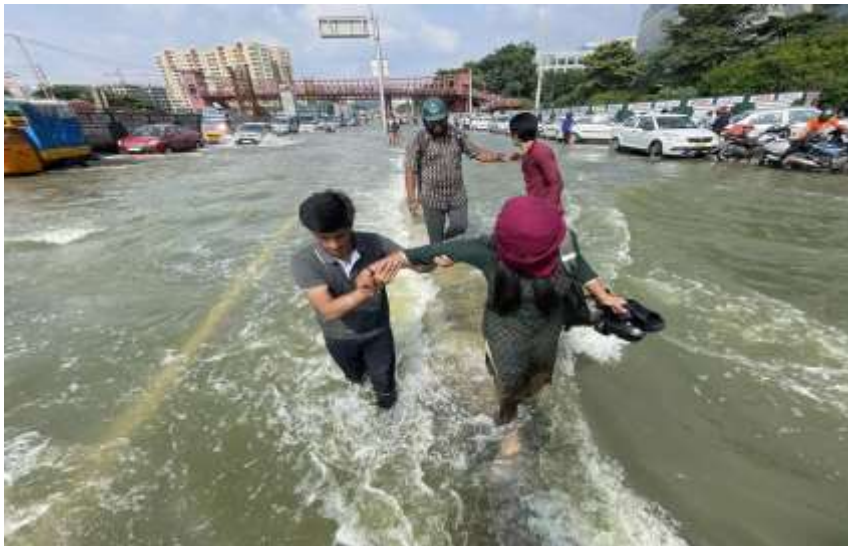
Many cab drivers parked their cars by the side of the road and helped people to get across the flooded stretch. | Photo Credit: Murali Kumar. K

Traffic movement was crippled on ORR due to water from Savalakere lake overflowing into a nearby drain following incessant rains, resulting in flooding on the roads

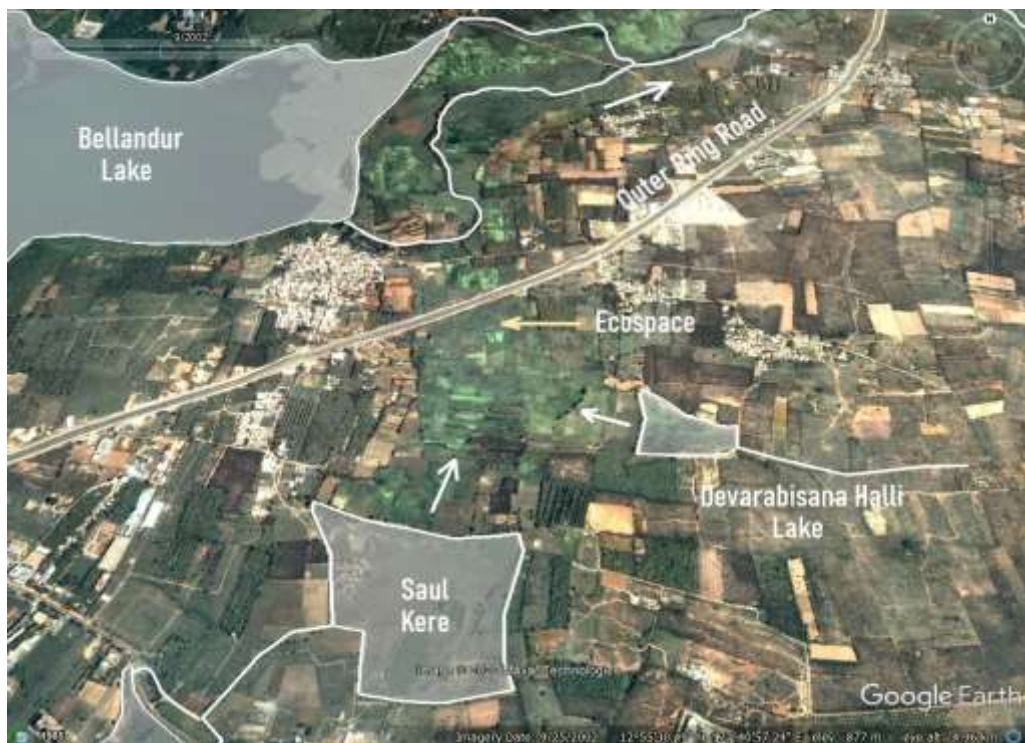
- ii. Figure 8.2 shows the Google image of the valley between Saul Kere and the Outer Ring Road in March 2002. The spill over from Saul Kere was thinly discharged at the valley. There was **no defined waterway**.

**Figure 8.2:** The Google image of the valley between Saul Kere and Outer Ring Road in March 2002. There was no defined stream path. The spillover from Saul Kere was discharged on the agriculture land over a wide area.

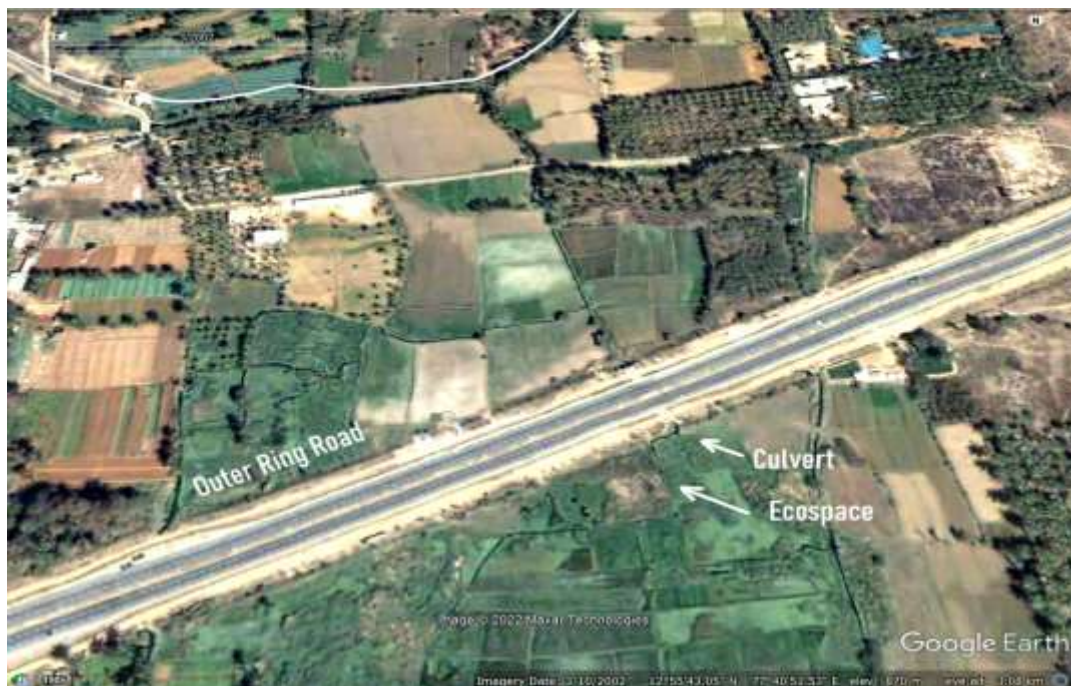
- iii. Figure 8.3 shows its Google image of the valley in March 2003. There was a small road at the reach before 2003. The Outer Ring Road was newly constructed with a culvert at the deepest point of the valley opposite to the location, where EPZ Ecospace is built now.

**Figure 8.3:** The Google image of the Outer Ring Road in March 2003. Earlier, there existed only a small road at the reach. The Ring Road was newly constructed with a culvert at the deepest point at the valley, opposite to the location, where EPZ Ecospace is built now.

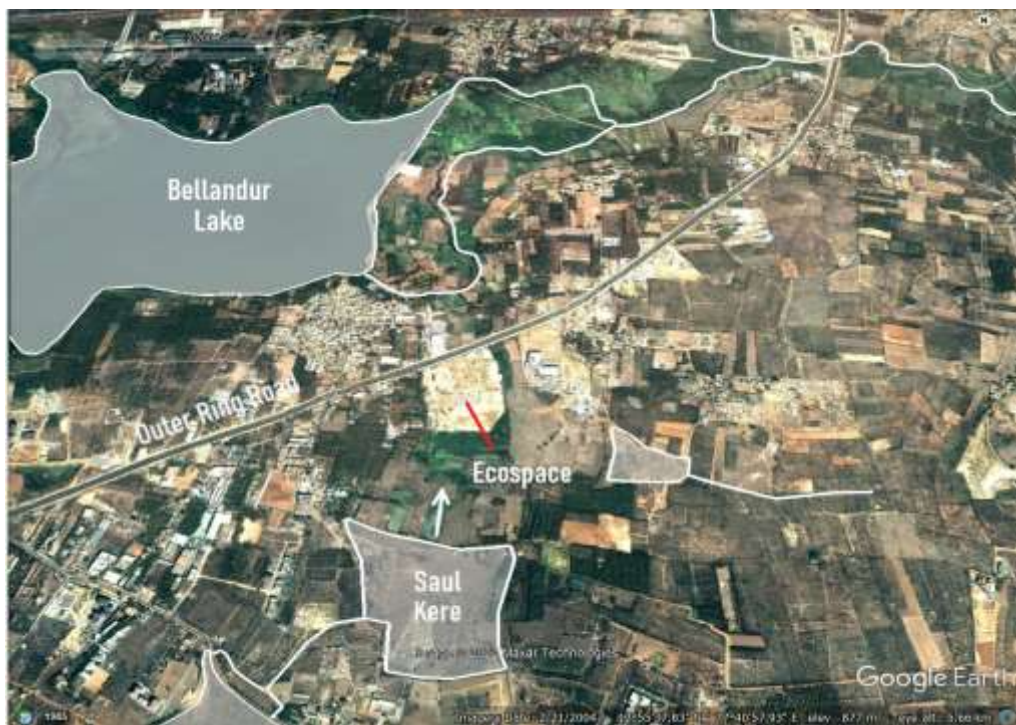
**Figure 8.4:** The Google image of Outer Ring Road and the valley in February 2004. The land at the upstream of the culvert was filled up and levelled for the construction of Ecospace complex.

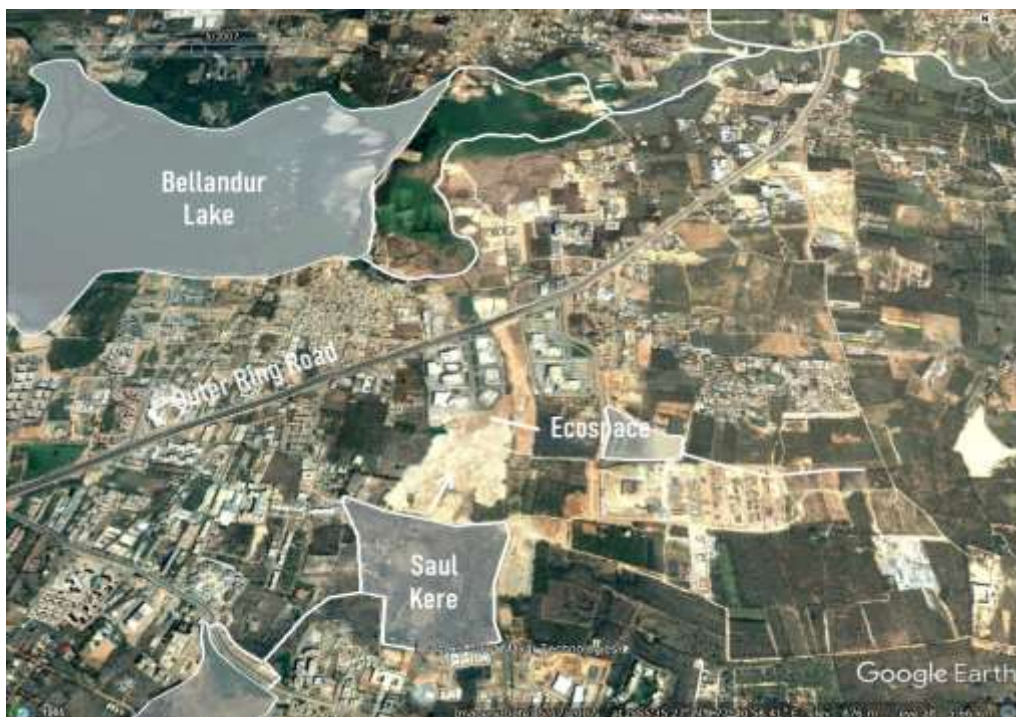
- iv. Figure 8.5 shows its Google image of the valley in May 2004. The land at the upstream of the culvert was filled up upto Saul Kere and levelled for the construction of Ecospace complex. The construction of the Ecospace complex was commenced.

**Figure 8.5:** The Google image of the road and the valley in May 2004. The entire stretch of the land upto Saul Kere was filled up and levelled. The construction of the Ecospace complex was commenced.

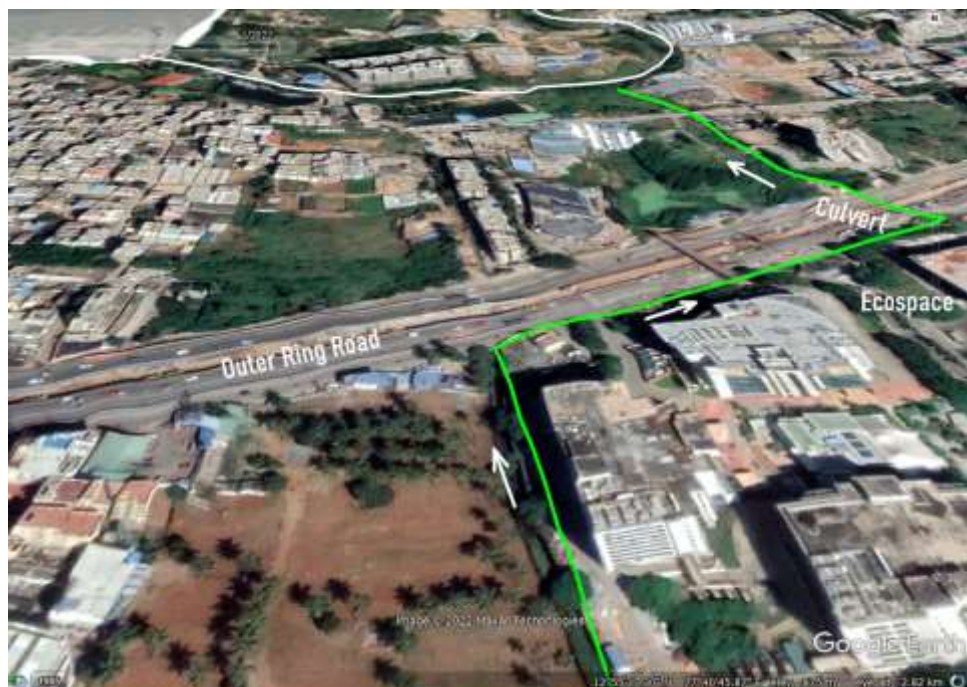
- v. A close view of the image of the valley in May 2004 reveals that there was **no specific stormwater drain** planned between Saul Kere and the main stream from Bellandur lake. The stormwater drain at the border of Ecospace is joined to the culvert on Outer Ring Road to regulate the discharge from Saul Kere as shown in Figure 8.7. The drain is completely covered under the slab along the road.

**Figure 8.7:** A close view of the Outer Ring Road near EPZ Ecospace. There is no specific stormwater drain planned at the reach. The drain at the border of Ecospace is joined to the culvert on the Outer Ring Road and it is attempted to regulate the spill over from Saul Kere through it. It is completely covered under slab adjacent to the road.

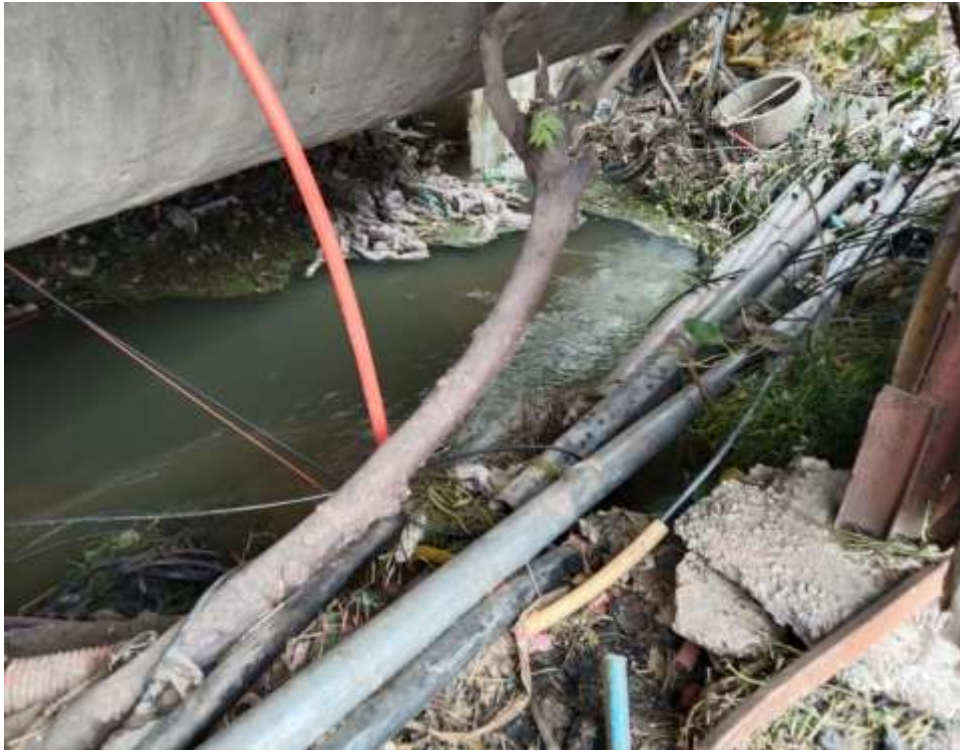
- ix. The Outer Ring Road has a total width of about 50 m at the reach. The entire discharge from a catchment of 27.9 sqkm is attempted to be regulated through a small culvert of above length. Figures 8.8 and 8.9 show the close views of the culvert near Ecospace.

**Figure 8.8:** A close view of the culvert near Ecospace. It has the capacity just to discharge sewage from its surrounding locality.

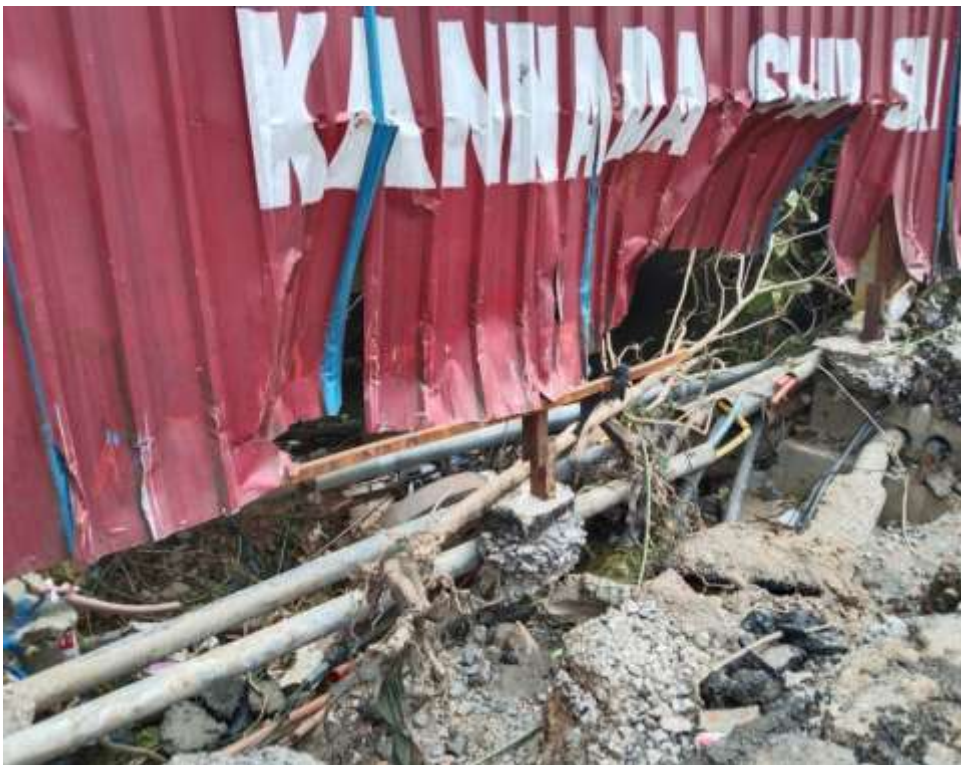
**Figure 8.9:** Another close view of the Culvert.

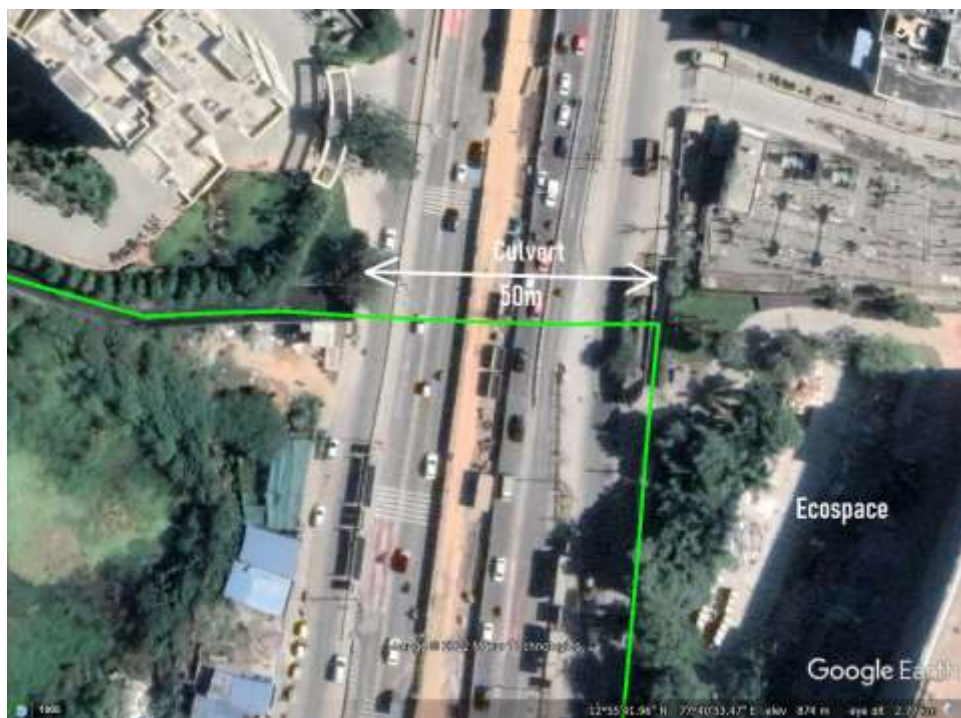
Figure 8.10: The culvert runs for a length of 50 m. The entire runoff from a catchment area of 27.9 sqkm is attempted to be regulated through it.

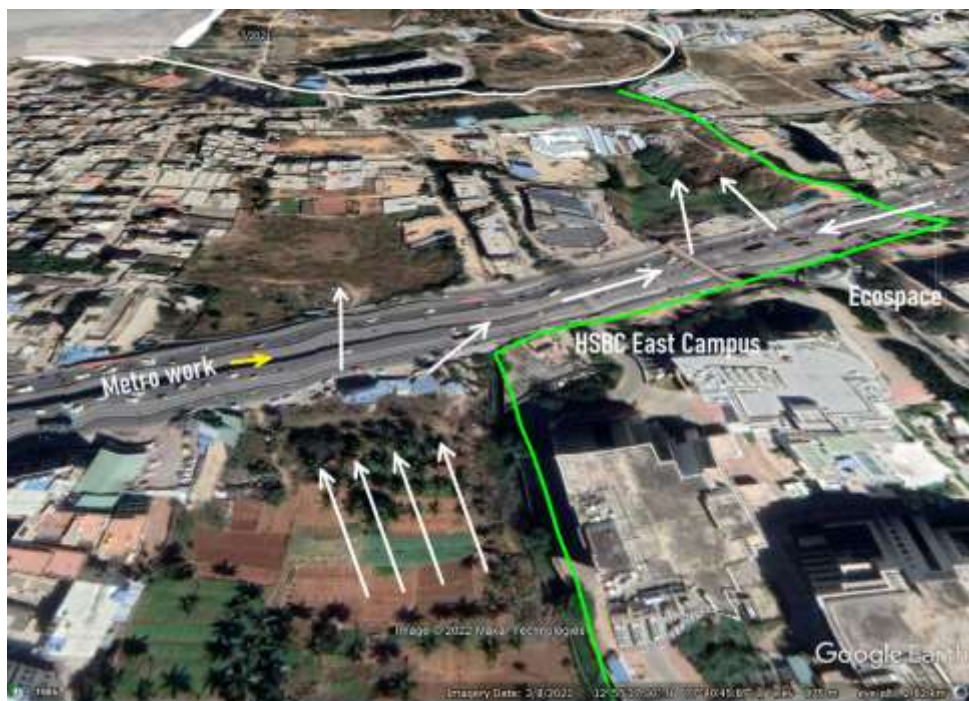
- vi. The construction of Metro rail was commenced in January 2022. Until its commencement, the discharge from Saul Kere was collected at the open land adjacent to Ecospace, spilling over the Outer Ring Road and finding its route to the main stream from Bellandur lake as shown in Figure 8.8.

Figure 8.11: The Google image of the Ring Road and the valley in January 2022. The Metro rail construction had just commenced. Until its commencement, the discharge from Saul Kere was collected at the open land adjacent to Ecospace, was spilling over the road and finding its route to the main stream from Bellandur lake as shown in the figure.

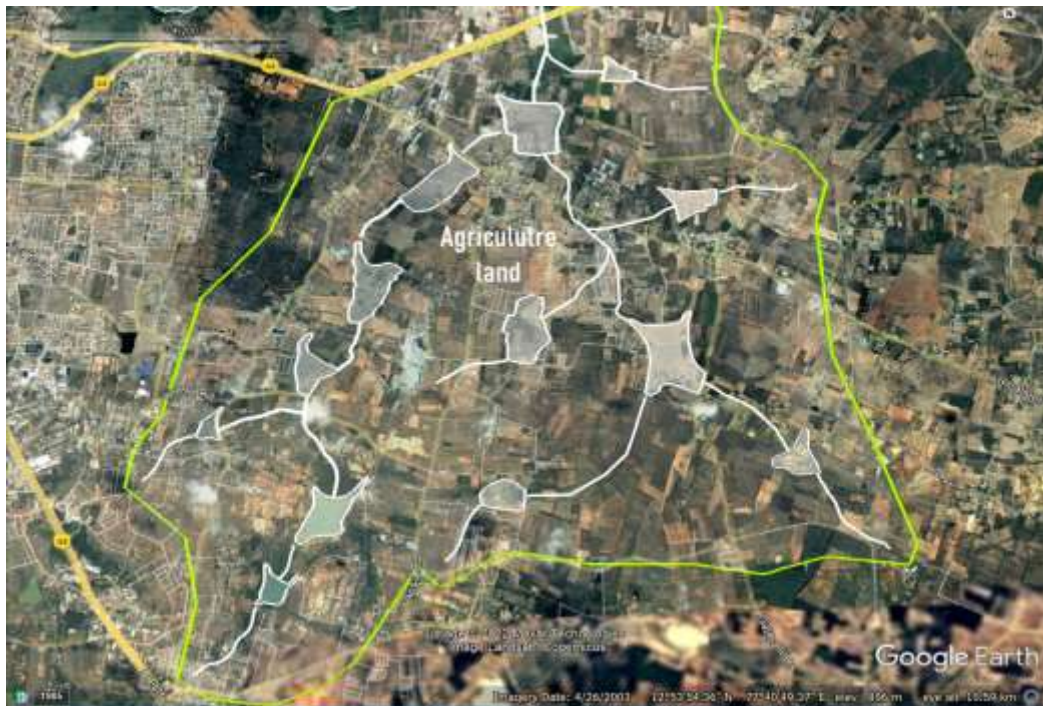
- vii. Figure 8.12 shows the Google image of the catchment at the upstream of the Outer Ring Road in 2003. The entire catchment was **agriculture land**. A significant portion of rainfall was percolated into the ground. The lakes were virgin. The discharge from them was not significant.

**Figure 8.12:** The Google image of the catchment area at Outer Ring Road near Ecospace in 2003. It was completely an agriculture land. A significant portion of rainfall was percolated into ground. The lakes were virgin. Another its large portion was absorbed by them.

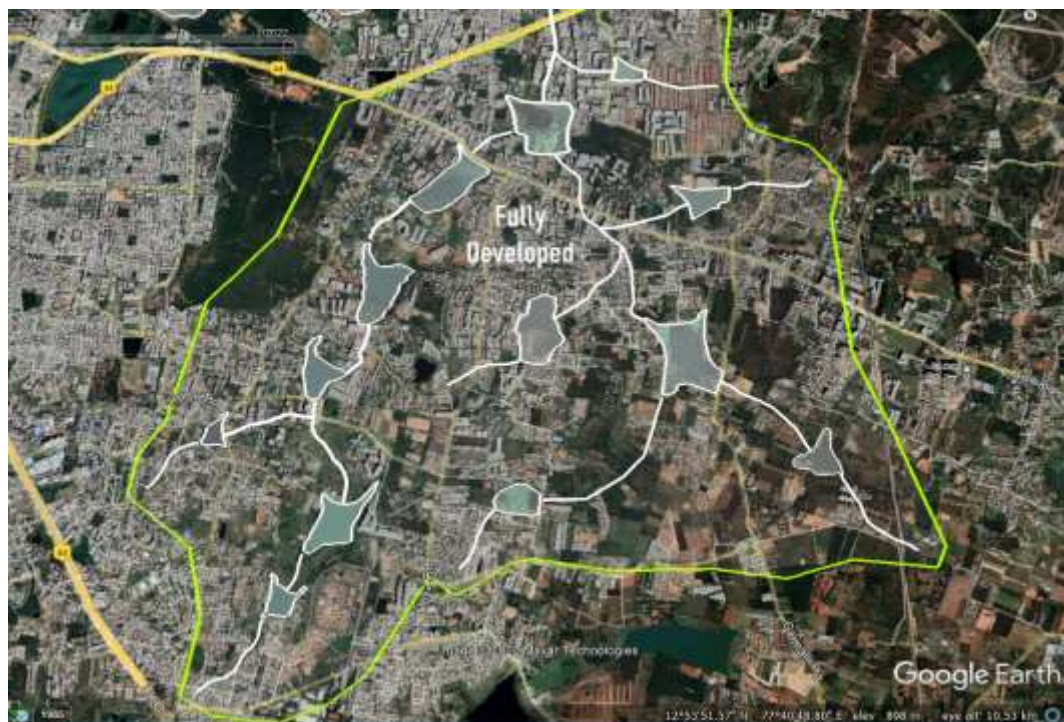
- viii. But over the years, the entire catchment was concretized as the Google image in 2022 in Figure 8.10 reveals. Near entire rainfall is turned into run-off and directed to Outer Ring Road.

**Figure 8.13:** The Google image of the catchment area in 2022. The entire catchment area is concretized except few pockets of open land. Near entire rainfall is converted into run-off and directed at the Outer Ring Road.

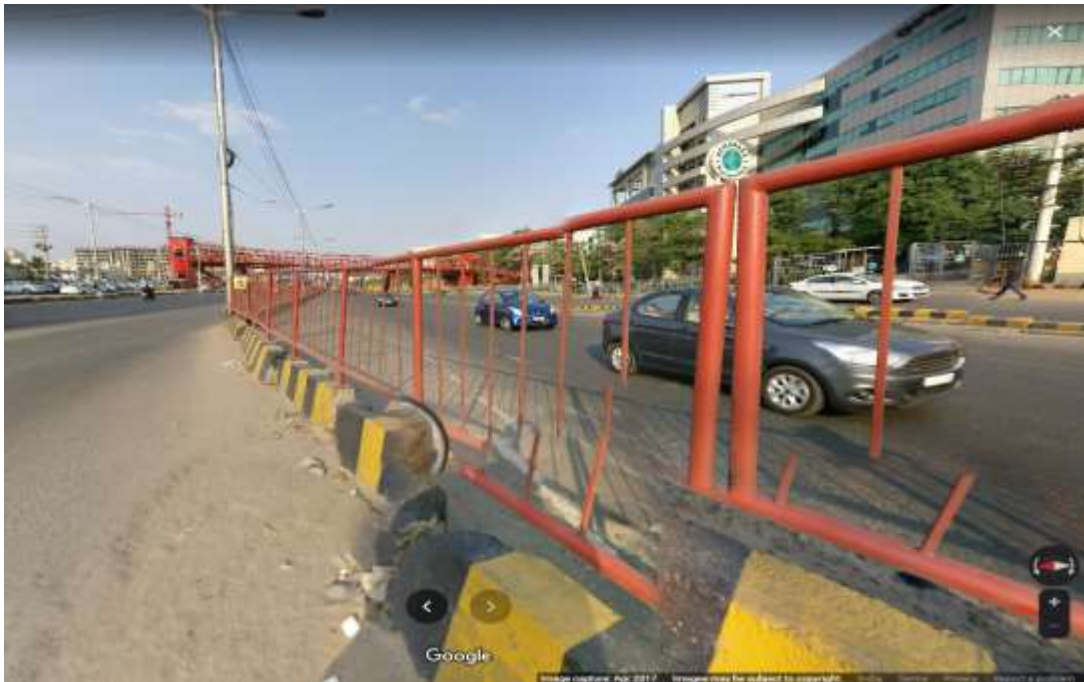
- x. Before the commencement of Metro rail work, the road had just dividers at its centre and between it and service road as shown in Figure 8.14. The discharge from Saul Kere spilling over the road could easily negotiate them.

**Figure 8.14: The dividers at the centre of the road and between the road and service road near Ecospace before commencement of Metro rail construction. The discharge from Saul Kere spilling over the road could easily negotiate them.**

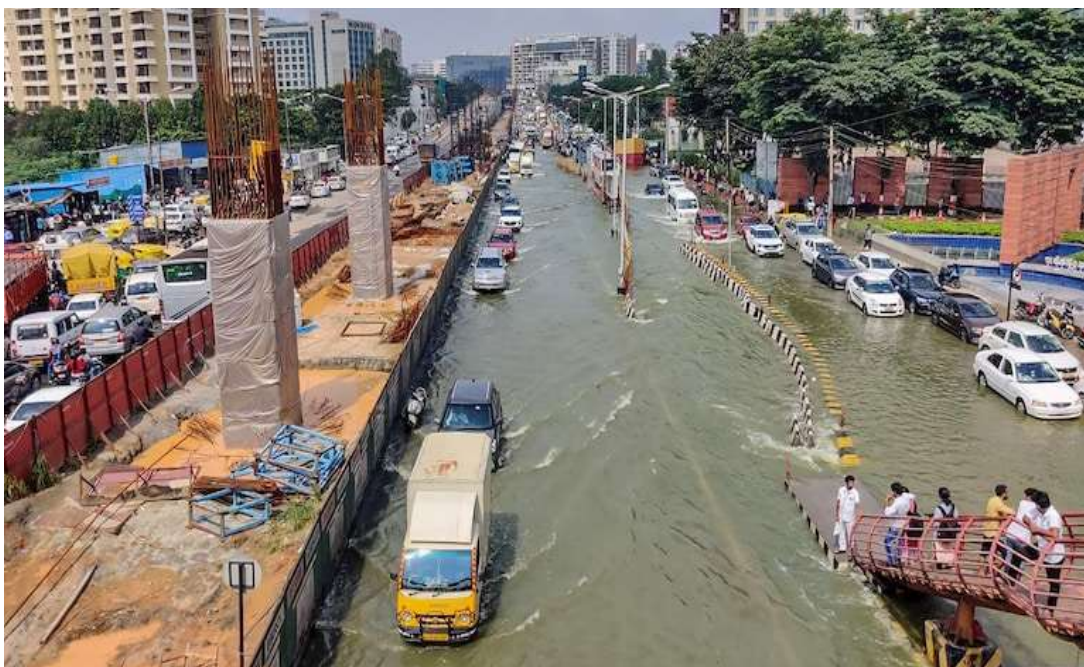
**Figure 8.15: A view of the Metro rail construction at the road. The discharge from Saul Kere spilling over the road is totally obstructed by the wall constructed all along its length and is held back. We could clearly observe that there is a large waterlogging at the lane opposite to Ecospace and only at the above side, while the lane on its other side is completely free from any waterlogging. There is free traffic movement on it. (Photo courtesy: India Today)**

It is interesting to observe that the road is inundated at the reach since quite few years. But there are no efforts to investigate into the reasons for its inundation and initiate any measures for it. On the other hand, the Metro rail work is commenced. It demands construction of a large dedicated stormwater drain between Saul Kere and the main stream of Bellandur lake and a large culvert across it on Outer Ring Road depending on the present topography. Once the Metro work is completed, it would be too difficult to take up their construction.

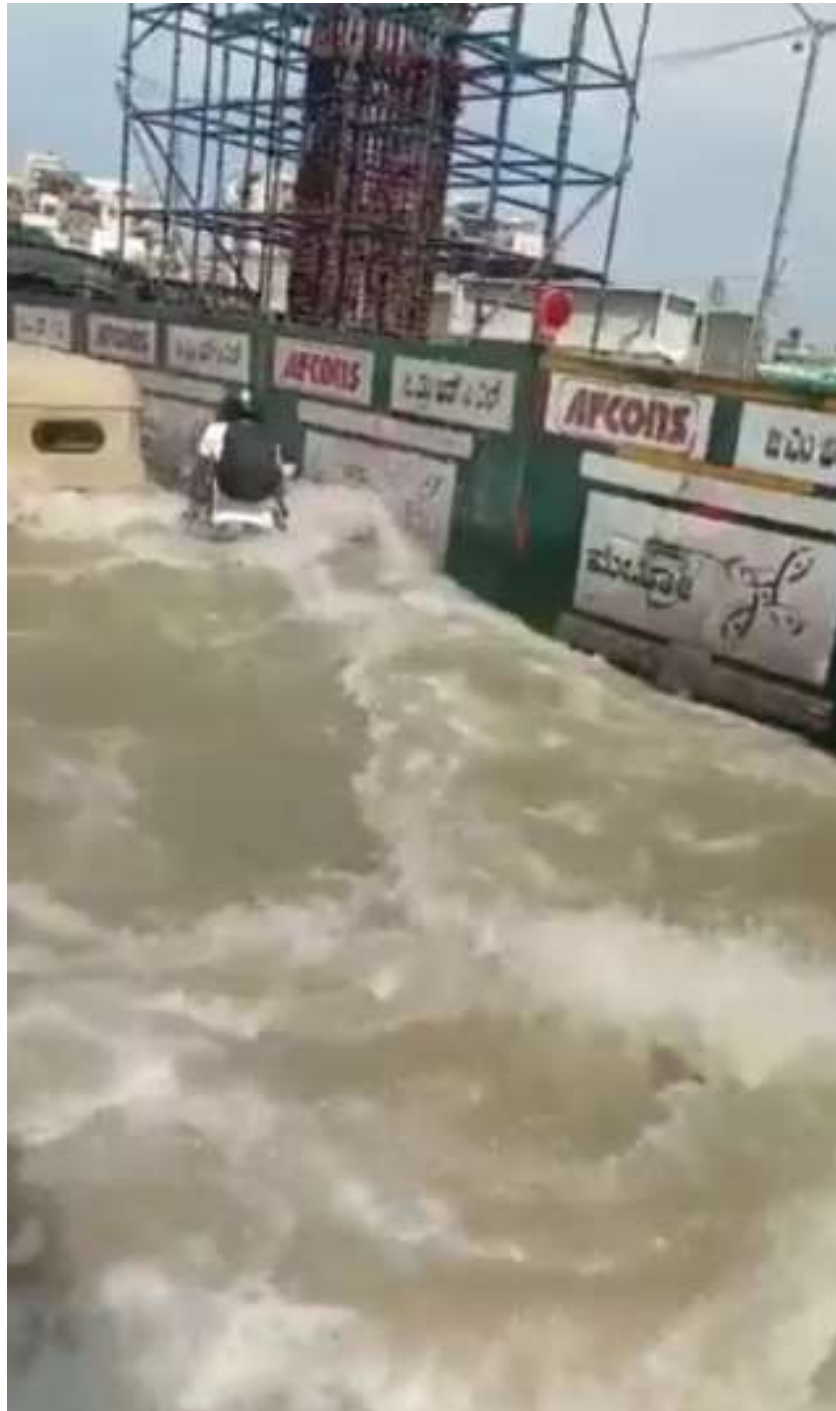
**Figure 8.17: An image of the flood water striking the wall of Metro rail in front of Ecospace on 6<sup>th</sup> September, 2022. (Courtesy: twitter@\_maqtab)**

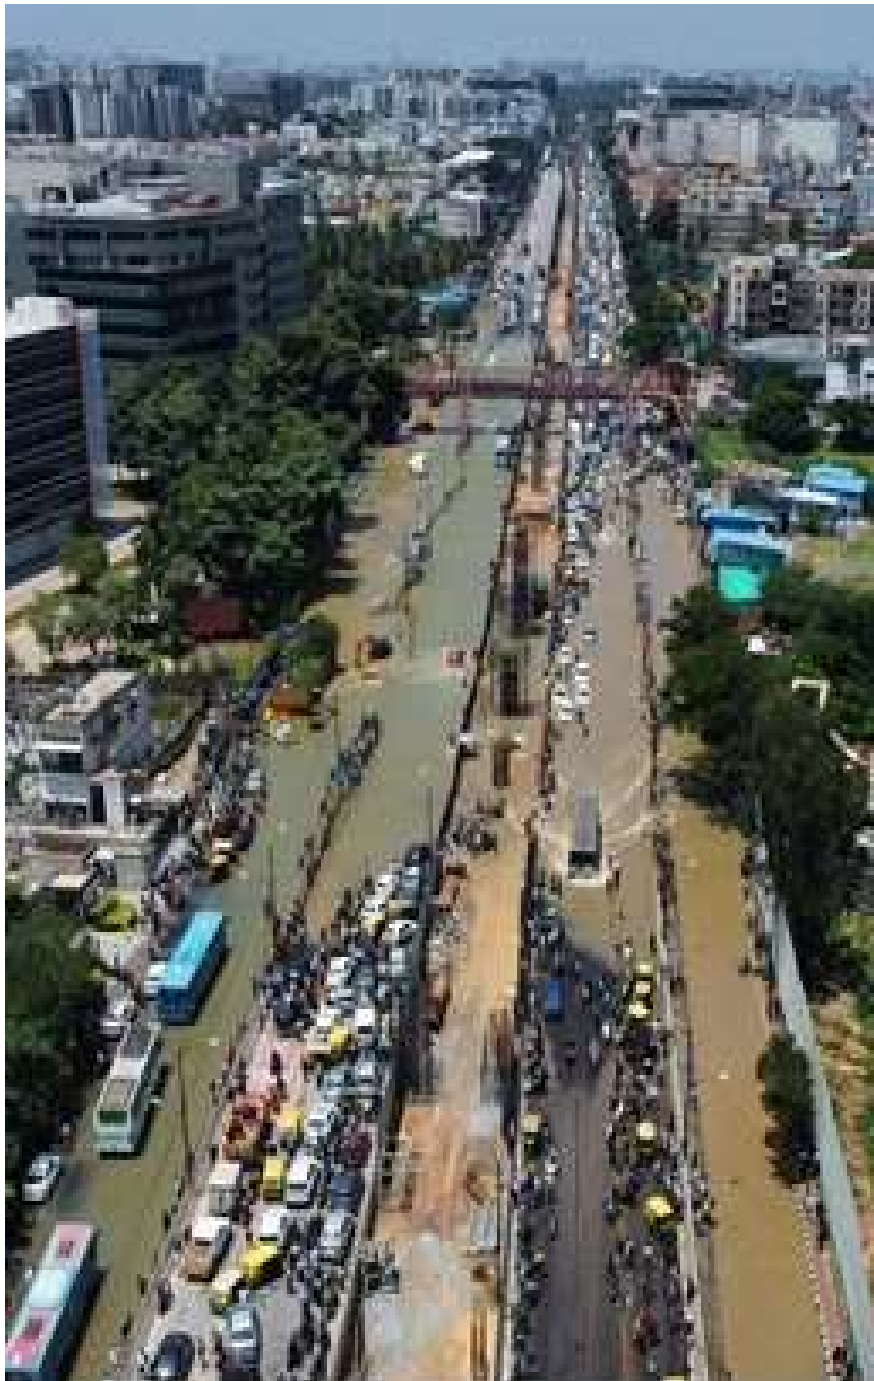
**Figure 8.18:** Another view of the waterlogging at the Ring Road during the flood. We could clearly see that the lane towards Ecospace is completely waterlogged while the lane on its opposite side is relatively free. The traffic could negotiate it. It clearly indicates the reason for the increased severity of waterlogging at the reach during 2022. The free flow of flood over the road is completely held up by the construction of the wall. (Photo courtesy: The Print)

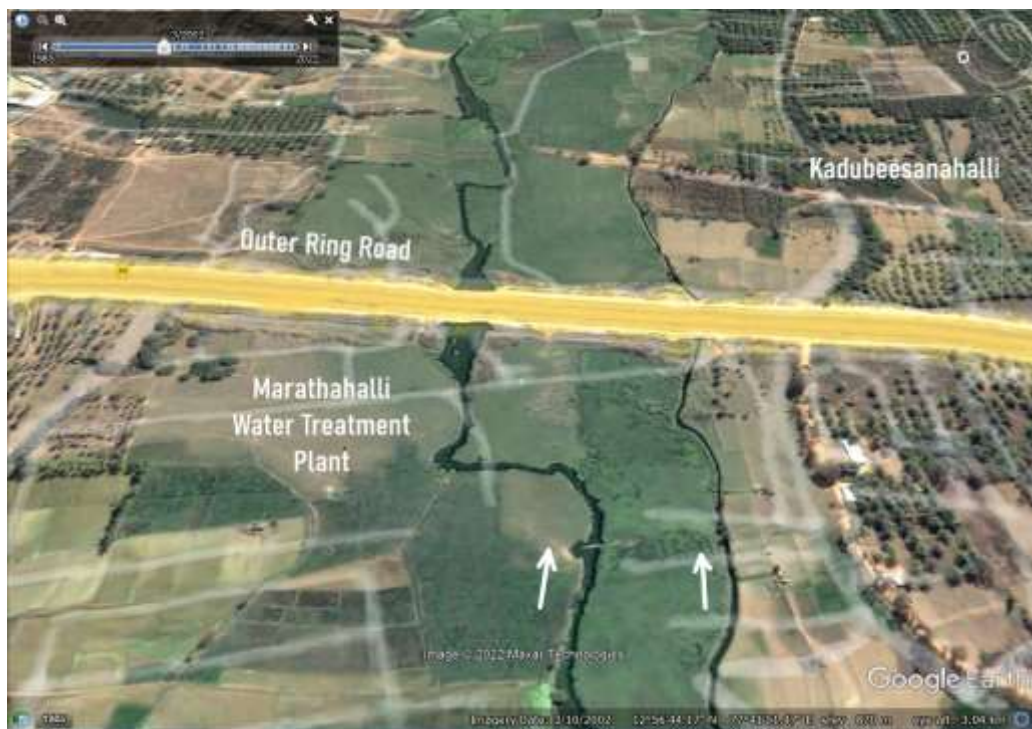
- iii. Figure 9.4 shows the Google image of the area upstream of the road in March 2002. The spill over from Bellandur lake was discharged in two streams at the reach. **Two separate bridges** were built on each of them.

**Figure 9.4:** The Google image of the valley at the upstream of the bridge near Marathahalli Police Station in March 2002. The spillover from Bellandur lake was discharged through two streams. There were bridges on each of them on Outer Ring Road. It was completely a wet land at the both upstream and downstream of the bridges.

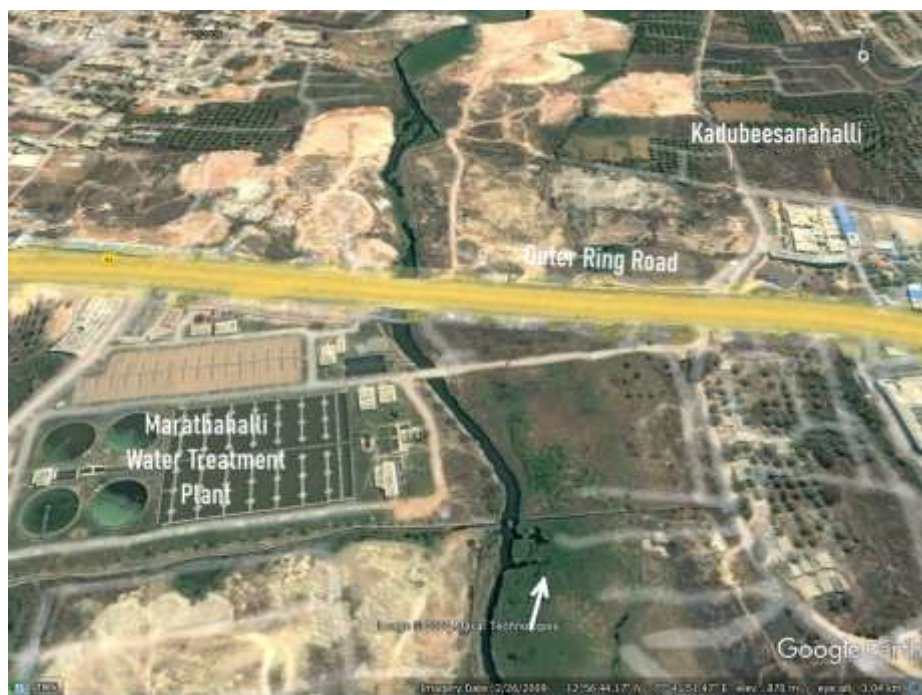
**Figure 9.5:** The Google image of the valley in February 2009. The BWSSB sewage treatment plant was constructed between left stream and Outer Ring Road.

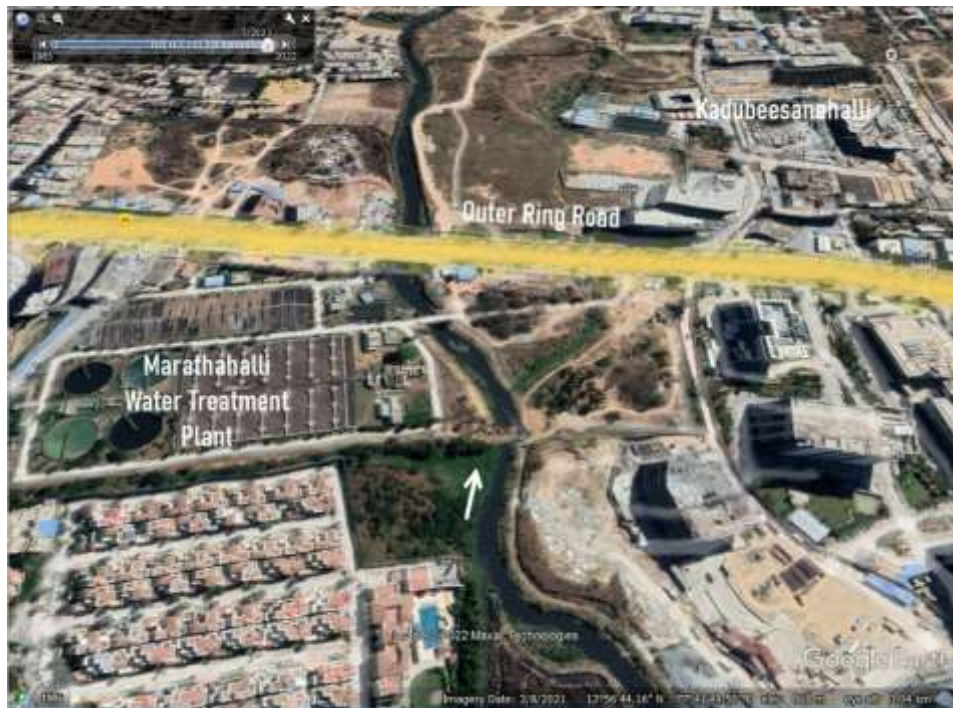
**Figure 9.6: The Google image of the valley in March 2021. The entire land between the two streams was filled up and developed except for a small strip near the road. However, the right bridge was still functioning.**

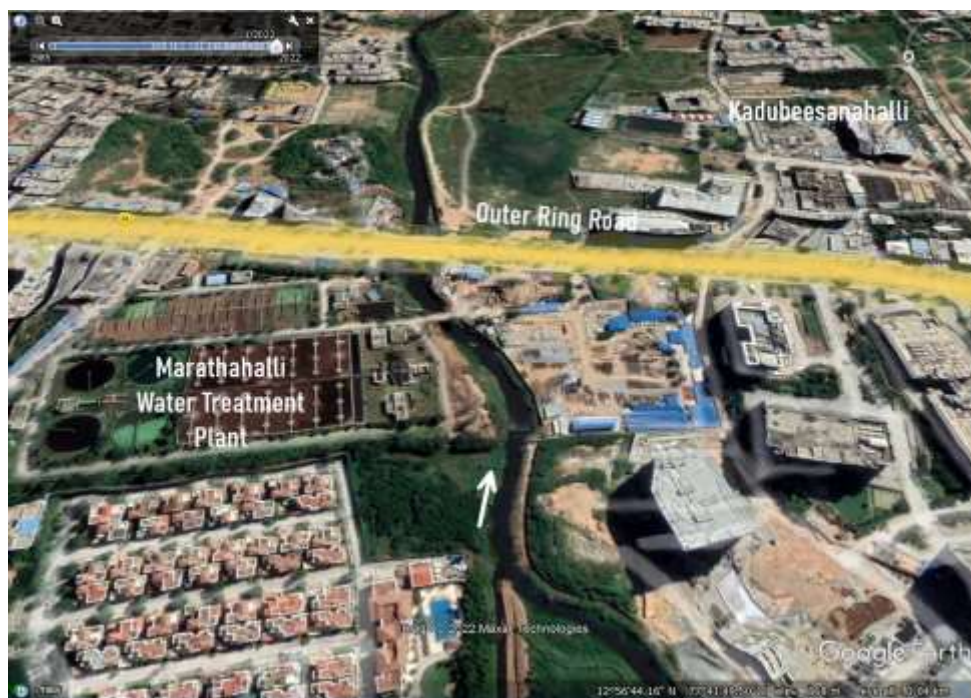
- v. Figure 9.7 shows the Google image of the reach in January 2022. Between March 2021 and January 2022, the open land between the streams and adjacent to the road was also filled up for the construction of ancillary treatment plant. The discharge through the right bridge was **disconnected**.

**Figure 9.7: The Google image of the valley in January 2022. Between March 2021 and January 2022, the open land between the streams was filled up for construction of the ancillary treatment plant. The discharge through the right bridge was disconnected.**

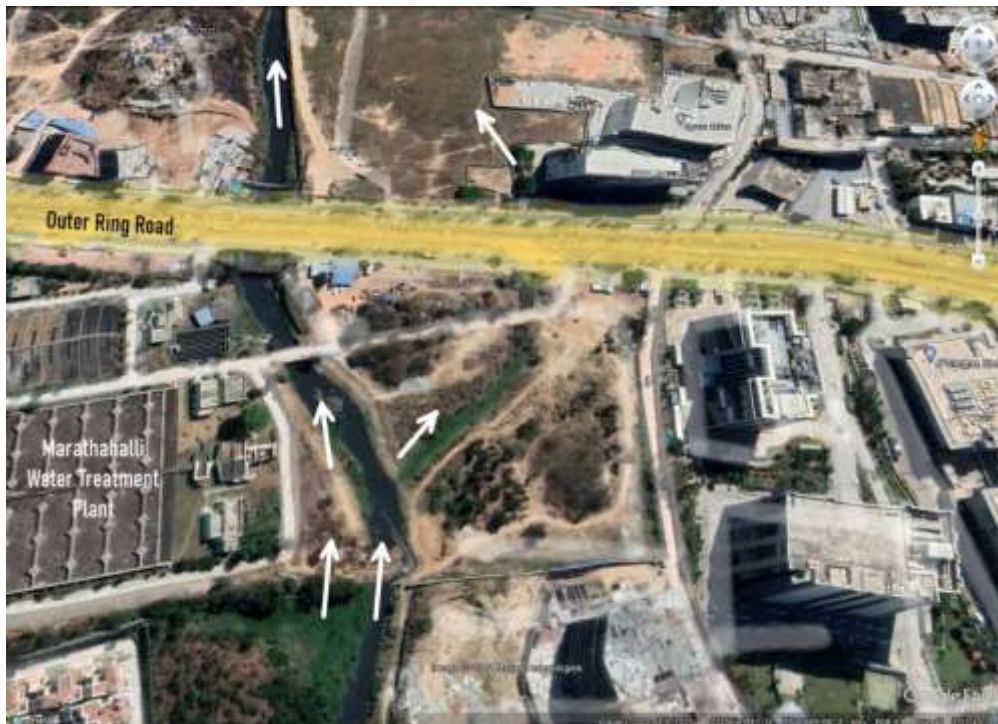
**Figure 9.8:** The close view of the bridges on Outer Ring Road near Marathahalli Police Station in March 2021. Both were functioning. The spill over from Bellandur lake and its downstream catchment was discharged through both of them.

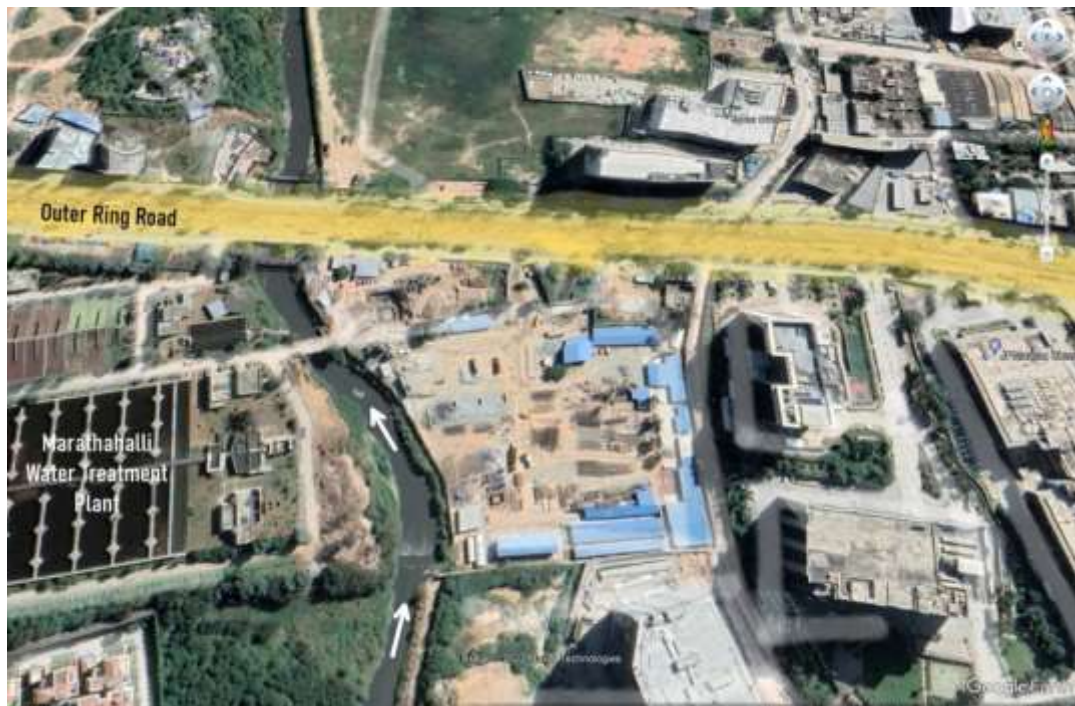
**Figure 9.9:** The close view of the bridges on Outer Ring Road near Marathahalli Police Station in January 2022. The open land between the two bridges was filled up. The flow through the right bridge was disconnected.

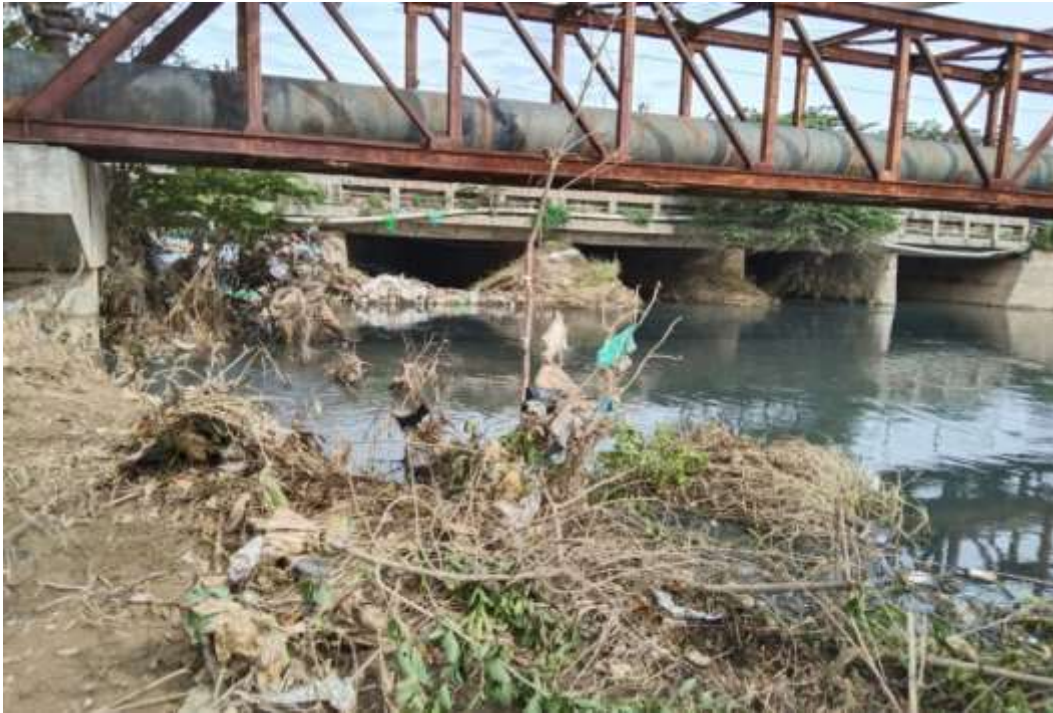
- vi. Figure 9.10 shows a view of the left bridge. It has the capacity just to discharge sewage from Bellandur lake and its downstream catchment. The entire stormwater from nearly 1/4<sup>th</sup> of the city is attempted to be regulated through the above bridge.

**Figure 9.10:** A close view of the left bridge. It has the capacity just to discharge the sewage from Bellandur lake and its downstream catchment area. It gets completely choked up by the weed during flood. The sewage and stormwater from a catchment area of about 191 sqkm or about 1/4<sup>th</sup> of the total area of the city is attempted to be regulated through it. It is totally held back.

As a follow up measure to ease the discharge at the reach, a small bridge that existed at the entrance of the bridge was dismantled immediately after the flood. The drain was cleaned at the reach and widened. But it may facilitate free discharge of sewage. The bridge would invariably be choked up by weed during flood due to its small vent openings. The discharge through it would invariably be obstructed. Similarly, the inundation at Yemalur road and housing complexes and apartments in its surrounding is thought to be due to encroachments of drains in their vicinity and they are attempted to be cleared. It would in no way help in preventing the waterlogging at the layouts and road, until free discharge of flood is facilitated at the bridge on Outer Ring Road.

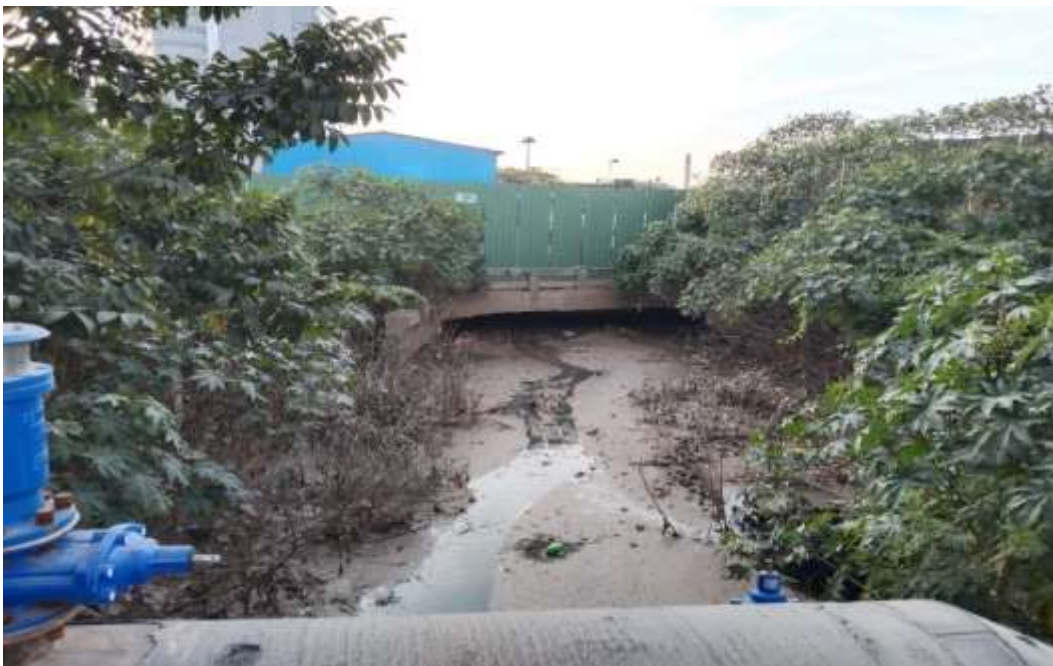
**Figure 9.11:** The view of the right bridge, which has become defunct after the land between the two bridges was filled up for the construction of the ancillary treatment plant.

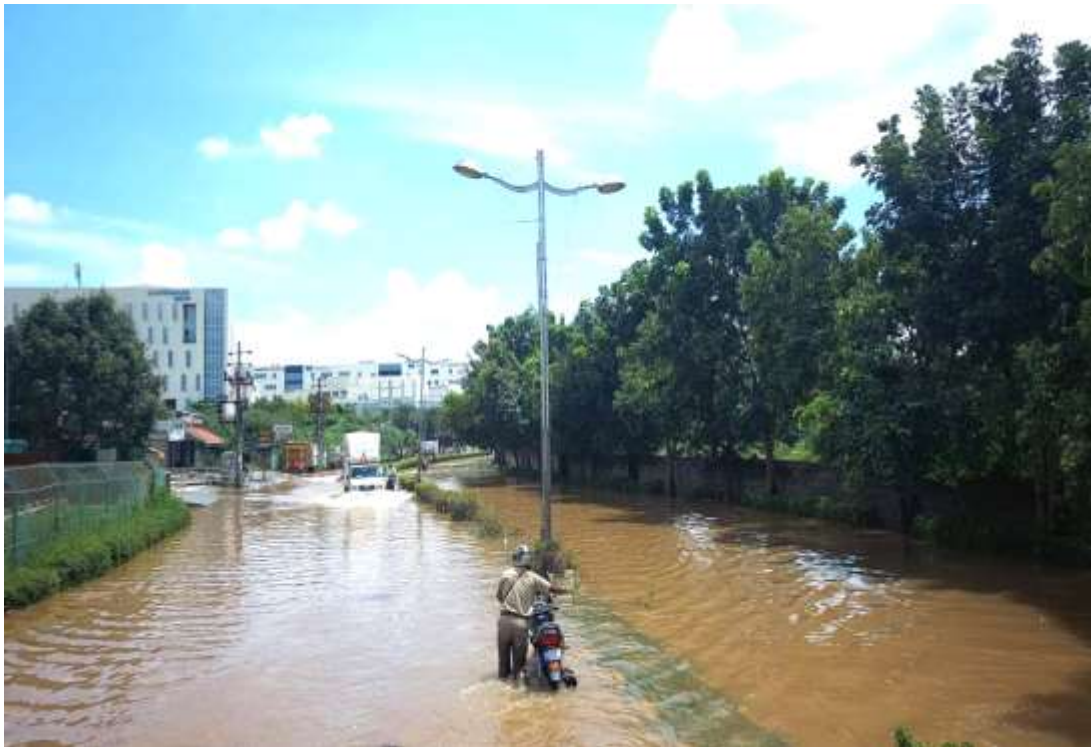
**Figure 9.13:** A view of the waterlogging at Yemalur road on September 5 and 6, 2022. It is just the held-up water at the bridge on Outer Ring Road stretched upto the road. (Photo curtesy: Times of India)

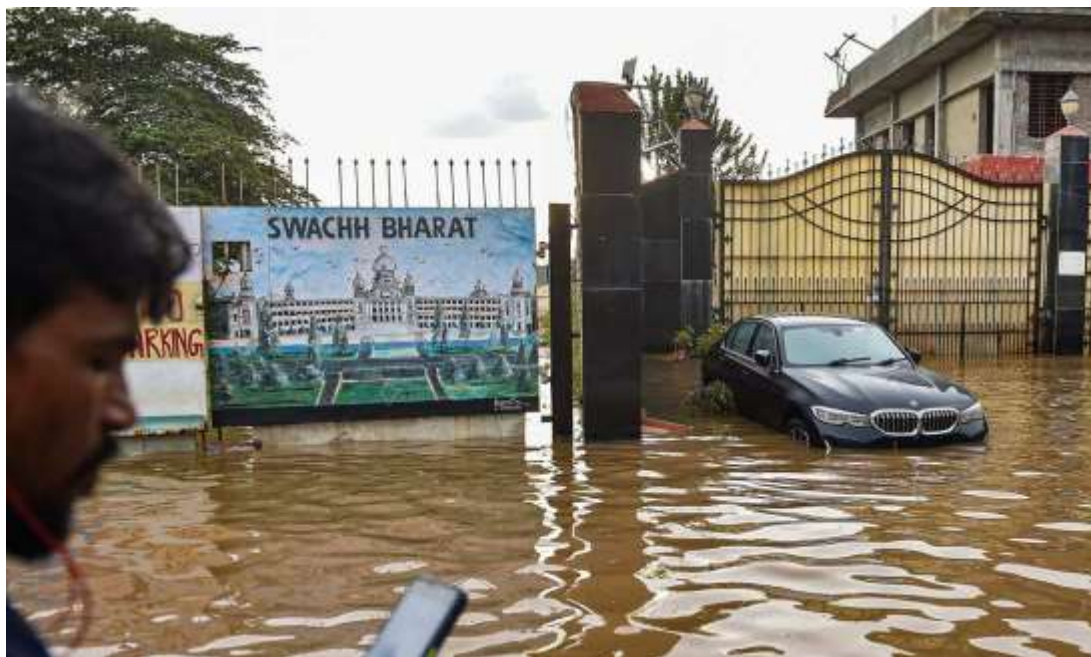
**Figure 9.14:** The view of the waterlogging in front of LCA Tejas gate on 6<sup>th</sup> September, 2022. It is the same held up water at the bridge on Outer Ring Road in Kadubeesalanahalli stretched upto the gate. (Photo curtesy: Times of India)
