# **Floods at Bengaluru City - A Technical Study**

**Dr. Sudhir Sajjan, B.E., M.B.A., Ph.D.**  
sajjan.sudhir@gmail.com

**December, 2022**

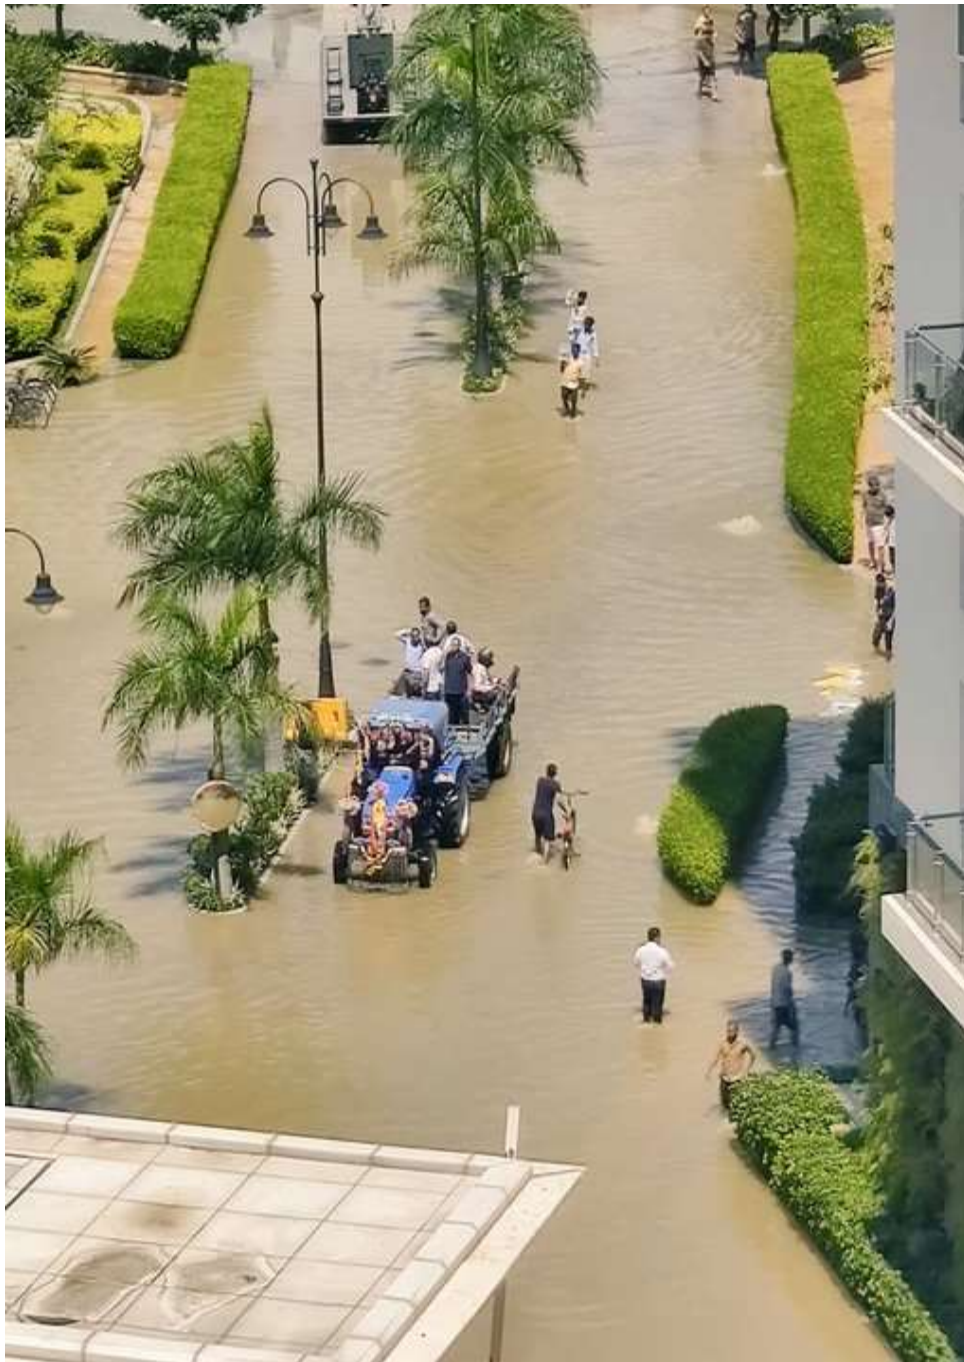
**Figure 9.15: The view of the waterlogging at the DivyaSree 77 East on 6<sup>th</sup> of September 2002. It is not the stormwater spilling over from the drains in its vicinity. It is the impounded water at the bridge on Outer Ring Road in Kadubeesalanahalli stretched up to it. (Photo curtesy: India.com)**

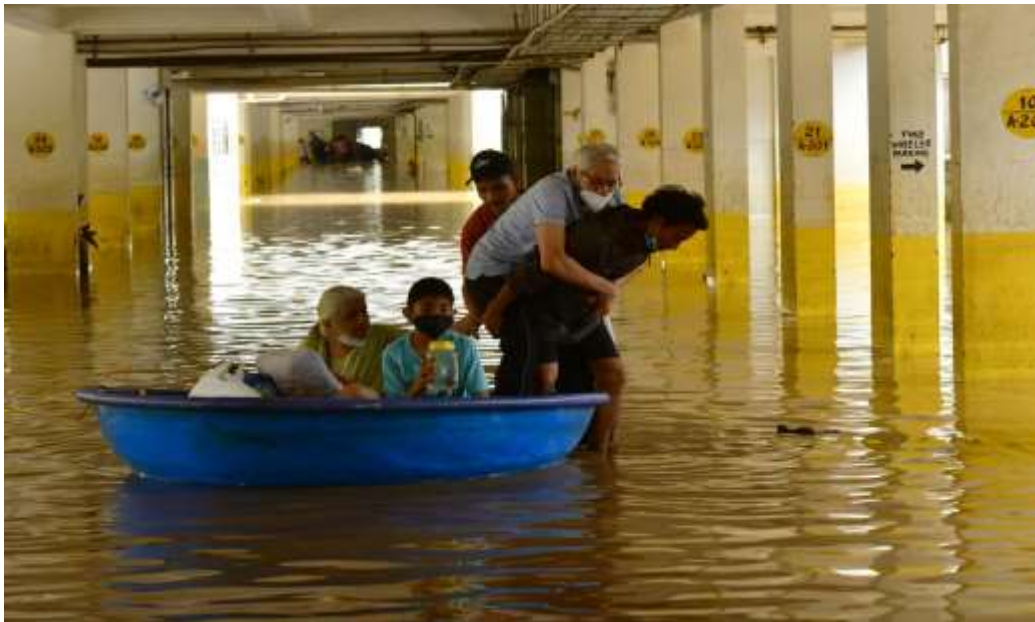
Residents moving out of apartments on Borewell road in Whitefield, after it was flooded due to Nallurahalli lake breach, in Bengaluru on Wednesday. | Photo Credit: K. Murali Kumar

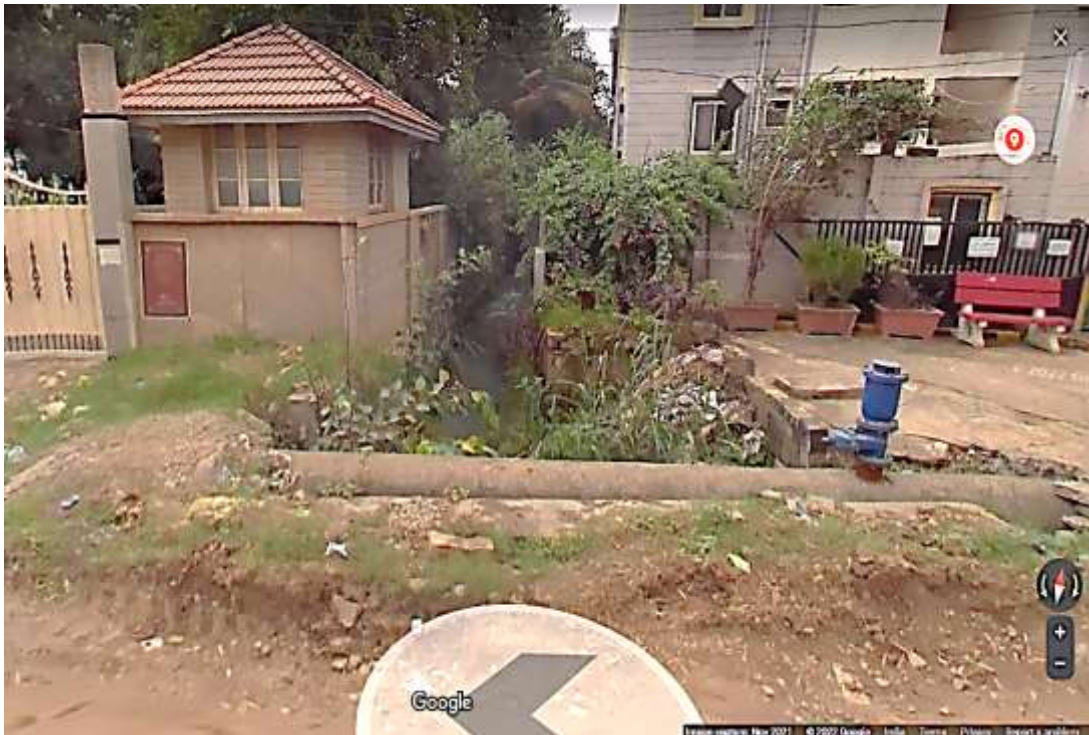
**Figure 10.4:** The close view of the drain between Ananya farm and SS Facility Apartment. It is connected to a culvert on Borewell road. The culvert runs at an angle and joins the drain at an open land between GSR Srinivasam and Malibu Paloma Apartments.

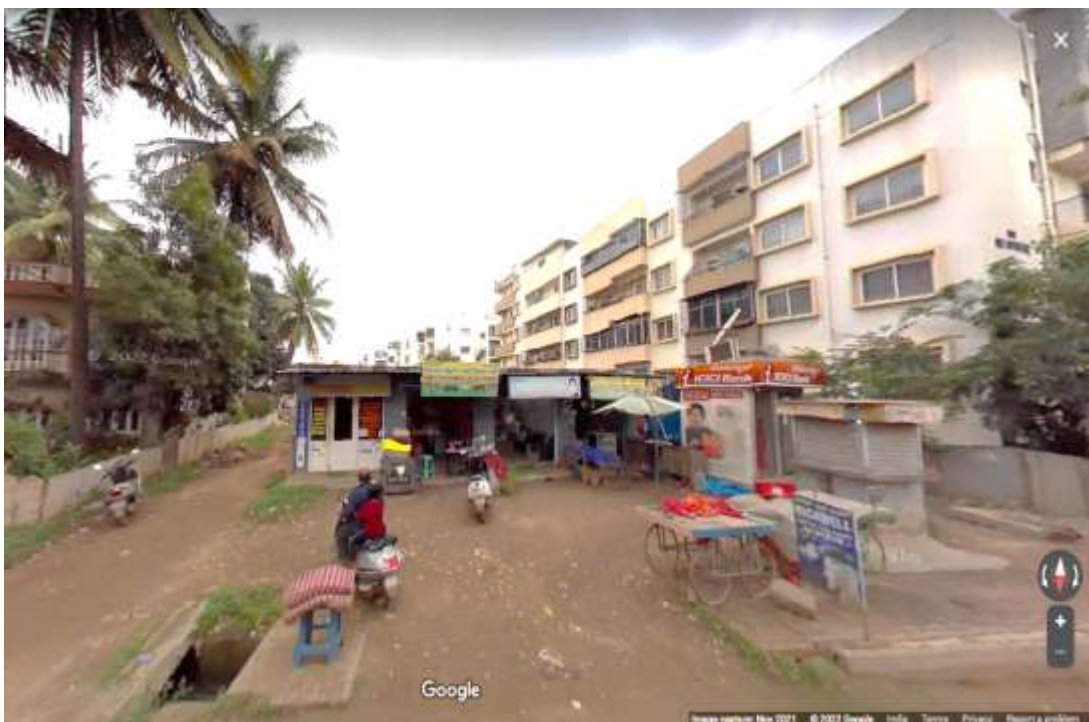
**Figure 10.6:** A close view of the drain between GSR Srinivasam and Malibu Paloma Apartments. It is covered with stone slabs. It is infact a sewage drain. The drain at the upstream of Borewell road and particularly the culvert has the capacity just adequate to discharge it. Therefore, the discharge from Nallurahalli lake spills over the road. It then runs on the open land between GSR Srinivasam and Malibu Paloma Apartments.

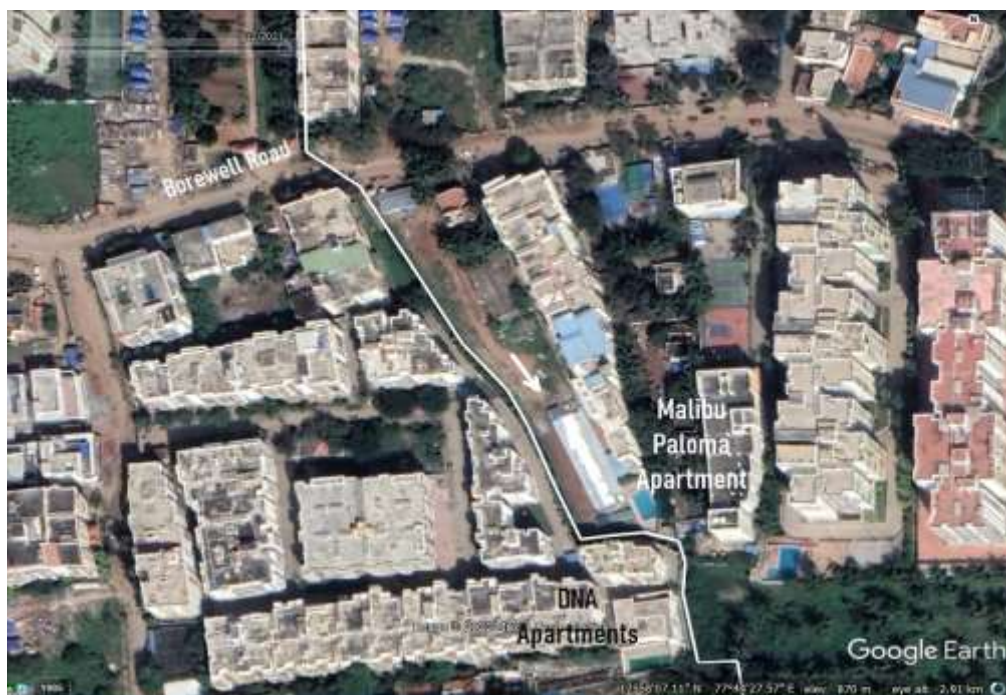
- vii. Figure 10.9 shows the Google image of the open land between GSR Srinivasam and Malibu Paloma Apartments in December 2021. Certain **labour sheds** were built on the above land and right at the mouth of the narrow space between the compound walls.

**Figure 10.9:** The Google image of the drain at the reach near Borewell road in December 2021. Certain labour sheds were built on the open land DNA and Malibu Paloma Apartments.

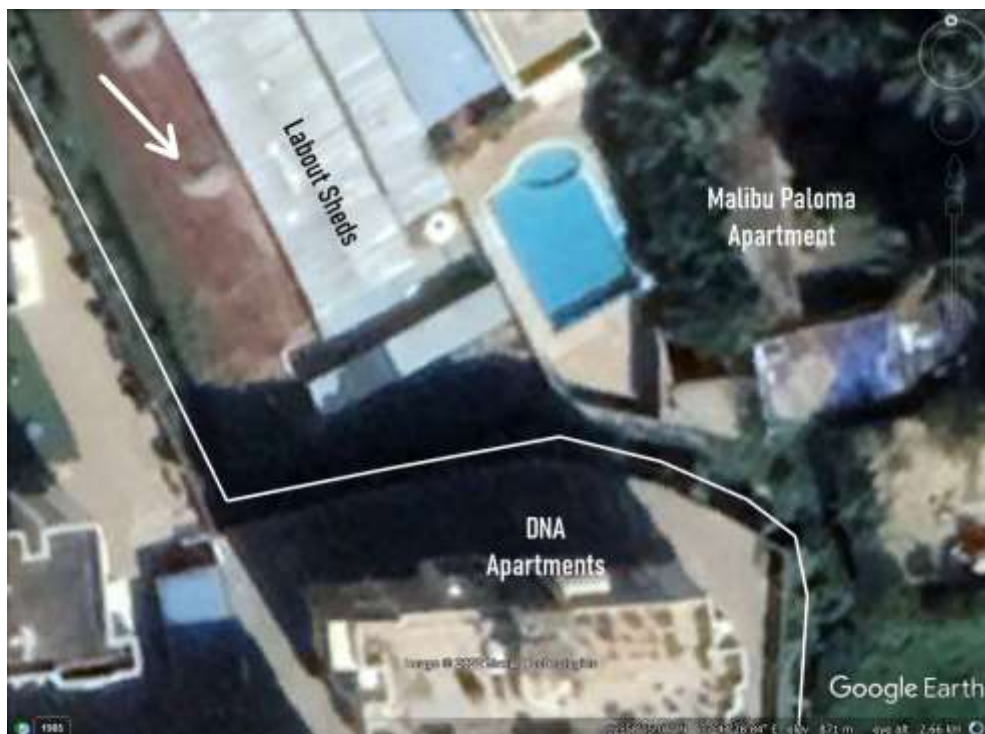
**Figure 10.10:** A close view of the labour sheds on the open land between DNA and Malibu Paloma Apartments. The labour sheds are constructed right at the mouth of the narrow space between the compound walls. It totally obstructed the discharge of Nallurahalli lake and runoff from the surrounding locality at the reach.

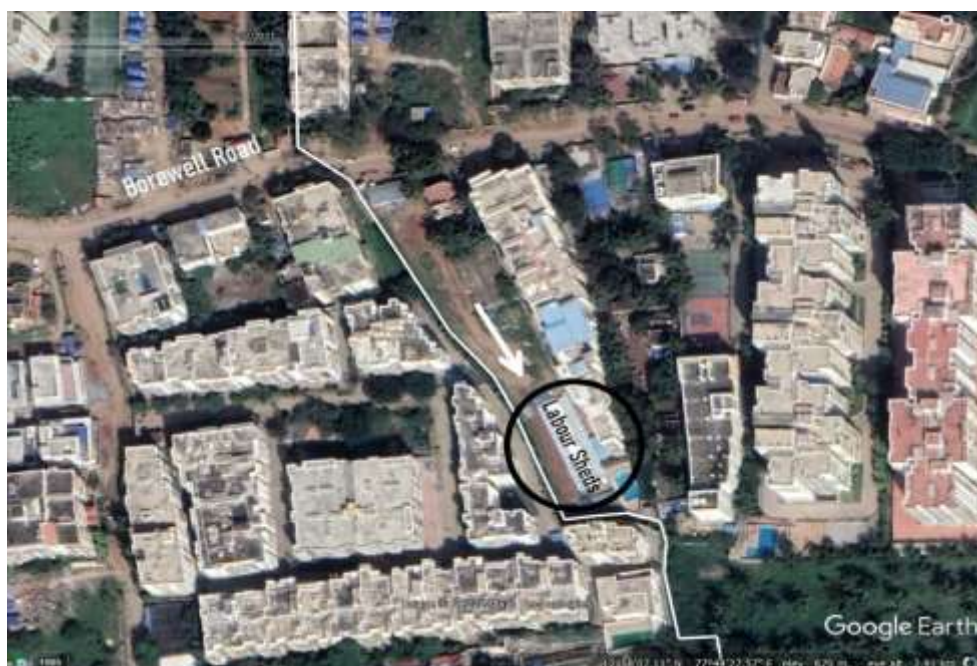
**Figure 10.11:** The spill over from the Nallurahalli lake which was freely discharging during 2021 is now obstructed by the construction of the labour sheds at the very mouth of the narrow space between the compound walls of DNA and Malibu Paloma Apartments. It is held back and impounded at the upstream of the sheds.

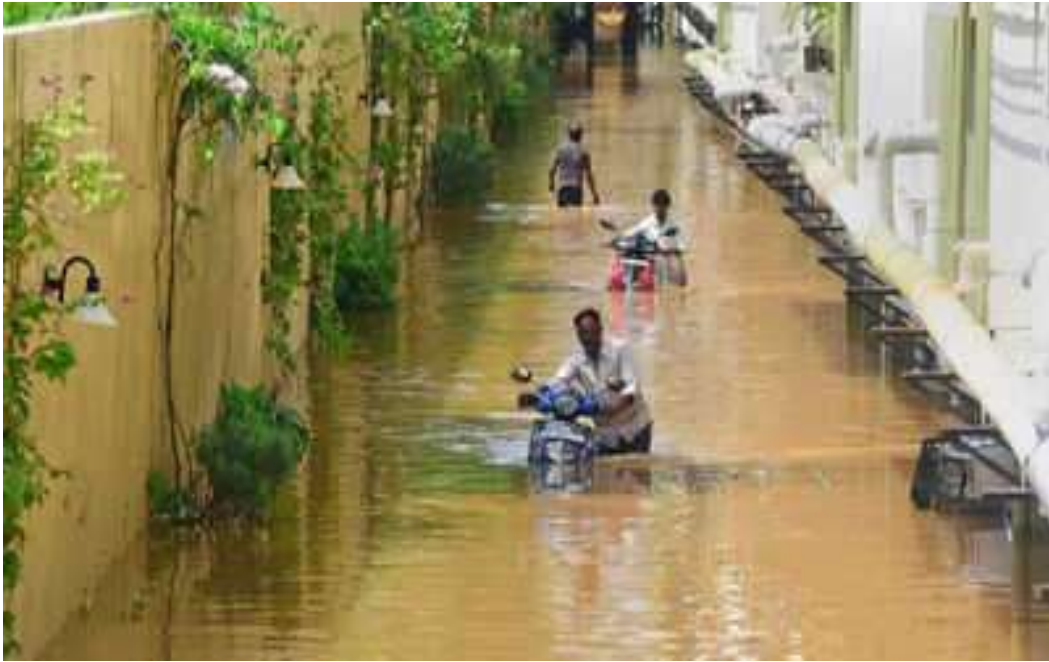
**Figure 10.13:** The view of the waterlogging at the basement of BM Glorietta Apartment on 7<sup>th</sup> September, 2022. It is just the held-up water by the construction of labour sheds on the open land between GSR Srinivasam and Malibu Paloma Apartments stretched upto the apartment.

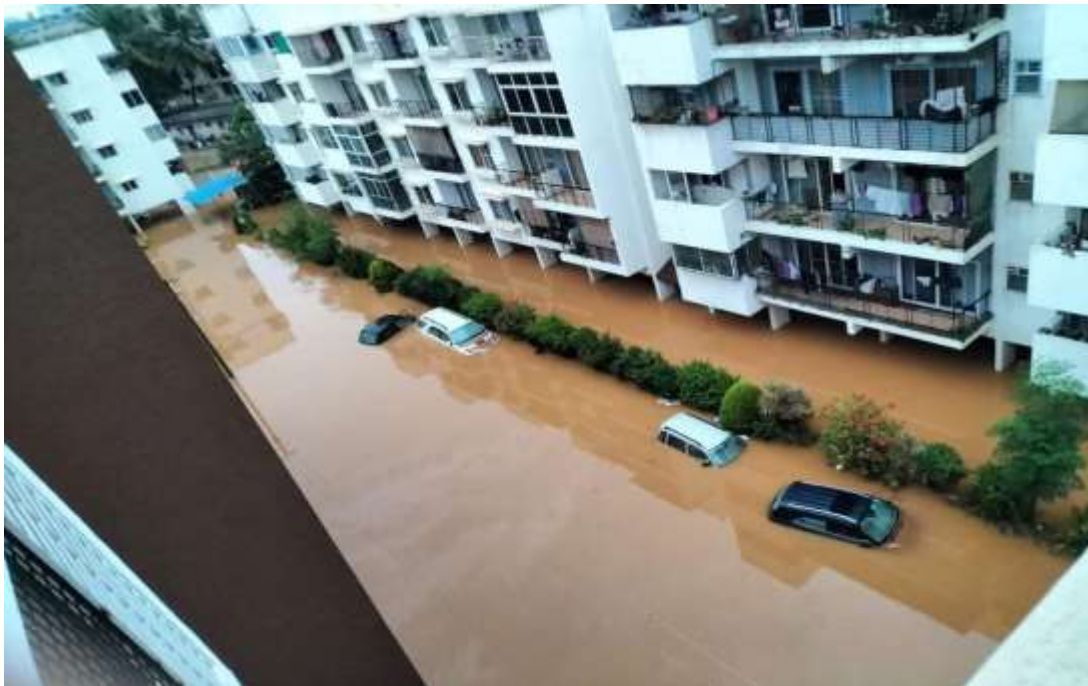
**Figure 10.14:** The view of DNA Eden View Apartments during peak flood. It is also the same obstructed water at the open land between GSR Srinivasam and Malibu Paloma Apartments stretched upto it. (Photo courtesy: The Hindu)

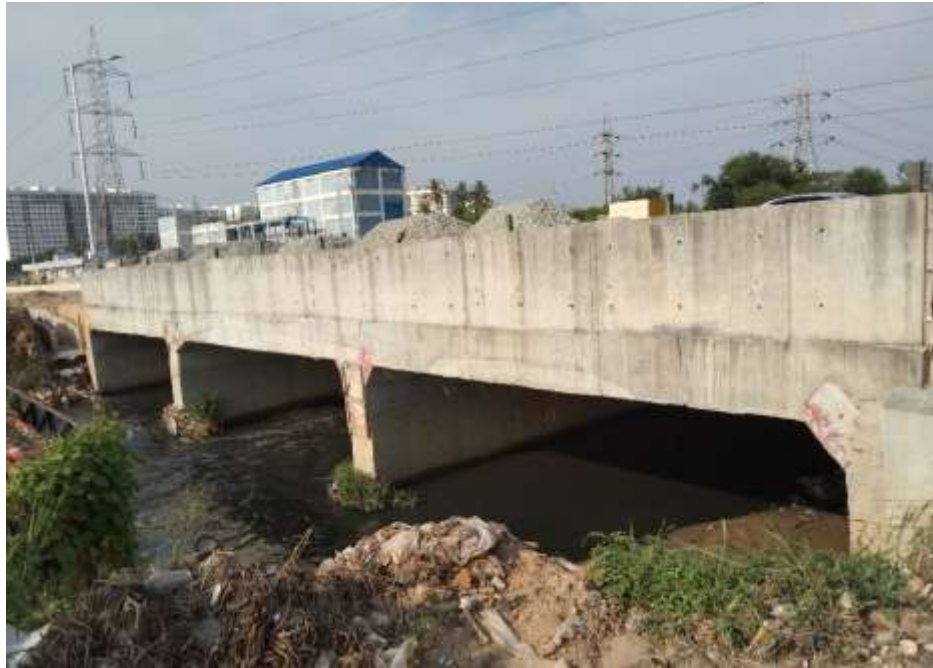
- vii. Figure 11.8 shows the view of the bridge. The runoff from about 28% of the total area of the city is directed at the bridge, besides sewage from Bellandur lake. But, it appears that it is designed just for discharge of sewage. Its vent openings are too small and they get choked up by the weed during flood. The flow is invariably obstructed.
- viii. A **GI sheet barricade** is put up at the upstream edge of the road all along its length as shown in Figure 11.9. The free discharge above the road is too prevented by it. As a result, the discharge from Bellandur and a large number of lakes at its downstream is held back and impounded at the upstream of the road.
- ix. Figure 11.10 shows the inundation map at the upstream of the road. The Balagere-Panathur road and the apartments in its vicinity are inundated in the above obstructed water.

**Figure 11.8:** The view of the bridge on the newly constructed road near BWSSB Sewage Treatment Plant. The runoff from about 28% of the total area of the city is directed at the bridge, besides sewage from Bellandur lake. But, it appears that it is just designed for discharge of sewage water. Its vent openings are very small and they get choked up by the weed during flood. The flow is invariably obstructed and held back.

Thus, what we were seeing at the Balagere-Panthur road during the flood was the held-up water at the newly constructed road near BWSSB Sewage Treatment Plant. We could observe that there would not have been any waterlogging at the reach, if a large bridge was constructed on the new road and an adequate waterway was provided for it for discharge of stormwater.

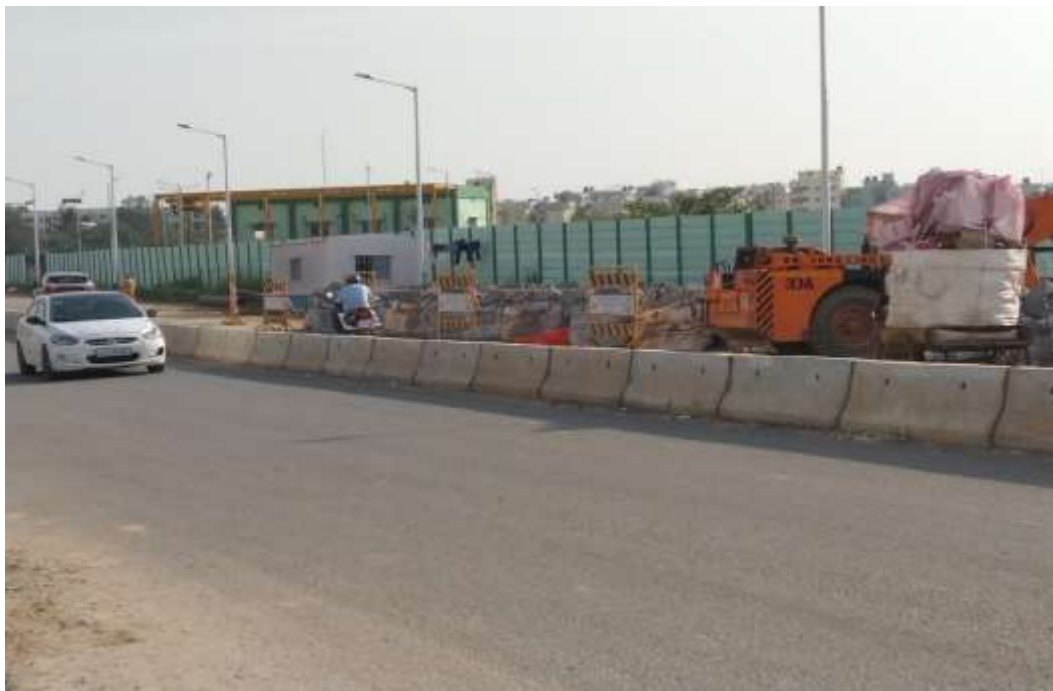
**Figure 11.9.** The view of the newly constructed road near the bridge. A GI sheet barricade is put up all along its upstream edge. The free discharge over it is too obstructed by the barricade.

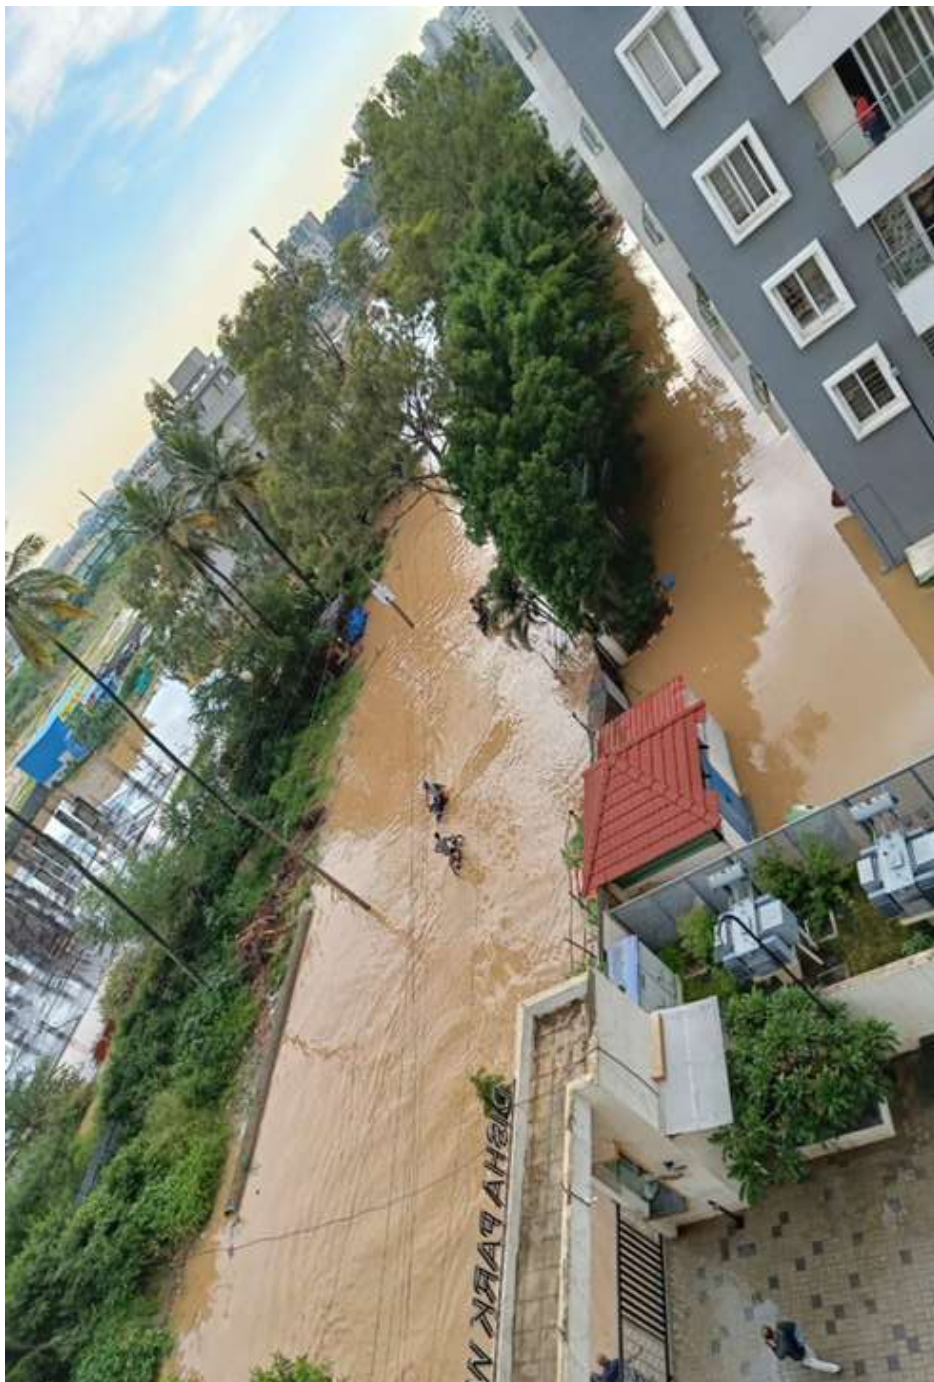
**Figure 11.12: A view of the waterlogging at Balagere-Panathur road near Disha Central Park on September 6, 2022. It is not the stormwater drained from its vicinity. It is actually the obstructed water at the newly constructed road near sewage treatment plant on the upstream of Varthur lake, impounded upto it. We could observe that there would not have been any waterlogging at the reach if there was a free discharge at the bridge on the newly constructed road. (Photo courtesy: Twitter)**
