COMDTPUB P16700.4 NVIC 7-95

NAVIGATION AND VESSEL INSPECTION CIRCULAR NO. 7-95

SUBJ: GUIDANCE ON INSPECTION, REPAIR AND MAINTENANCE OF WOODEN HULLS

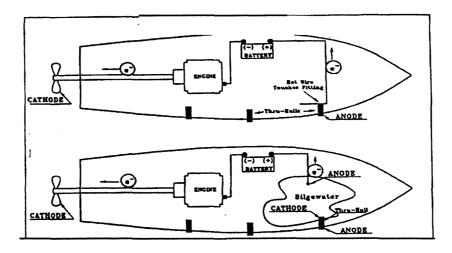
Figure C: Stray Current Corrosion

Typical sources of stray current are submersible bilge pumps, bilge pump float switches, and electrical wiring connections in the bilge area which might become submerged in the bilgewater. Fittings can be subject to stray current corrosion by coming into direct contact with a chafed positive (hot) DC wire or, more commonly, indirectly by a DC fault current to the bilgewater. Fittings which pass through the hull and are in contact with the outside seawater are most susceptible. In the case of an indirect stray current path through the bilgewater, fittings which are in direct contact with both the bilgewater and the outside seawater are most susceptible.

Stray current corrosion generally causes deep pitting of the objects it affects, and is almost always highly localized to within a few feet of the source of the stray current. In addition, the effected metal parts will appear to be unusually bright or shiny. A DC stray current may cause complete disintegration of a substantial fitting within a few days or even less. The magnitude of the DC stray current may be a few amps in severe cases, but usually not high enough to cause overcurrent protective devices to trip. Stray current can discharge batteries quickly, but in boats with shore-powered battery chargers, a substantial DC stray current may continue to flow indefinitely.

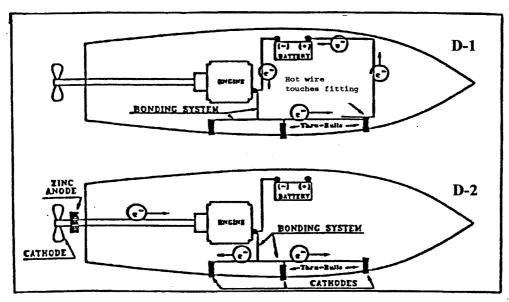
Figure D: Bonding Systems

In order to protect against the potentially disastrous effects of DC stray currents, many non-metallic hulled boats have a network of wires which connect hull fittings which are at risk of stray current corrosion with the negative, or ground side of the battery, usually via the engine block. This network is called a **bonding system**. In the case of a direct fault to a bonded fitting, sufficient current will probably flow to trip the overcurrent protective device, stopping the stray current. In the case of an indirect stray current (the wire in the bilgewater), it is unlikely that a sufficient current will flow to trip the circuit, even with a bonding system. In this case the bonding system and the stray current will share the fault current. An indirect fault, however, is often limited by the corrosion of the exposed metal at the source of the fault, which eventually stifles the current flow.

The bonding system ties the thru-hulls electrically to the negative terminal of the battery. When a hot wire touches the thru-hull, the electrical path presented by the bonding wire has so much less resistance than the electrolytic path of the stray-current cell that a high current flows in the
