# CD Moisture Profile and Reel Scanner Comprehensive Summary

N. Costello 08/02/2024

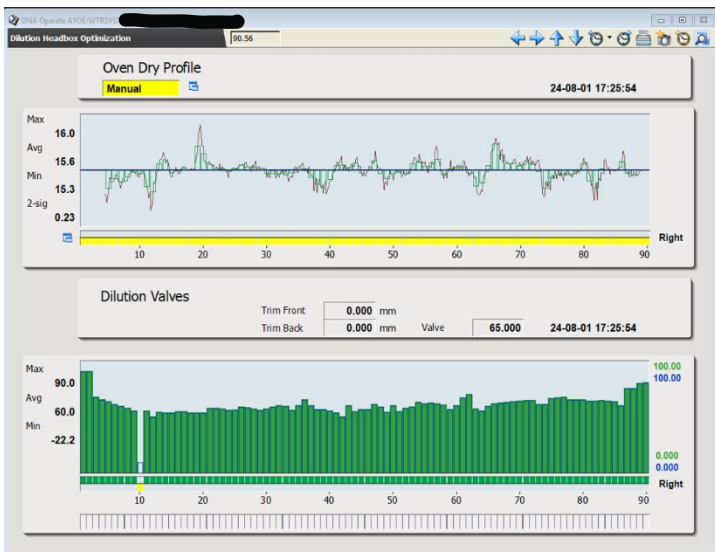
08/01/24 New Mapped Dilution Profile.

- The dilution profiling map and steam box maps will be saved, and dilution profiling loop run in *manual* until reprogramming is confirmed completed and effective.
- The improvements made were confirmed in FLUKE images of the sheet at the direct outfeed of our steam box and TAD2 exit roll. There is visibly less frequent/less aggressive streaking (please note the identified

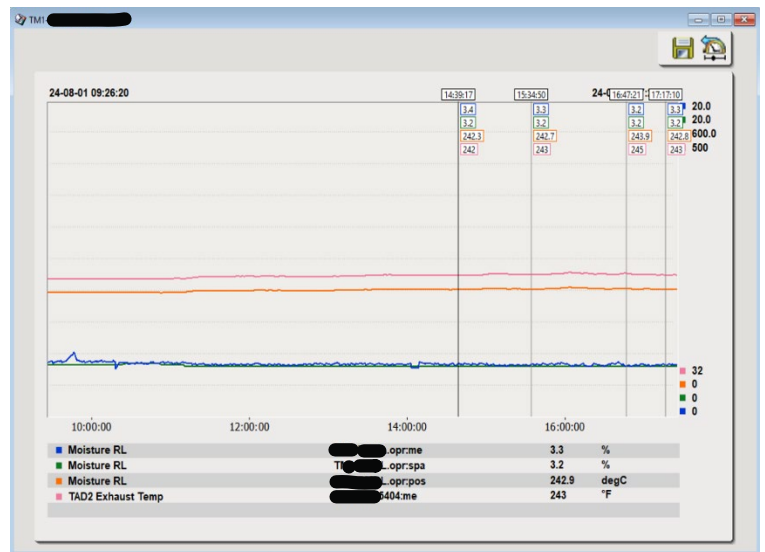
- Below are the new mapped DP actuator positions, and a trend of reel moisture and TAD2 exhaust temperatures after mapping. The reel moisture + RL 2-sigma, basis weight + BW 2-sigma, TAD2 exhaust temperature, and steam box actuators remained stable overnight.

Reel Moisture and TAD2 Exhaust Temperatures Remained Stable.

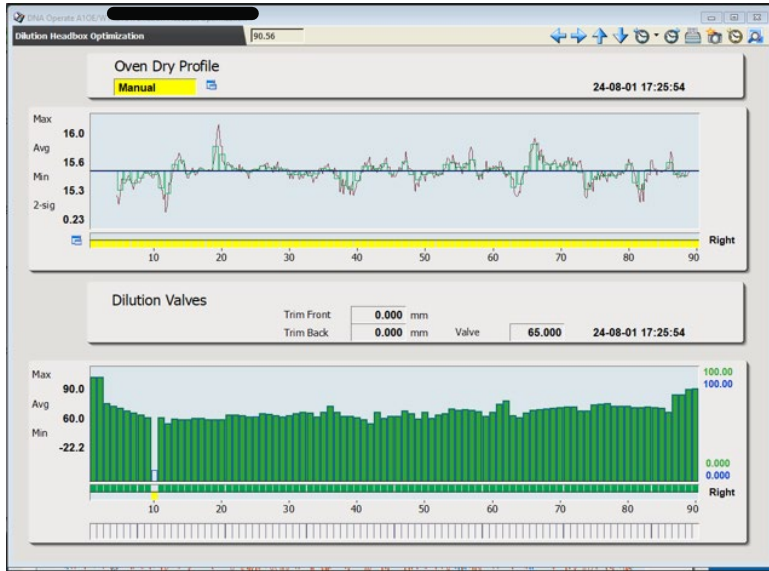
Dilution Profile Map.
