# RockSat-X 2024 Final Report

## DAEDALUS II

Northwest Nazarene University

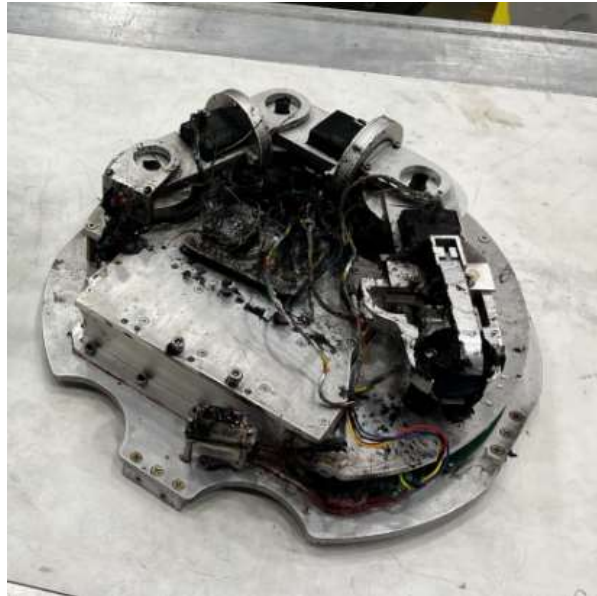
Following the flight and recovery, the payload was in relatively good condition. While some evidence of reentry was present most subsystems survived with relatively little damage. During reentry the EMBER system was lost. This was expected outcome considering the mounting points were made of ABS and could have been prevented by milling the housing out of aluminum.

After removing the dry box lid, it was apparent that the seals did not hold. Removing the top plate the team found that all components were submerged in seawater. The silicone RTV utilized to encase both SD cards performed exemplarily well with data being recovered from both cards. Due to the presence of water no parts housed in the dry box will be reused.

*Figure 19 – Experiment condition post reentry*

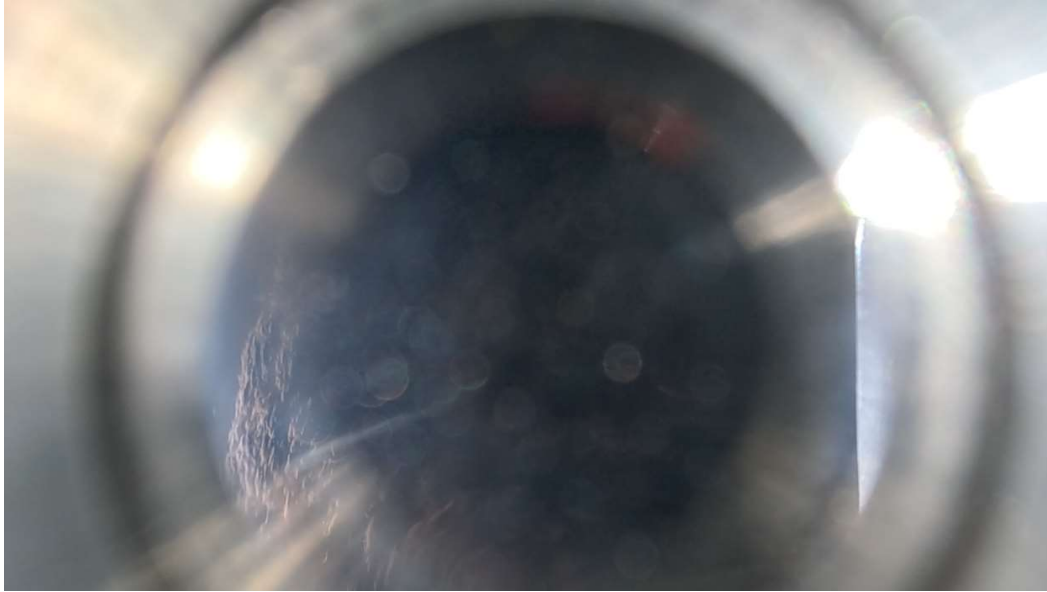
After analyzing the SD Cards, students analyzed the video recorded on the GoPro. Early in the footage it becomes apparent that something is partially occluding the lens. Viewing footage from GSE testing at WFF it was determined that no compound was present on the lens until launch. Therefore, it is believed that an unknown compound potentially outgassed and covered the lens during the experiment. This was corroborated by the presence of seawater in the dry box determined upon post launch inspection at Wallops. One of the seals of the dry box did not hold allowing for outgassing to occur while also allowing seawater to wash the unknown compound off the lens leaving students unable to determine the compound. The compounds' effect on video quality can be seen in figure 32. This issue was only compounded by glare from the sun.

*Figure 20 – GoPro Footage with Glare.*
