# CT\Meter Check Fault

## FAQ\Hybrid INV

### Issue introduction:

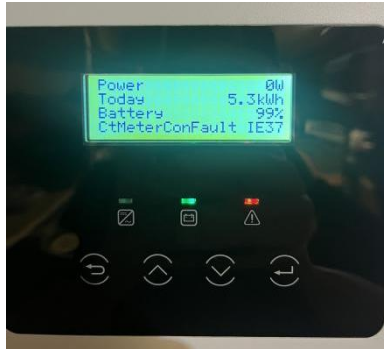
The inverter screen displays:CTMeterConFault IE37.

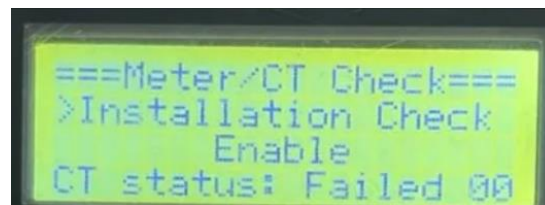
The error message is just a reminder and may not necessarily correspond to the actual installation issue. Usually, if there are no issues with the installation wiring of the meter or CT, updating the firmware version to the latest one can solve the problem.

Step3: Disconnect the PV and battery of the inverter, open any three-phase equipment at home, if the three-phase load can be stably taken from the grid and the meter sampling data conforms to the load rated power value, then restart the inverter and enable the Installation Check function. (This

Setting Path: *Advanced->Meter/CT Setting->Meter/CT Check->Installation Check*

Wait a minute for the results, make the necessary corrections to the table based on the prompt code

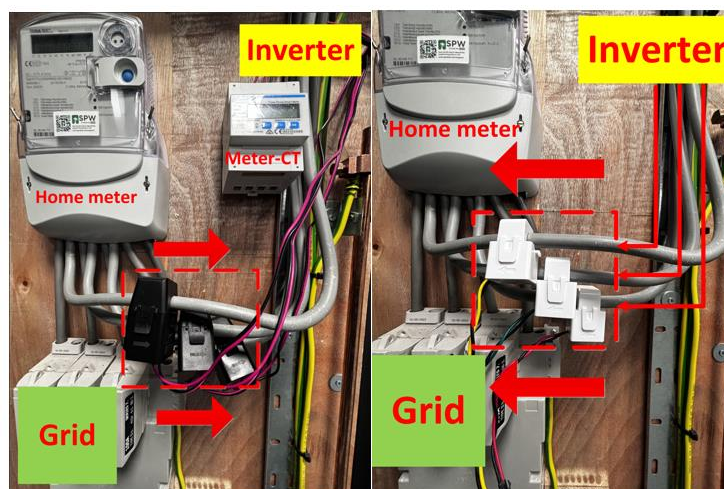
2. [Photo] CT direction.

Step2: Check CT direction, when only CT is connected, the CT arrow points to the grid, and when meter-CT is connected, the CT direction points to the inverter.
