# PV Connection Direction Fault

## String INV\Hybrid INV

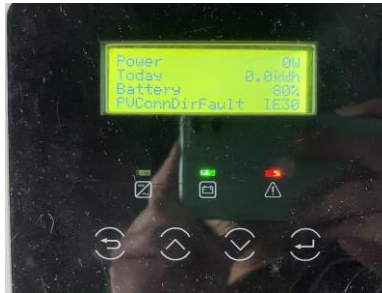
The inverter screen displays: PVConnDirFault

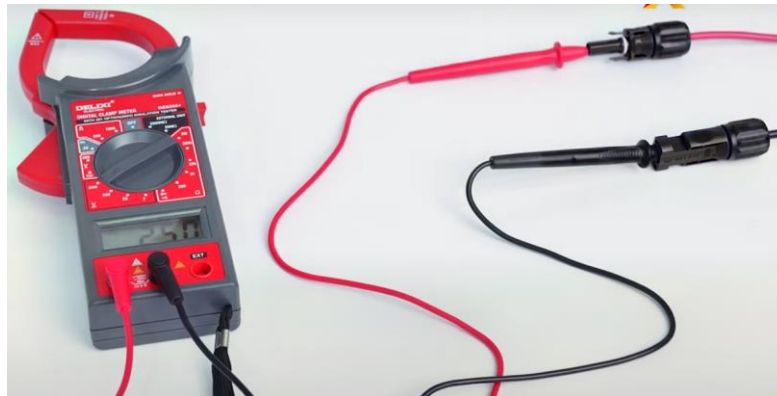
Measuring the voltage on the PV side with a multimeter, ensure the red probe is connected to the positive terminal and the black probe to the negative terminal. The correct measurement should be a positive number within the MPPT range. If a negative number appears, it indicates that the PV wires are reversed.

If the voltage difference between two strings of PV panels within the same MPPT is too large, it can also cause this error. Therefore, try to ensure that each string has the same number of PV panels, and ideally, keep the voltage difference between strings within 200 volts.
