WILL STAINLESS BLADE STEEL RUST IN A SALTWATER ENVIRONMENT?

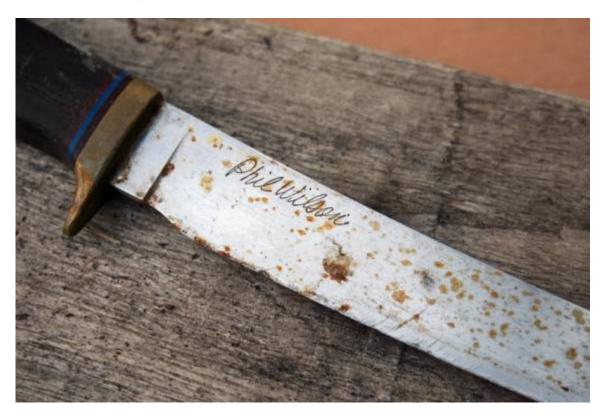
I have never really had any trouble with corrosion resistance on any of the stainless steels I use for knife blades. The reason for this is that after each use in and around salt water I always rinse the blade with fresh water, dry it off and give it a quick shot of "Pam" non stick cooking oil before putting it away in the sheath. The term "stainless steel" is pretty descriptive. Stainless means that the steel will stain less not stain at all. Chrome is the alloy element that does the trick. The stainless 400 steels vary in the amount of chrome in the mix. "The low end is about 14% and the high end 18%. Other factors like the amount of carbon, other alloy elements and the heat treating will all affect the final efficiency of the chrome to resist corrosion. If the blade is not cleaned and put away dry it can rust and pit. How serious can this be? Well I inadvertently found out. The blade below is probably the worst case possible.

This blade is 154 CM at RC 60. How did it get so corroded? Here's the story: I like to fish in Baja and make at least 2 fishing trips down there each year. We always end up in Bahia de Los Angles and have a favorite Panga guide we fish with. A little more that a year ago I made

Last summer we went back down and fished with him again. I asked him how his knife did and could I see it. He dug it out of the under seat compartment and handed it too me. It was a mess, the sheath was wet and mildewed, and the copper rivets were all green. I pulled the knife out of the sheath and saw the corrosion and tried not to let my face reflect what I was feeling. He apologized for the condition and told me that it must have been his mate that let it get in that condition. I said, "No problem I will take it home and clean it up and bring it back to you next trip". Before I cleaned it up I took the photo above. I guess this answers the question, Stainless will corrode in salt water conditions if not given at least reasonable care.

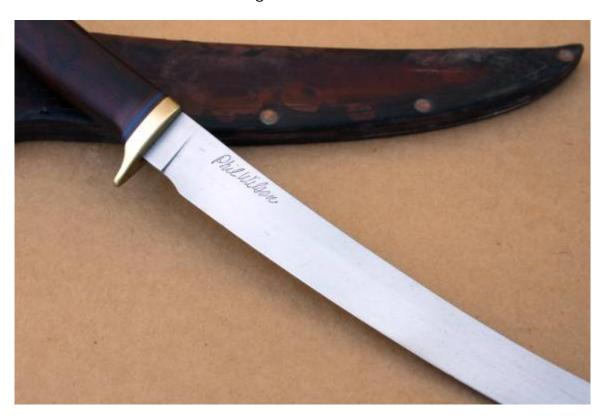
The photo above shows the blade as cleaned up. I started with 220 grit wet/dry paper and finished at 400 grit. If you look close you can see some small residual pits. On the whole the blade is still useable

and I was surprised that it did clean up as well as it did. This is an extreme example of what can happen to 154CM if it is never rinsed off and if it is put away in a damp salt saturated sheath. Even though the blade was corroded it still was used to fillet more than a hundred Yellow Tail and many Grouper over about an 8 month period. I think the particle metallurgy steels like CPM 154 CPM S30V, CPM S90V would probably fare a little better due to the finer grain structure. In any case this is one point on the curve under an actual use/abuse real world test.
