MBE7002\_Wired Disconnection on child node

Ticket ID  
#TE00126188

| PRODUCT CATEGORY | MESH SYSTEMS | PRODUCT - MESH SYSTEMS | MBE7000 |

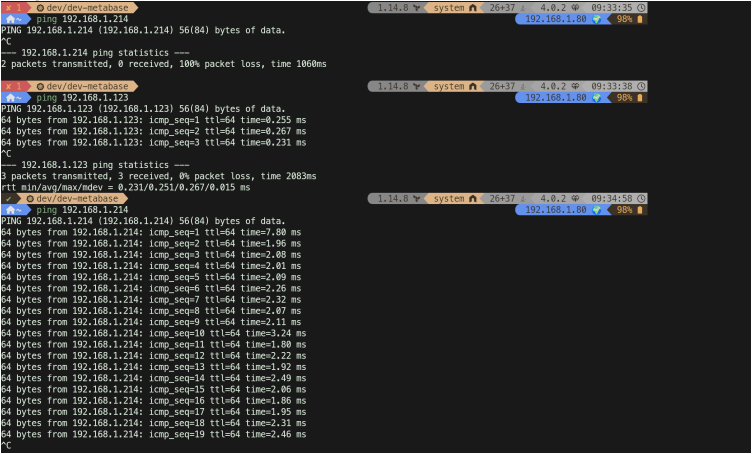
Ping commands:

So I was not able to ping 192.168.1.214 (main node), however I was able to ping the 192.168.1.123 (where the machines are connected to by ethernet cables), so my deduction is that the node is not connected anymore.

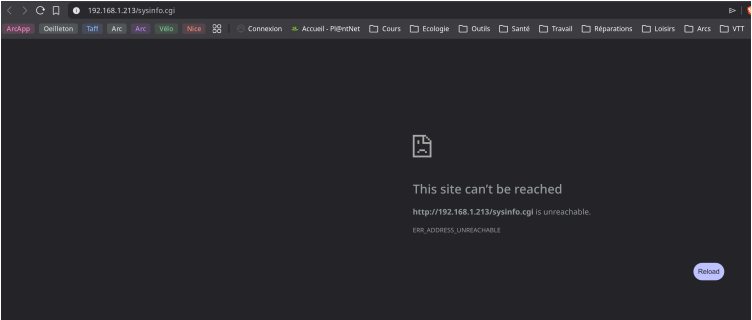
At that moment, the led was solid white and it looks like I was unable to connect though http to 192.168.1.123:

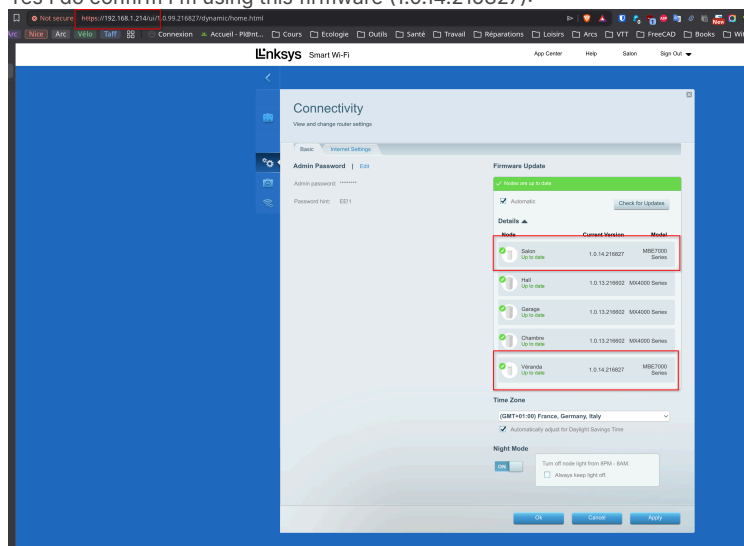
Yes I do confirm I'm using this firmware (1.0.14.216827):

When the issue occurs, both nodes are unavailable from computers behind the "Véranda" nodes (reported in the document I've sent: "Unreachable: read body: context deadline exceeded (Client.Timeout or context cancellation while reading body)" )

According to syslog, it looks like both nodes rebooted at the time and generate this issue. FYI, there was no electricity shortcut at that moment.

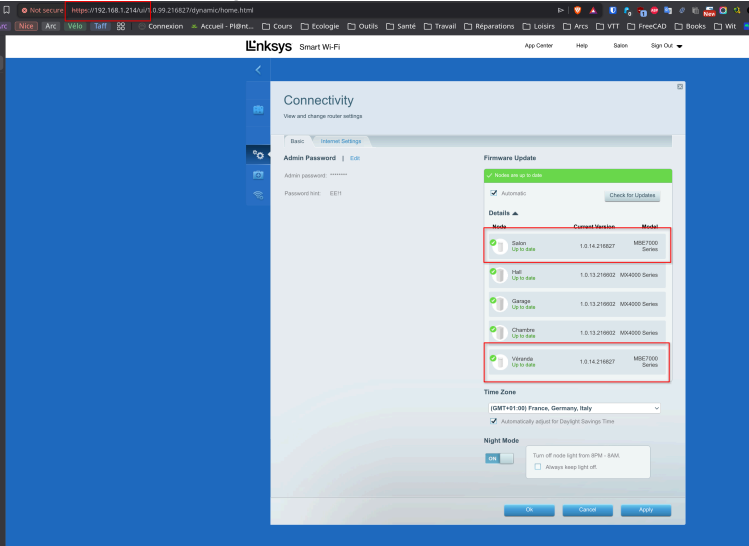
*Yes I do confirm I'm using this firmware (1.0.14.216827):*

*When the issue occurs, both nodes are unavailable from computers behind the "Véranda" nodes (reported in the document I've sent: "Unreachable: read body: context deadline exceeded (Client.Timeout or context cancellation while reading body)") )*

*According to syslog, it looks like both nodes rebooted at the time and generate this issue. FYI, there was no electricity shortcut at that moment.*

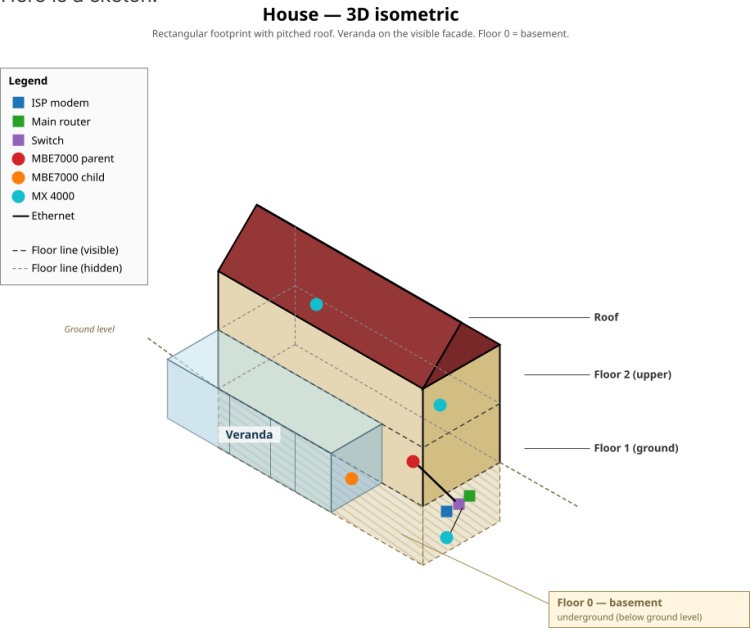
Here is a sketch:

- Total floors: 3
- Parent node location: **floor 1, (ethernet 1Gb/s connection),**
- Affected child node location: **floor 1, veranda**
- Other child nodes location:
  - \* **floor 0, garage (ethernet 1Gb/s connection),**
  - \* **floor 2, hall (wifi connected to principal)**
  - \* **floor 2, bedroom (wifi connected to principal)**
- Approximate distance parent ↔ affected child: **5 meters**
- Walls between parent and affected child: **1 concrete load-bearing wall**
