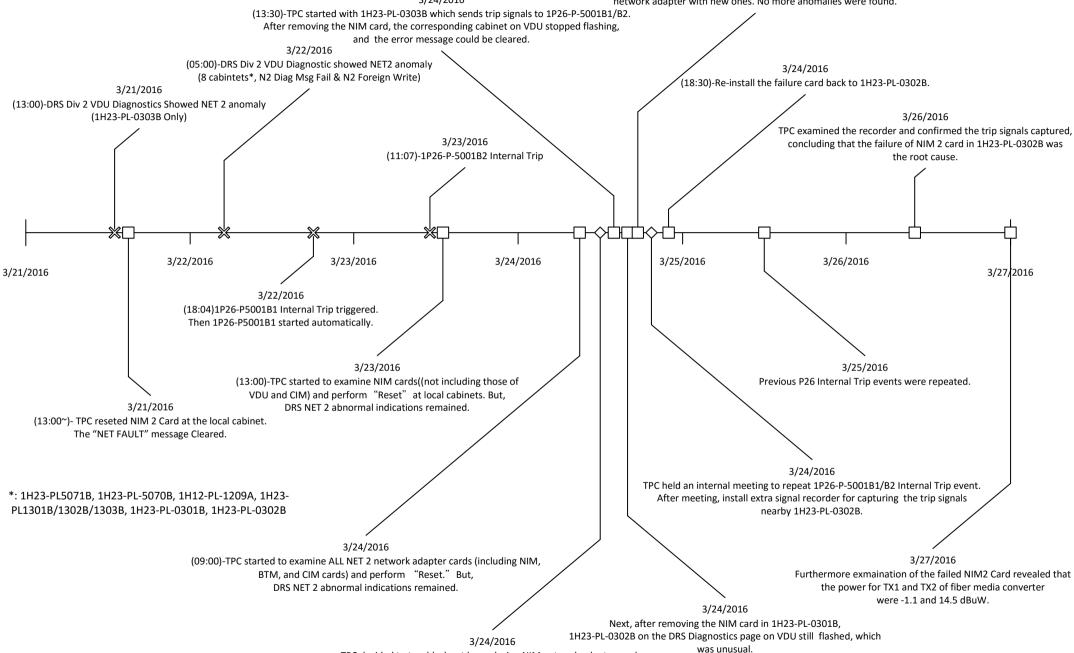
TPC decided to troubleshoot by replacing NIM network adapter cards, primarily focusing on those in 1H23-PL-0301B/0302B/0303B

3/24/2016 Next, TPC used fiber optic bridge to bypass network connection of 1H23-0302B. Then, DRS NET 2 restored to normal condition. TPC replaced the original network adapter with new ones. No more anomalies were found.
