Mat heating wire A'SSY repair method

How to tear off the webbing of the mat and repair
the heating wire, temperature sensor, and bimetal
lead wire of A'SSY.

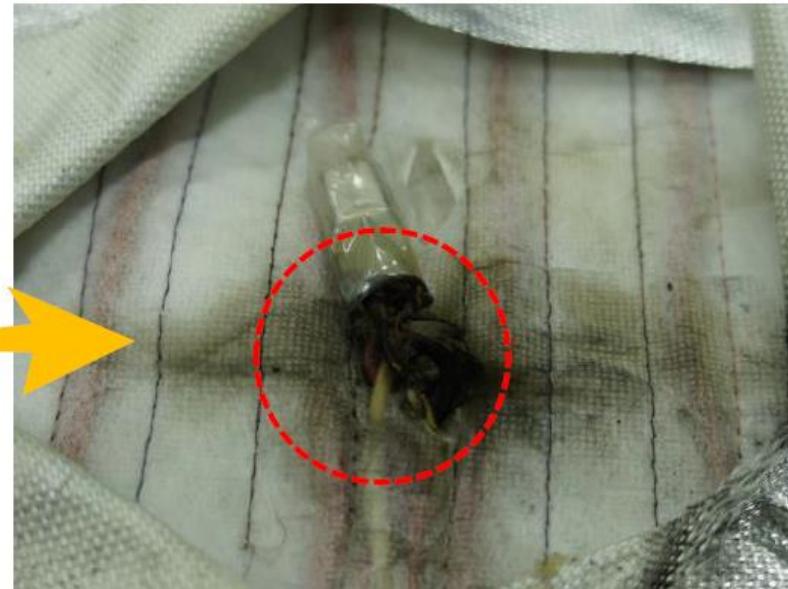
Carbonized and broken

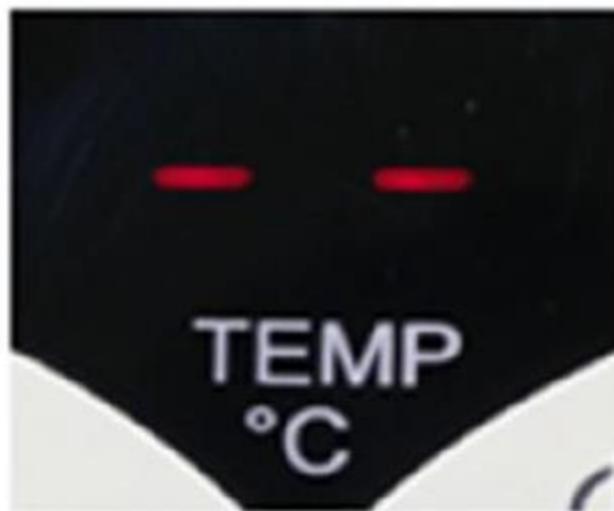
In many cases, the temperature

sensor lead wire is broken rather than a defective temperature sensor.

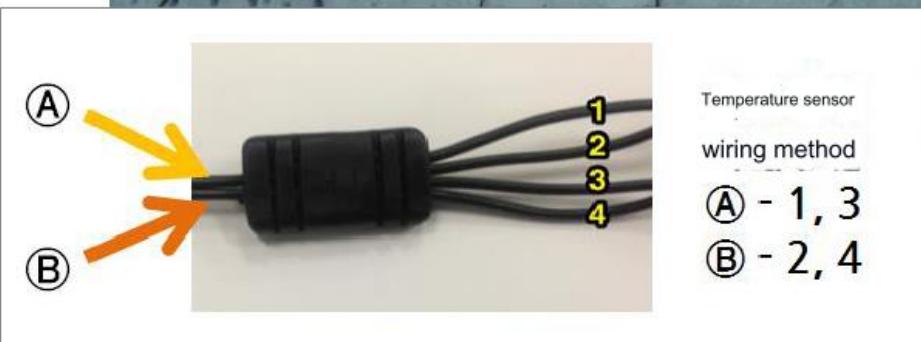
Temperature sensor

wiring method

Ⓐ - 1, 3

Ⓑ - 2, 4
