### Wednesday 06.18.14

# How to clean a Kodak/Pakon scanner

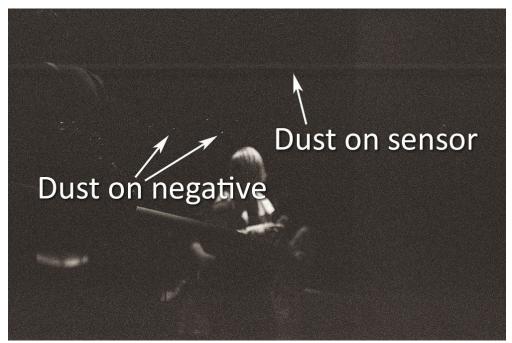
Examples of dust on negative and dust on sensor.

Dust on the sensors, however, is not so easy to deal with. It leaves a horizontal line on your scans which, more often than not, isn't so easy to remove in Photoshop.

Blowing some compressed air into the opening the film enters the scanner can sometimes fix the problem, so always try that first. If that doesn't work, then it's time to take this baby apart. And here's what you'll need...

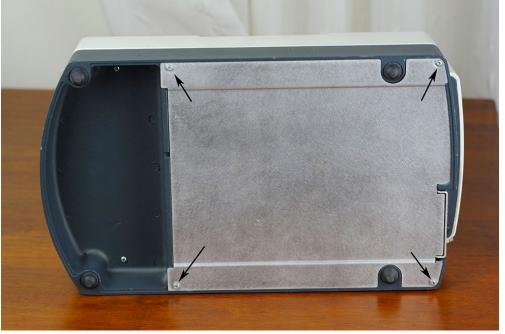
Remove these four torx screws

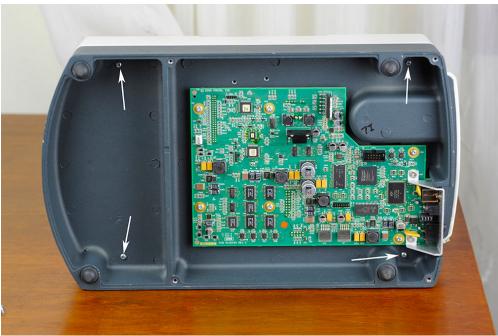
Remove these four screws

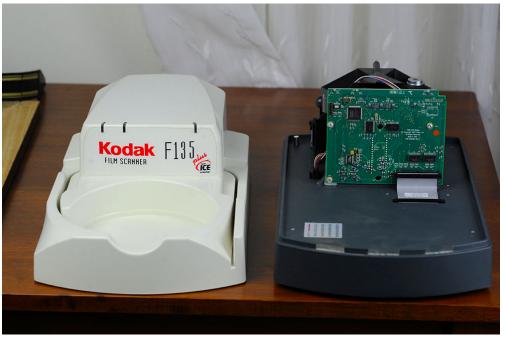
Top cover removed

As you're looking at the scanner from the front (as in the above photo), you'll notice a plug on the left with two sets of wires coming off it. One set heading to the top and one set going underneath. These wires lead to your top and bottom sensors, so be careful when handling them. They're shown a bit clearer in the next photo.
