## BAY PROCEDURE

Tacoma RV Center · Document Library

| CONCERN | Icing up on rear wall - only about half from the top down | | | |
| MODEL | Furrion FCR10DCGTA-BL | DATE | 2026-09-19 | WO# WO-ICE |

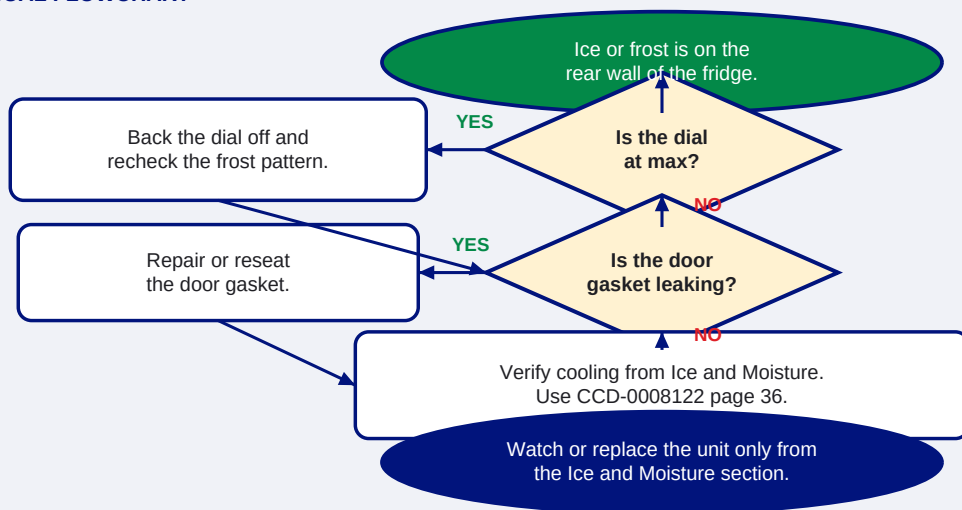
### VISUAL FLOWCHART

Ice or frost on the rear wall, including a pattern that starts about halfway down from the top, is an Ice and Moisture problem. Follow Ice or Moisture in the Fridge on CCD-0008122. This is a moisture, door gasket, and cooling path. It is not a dead-unit fuse check, and it is not a 12-volt inverter path.

- ☐ 1. Look at the frost pattern on the rear wall, including whether it starts about halfway from the top.
- ☐ 2. Check whether the temperature dial is all the way at max. If it is, back the dial off and recheck the frost pattern.
- ☐ 3. Inspect the door gasket and reseal or repair it before you condemn the cooling unit.
- ☐ 4. Verify cooling from the Ice and Moisture section on CCD-0008122 page 36. Watch or replace the unit only from that section.
