## BAY PROCEDURE

Tacoma RV Center · Document Library

| CONCERN | Icing up on rear wall - only about half from the top down | | |
| MODEL | Furrion FCR10DCGTA-BL | DATE | 2026-09-19 |

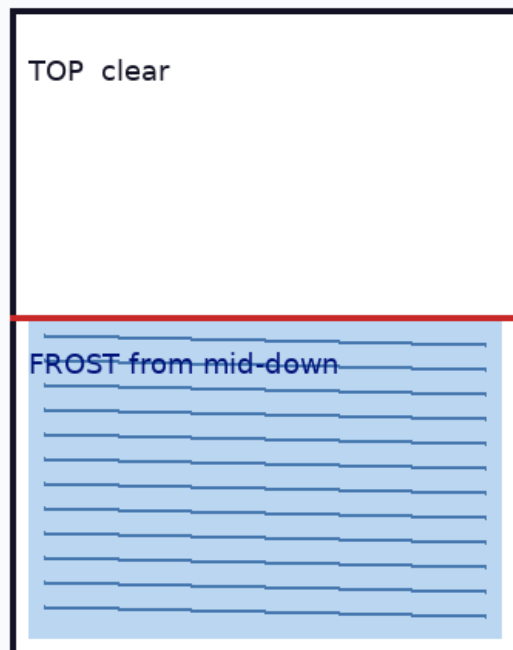
Fig. 36 Rear-wall frost pattern

A light sheet on the back wall alone can be normal cycling.

Heavy frost starting halfway down is the Ice and Moisture pattern. Stay on that section.
