# BAY PROCEDURE

Tacoma RV Center · Document Library

CONCERN  
MODEL  
PRIMARY

Furrion FCR10DCGTA-BL

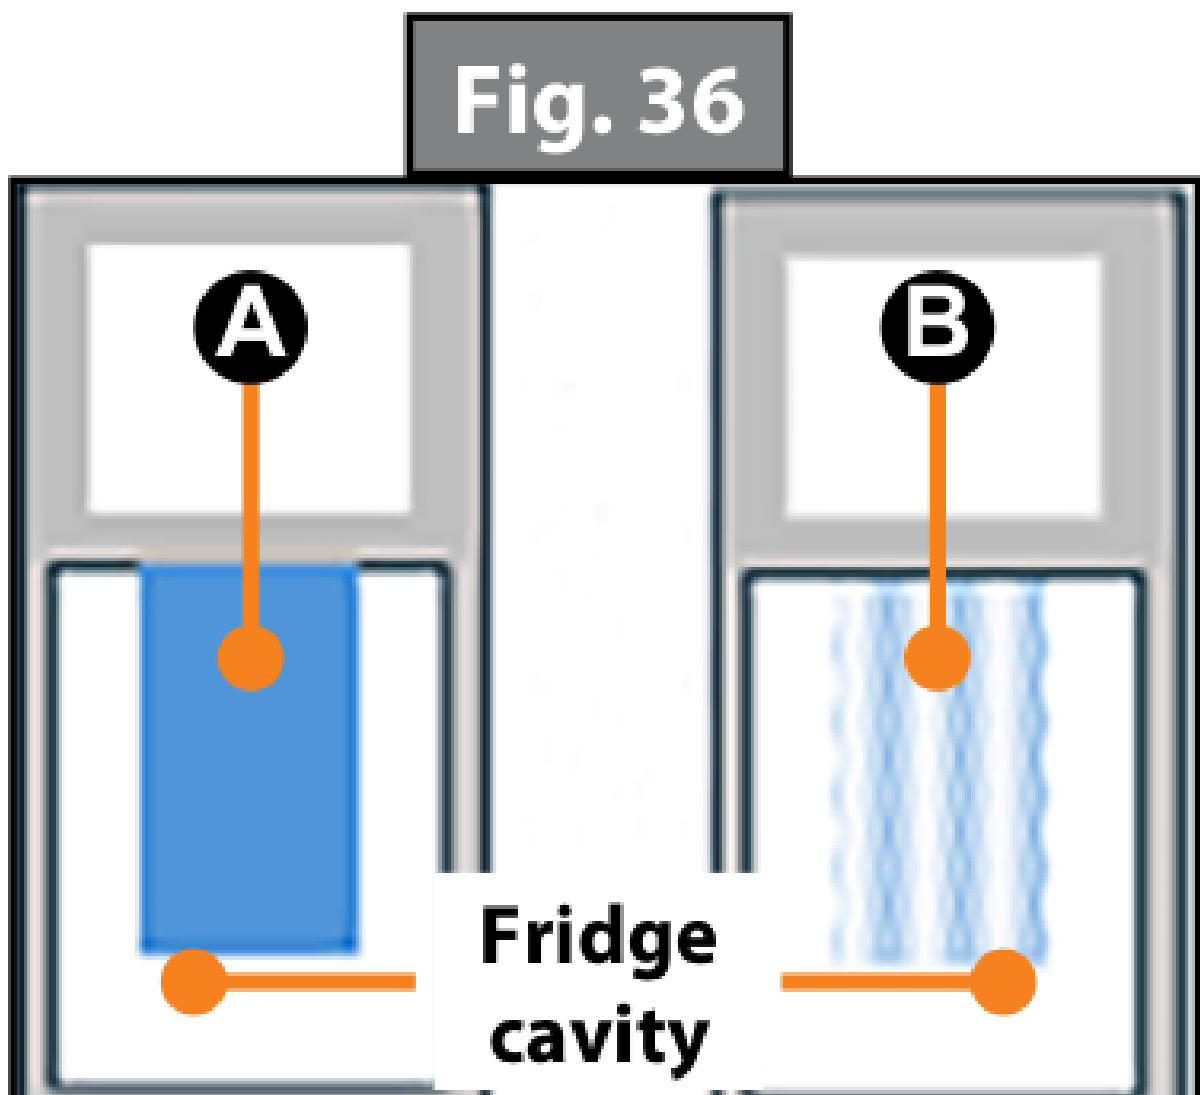
Fig. 36 rear-wall frost pattern, views A and B -- Furrion FCR08/FCR10 SM CCD-0008122 p.36

A frost or ice band on the upper rear wall, with the lower rear often clearer, is a common Furrion fridge complaint. It is usually moisture on a cold evaporator surface from the door seal, humidity, setpoint, airflow, or the drain. A light sheet of ice or moisture only on the back wall is normal cycling: the cabinet condenses, freezes, and thaws. This pattern by itself is not proof of a sealed-system failure.

- ☐ 3. Do a full manual defrost. Power the unit off, open both doors, and use towels. Do not scrape, do not use a heat gun, and do not set hot-water pans in the cabinet. When the ice is gone, go to the dry-and-drain step.

- ☐ 4. Dry the cabinet completely. Clear the rear drain and trough with a soft plastic probe only so melt water can leave. If water backs up, keep clearing until it leaves, then go to the gasket. If the drain is already open, go to the gasket next.

- ☐ 5. Check the door gasket with a dollar-bill test around the full perimeter, and check the hinges, latch, and door alignment. If the bill slides out with no drag, reseal or replace the gasket, set the dial to about 4 to 5, leave an air gap at the rear wall, and recheck in 24 to 48 hours. If the gasket holds, set the dial mid, leave the air gap, and recheck in 24 to 48 hours.

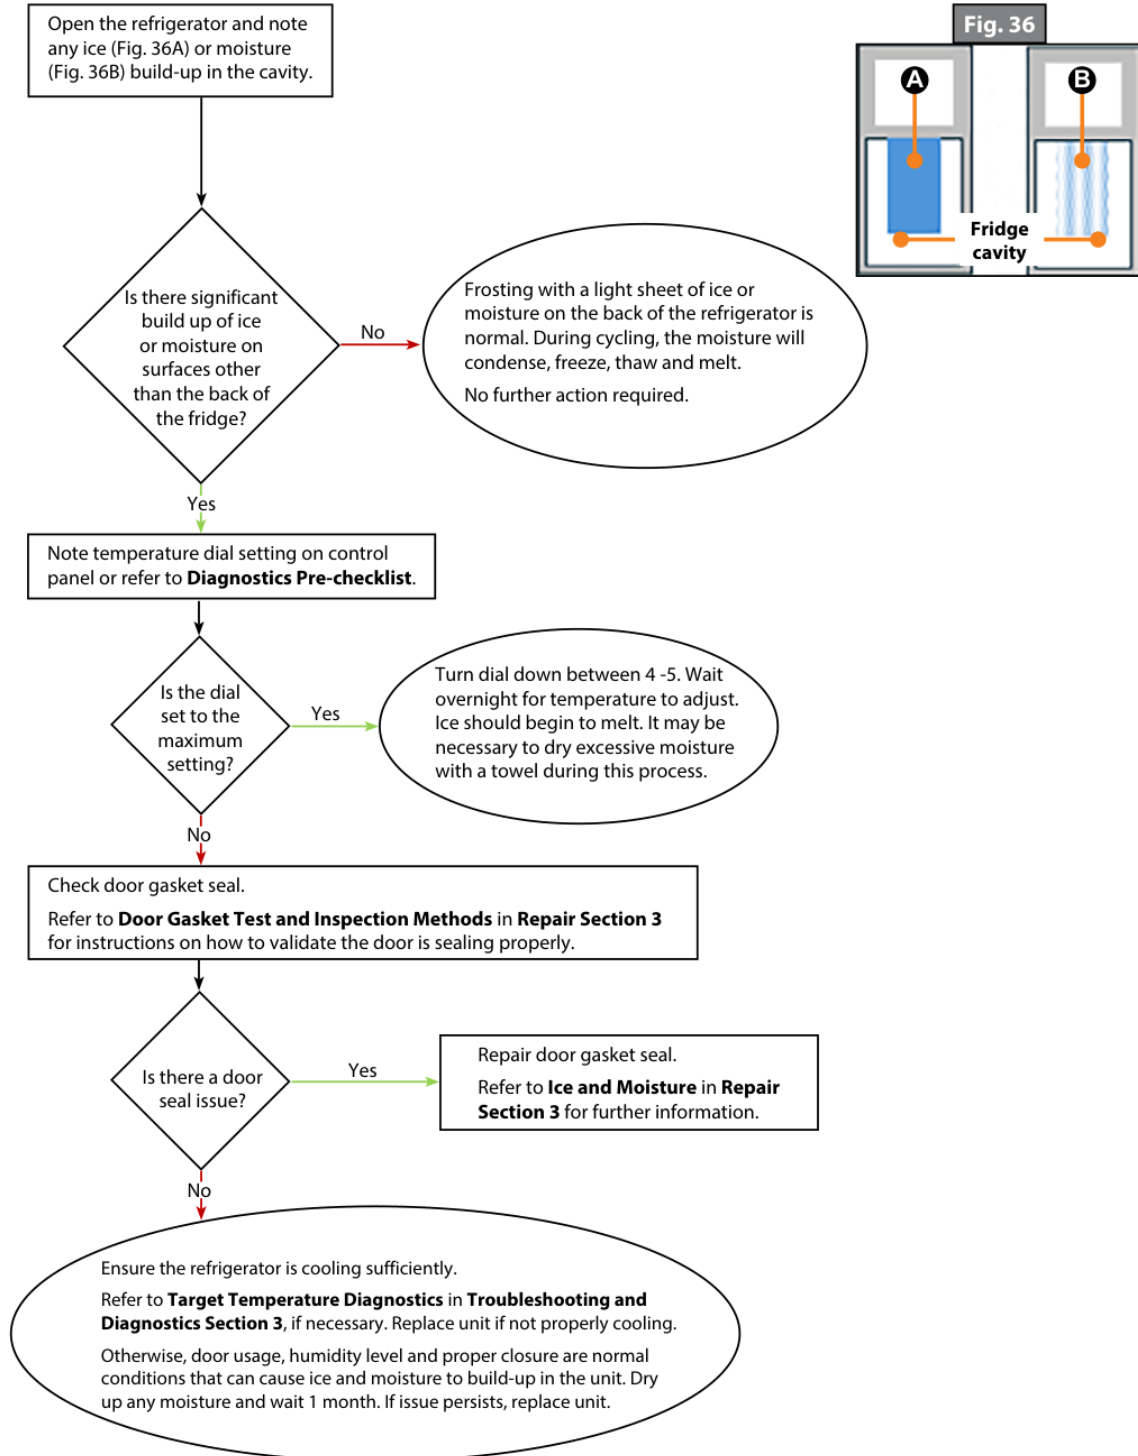
CCD-0008122 page 36 Ice and Moisture -- Furrion FCR08/FCR10 SM CCD-0008122 p.36

### Internal Ice and Moisture in Cavities - Ice or Moisture in the Fridge Diagnostics
