## BAY PROCEDURE

Tacoma RV Center · Document Library

Icing up on rear wall - only about half from the top down

Furrion FCR10DCGTA-BL

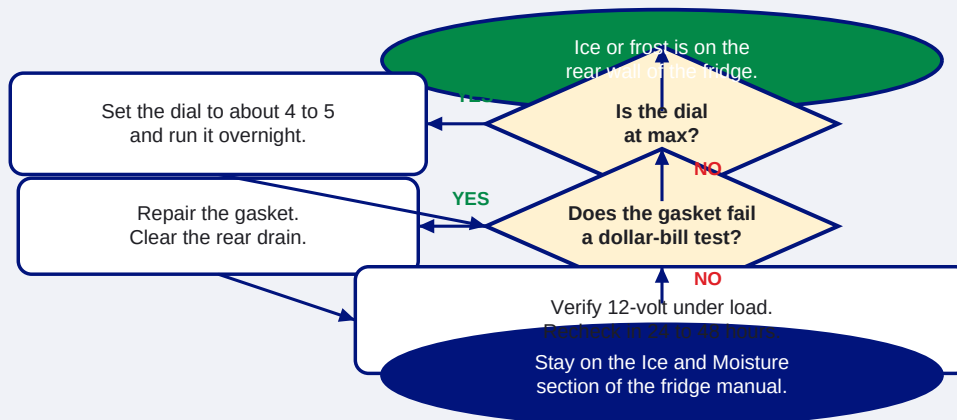
### VISUAL FLOWCHART

Ice or frost on the rear wall, including a pattern that starts about halfway down from the top, is an Ice and Moisture problem. Follow the Ice and Moisture section of the Furrion fridge service manual. A light sheet on the back wall alone can be normal cycling. This is a moisture, door gasket, and cooling path. It is not a dead-unit fuse check.

- ☐ 1. Look at the frost pattern on the rear wall. A light sheet on the back wall alone can be normal cycling.
- ☐ 2. If the temperature dial is at max, set it to mid, about 4 to 5, and let the fridge run overnight.
- ☐ 3. Check the door gasket with a dollar-bill test, then reseal or repair the gasket before you condemn the cooling unit.
- ☐ 4. Clear the rear drain and trough so melt water can leave. Verify 12-volt supply under load at the fridge.
- ☐ 5. Recheck the frost pattern in 24 to 48 hours. Watch or replace the unit only from the Ice and Moisture section of the Furrion fridge service manual.

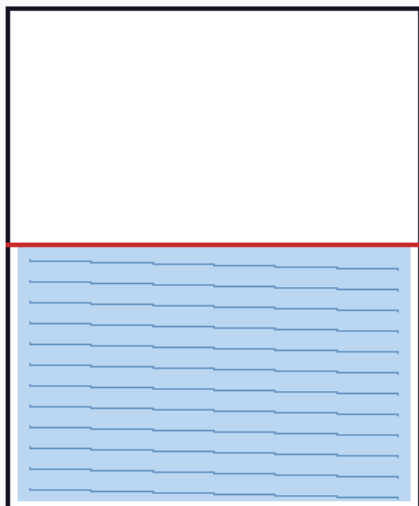
Fig. 36 -- Furrion FCR08/FCR10 SM CCD-0008122 p.36

Fig. 36 rear-wall frost pattern

Lightsheet on the back wall

alone can be normal cycling.

Top half clear / frost from mid-down

is the Ice and Moisture pattern.
