## BAY PROCEDURE

Tacoma RV Center · Document Library

Icing up on rear wall - only about half from the top down

Furrion FCR10DCGTA-BL

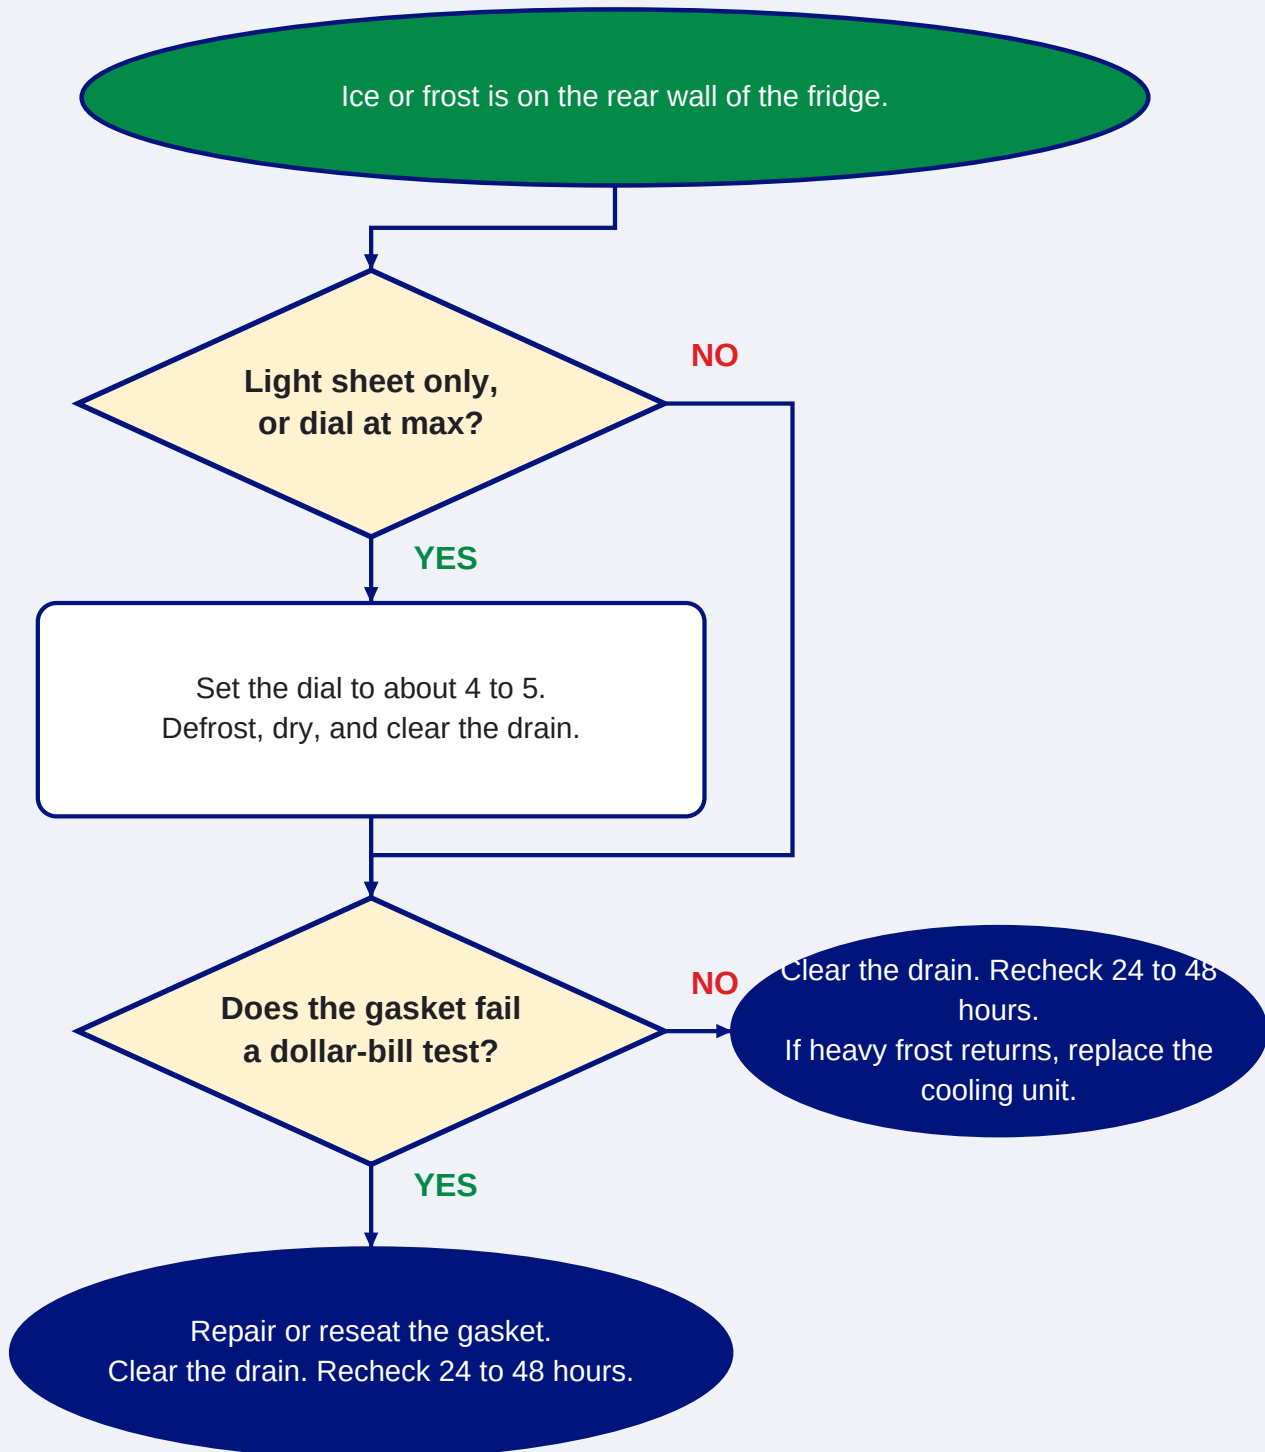
### VISUAL FLOWCHART

A frost or ice band on the upper rear wall, with the lower rear often clearer, is a common Furrion fridge complaint. It is usually moisture on a cold evaporator surface from the door seal, humidity, setpoint, airflow, or the drain. A light sheet of ice or moisture only on the back wall is normal cycling: the cabinet condenses, freezes, and thaws. This pattern by itself is not proof of a sealed-system failure.

- ☐ 1. Open the fridge and note the ice or moisture pattern. Photograph it. If it is only a light sheet on the back wall and nowhere else, that is normal cycling: no further action is required for that alone, and you are done. If frost is heavy, starts halfway down, or shows on other surfaces, keep going.

- ☐ 2. Record the dial setting and the fridge and freezer cavity temperatures. If the dial is at max, set it to about 4 to 5, towel-dry the melt, let the fridge run overnight, then look at the pattern again. If the ice begins to melt at mid setpoint, stay on the moisture path. If the dial is already mid, go to the defrost next.

- ☐ 3. Do a full manual defrost. Power the unit off, open both doors, and use towels. Do not scrape, do not use a heat gun, and do not set hot-water pans in the cabinet. When the ice is gone, go to the dry-and-drain step.

- ☐ 4. Dry the cabinet completely. Clear the rear drain and trough with a soft plastic probe only so melt water can leave. If water backs up, keep clearing until it leaves, then go to the gasket. If the drain is already open, go to the gasket next.

- ☐ 5. Check the door gasket with a dollar-bill test around the full perimeter, and check the hinges, latch, and door alignment. If the bill slides out with no drag, reseal or replace the gasket, set the dial to about 4 to 5, leave an air gap at the rear wall, and recheck in 24 to 48 hours. If the gasket holds, set the dial mid, leave the air gap, and recheck in 24 to 48 hours.

- ☐ 6. After 24 to 48 hours, if the frost is gone or only a light sheet remains on the back wall, the correction is the moisture path: mid setpoint, a holding gasket, and a clear drain. You are done. If heavy frost returns with a mid dial, a good gasket, and a clear drain, the unit is not cooling to target: replace the cooling unit.

- ☐ 7. If cooling is good but the same heavy frost still returns after the moisture path is cleared, dry the cabinet again and watch door-open time and humidity for about a month. If the heavy frost returns hard after that watch, replace the cooling unit. That is the confirmed correction.
