## BAY PROCEDURE

| CONCERN | Icing up on rear wall - only about half from the top down | | |
| MODEL | Furrion FCR10DCGTA-BL | DATE | 2026-09-19 |
| | WO# | WO-ICE | |

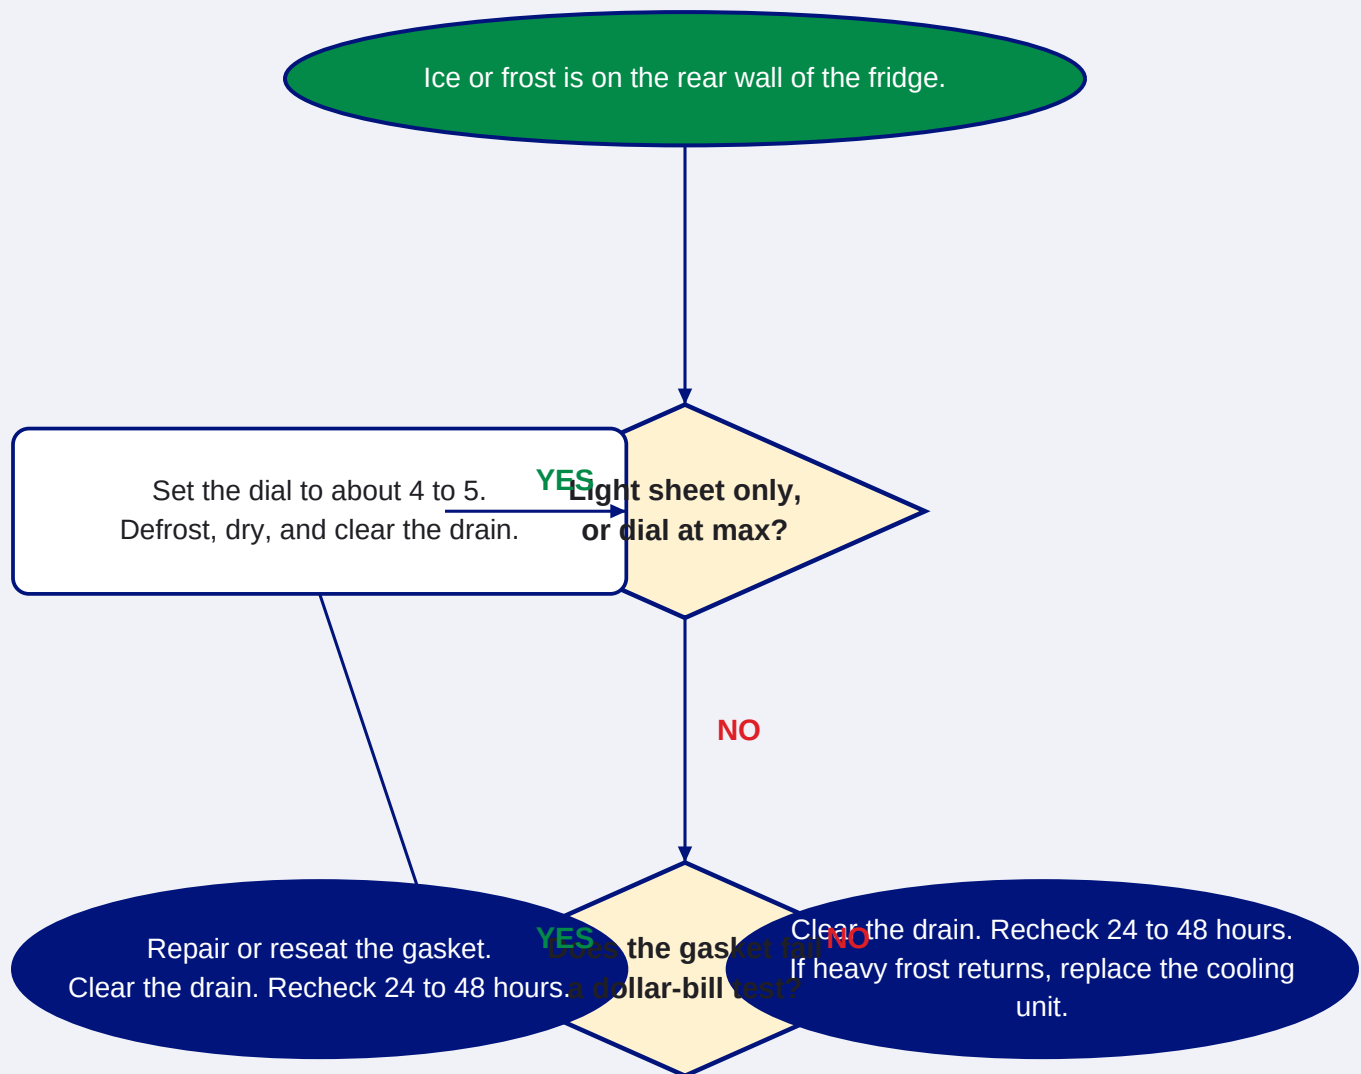
### VISUAL FLOWCHART

A frost or ice band on the upper rear wall, with the lower rear often clearer, is a common Furrion fridge complaint. It is usually moisture on a cold evaporator surface from the door seal, humidity, setpoint, airflow, or the drain. A light sheet of ice or moisture only on the back wall is normal cycling: the cabinet condenses, freezes, and thaws. This pattern by itself is not proof of a sealed-system failure.

- ☐ 1. Open the fridge and note the ice or moisture pattern. Photograph it. If it is only a light sheet on the back wall and nowhere else, that is normal cycling: no further action is required for that alone, and you are done. If frost is heavy, starts halfway down, or shows on other surfaces, keep going.

- ☐ 2. Record the dial setting and the fridge and freezer cavity temperatures. If the dial is at max, set it to about 4 to 5, towel-dry the melt, let the fridge run overnight, then look at the pattern again. If the ice begins to melt at mid setpoint, stay on the moisture path. If the dial is already mid, go to the defrost next.

- ☐ 3. Do a full manual defrost. Power the unit off, open both doors, and use towels. Do not scrape, do not use a heat gun, and do not set hot-water pans in the cabinet. When the ice is gone, go to the dry-and-drain step.

- ☐ 4. Dry the cabinet completely. Clear the rear drain and trough with a soft plastic probe only so melt water can leave. If water backs up, keep clearing until it leaves, then go to the gasket. If the drain is already open, go to the gasket next.

- ☐ 5. Check the door gasket with a dollar-bill test around the full perimeter, and check the hinges, latch, and door alignment. If the bill slides out with no drag, reseal or replace the gasket, set the dial to about 4 to 5, leave an air gap at the rear wall, and recheck in 24 to 48 hours. If the gasket holds, set the dial mid, leave the air gap, and recheck in 24 to 48 hours.

- ☐ 6. After 24 to 48 hours, if the frost is gone or only a light sheet remains on the back wall, the correction is the moisture path: mid setpoint, a holding gasket, and a clear drain. You are done. If heavy frost returns with a mid dial, a good gasket, and a clear drain, the unit is not cooling to target: replace the cooling unit.

- ☐ 7. If cooling is good but the same heavy frost still returns after the moisture path is cleared, dry the cabinet again and watch door-open time and humidity for about a month. If the heavy frost returns hard after that watch, replace the cooling unit. That is the confirmed correction.

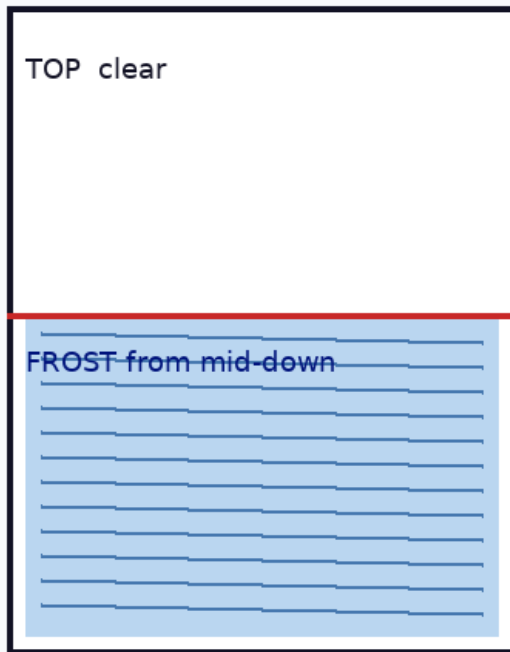
Fig. 36 -- Furrion FCR08/FCR10 SM CCD-0008122 p.36

Fig. 36 Rear-wall frost pattern

A light sheet on the back wall alone can be normal cycling.

Heavy frost starting halfway down is the Ice and Moisture pattern. Stay on that section.
