LATEST VEHICLE CONCERN FIXES

LED Headlamp Reflector

F-TYPE 18 MY Onwards

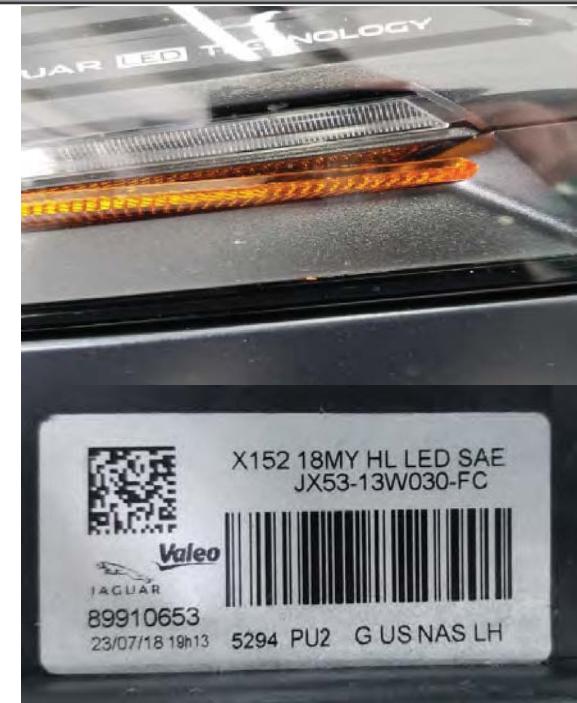
- The amber reflector in the headlamp assembly is delaminating

- The upper corner of the headlamp reflector has delaminated on F-TYPE vehicles fitted with LED headlamps

- Under investigation
- If the issue is noticed, do not replace the headlamp at this time. Please submit an EPQR with pictures of the reflector and the date code of the headlamp.
