# TECHNICAL TOPICS

### Seat Cushion Pan Service Kit Available as Lower Level Assembly

17MY-Onwards Range Rover, RR Sport, XF, F-TYPE 15-19MY RR Evoque, 11-20MY XJ

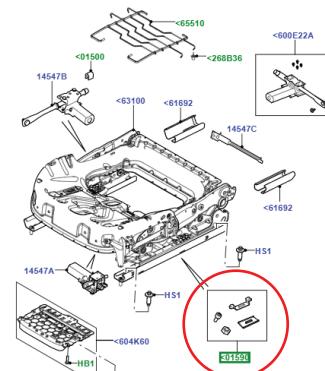
- A customer may report a rattle type noise from the front seat base area.

- This may be caused by a seat pan bracket.

2x NV clips

2x NV clip sliders

2x bolts

2x nuts

- A front seat pan service kit has now been released as a lower level service part to allow a repair to be done in the vehicle without separating the seat cushion from the seat squab.
- Please refer to the Electronic Parts Catalog (EPC) with the VIN for the correct lower level assembly part number should diagnosis of a customer concern identify a seat pan bracket concern.
- The replacement procedure has been added to the Workshop Manual, section 501-10: Seating > General Procedures > Front Row Seat Pan Bracket.
