**SSM 74857 - Suspended Campaign H291 - XCL / AJ20P - Ingenium 2.0  
Petrol Coolant Pump (P2B61-73 / P26CB-72)**

JLRTB02023NAS1

**TECHNICAL BULLETIN**

Malfunction Indicator Lamp (MIL) Illuminated on the Instrument Panel Cluster (IPC)

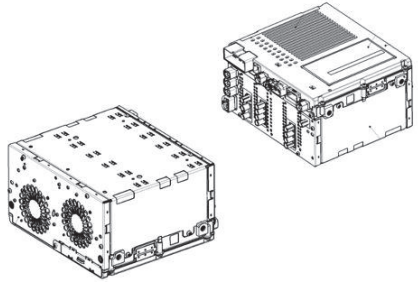
| No Audio Output or Loss of Audio | 19 – 20MY E-PACE, F-PACE, I-PACE, F-TYPE, XE, XF, XJ, Range Rover, RR Sport, RR Velar, RR Evoque, Discovery, Discovery Sport with InControl Touch Pro Audio System |
|---|---|
| <p><b><u>Customer Voice:</u></b></p> <ul style="list-style-type: none"> <li>Customer states there is no audio output from the speakers on all sources</li> </ul> <p><b><u>Technical Description:</u></b></p> <ul style="list-style-type: none"> <li>IMC hardware failure</li> </ul> <p><b><u>Status:</u></b></p> <ul style="list-style-type: none"> <li>Primarily reported on 19MY vehicles</li> <li>LR – SSM 74491 has been released on July 26<sup>th</sup> 2019</li> <li>JAG – SSM 74490 has been released on July 26<sup>th</sup> 2019</li> <li>Part stock has been confirmed clean.</li> <li>Permanent Corrective Action PCA to be completed by Dec 20<sup>th</sup> 2019.</li> </ul> | |

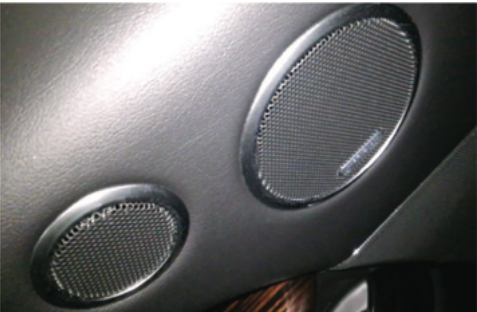
| Pop Noise From Audio Output | 16 – 20MY E-Pace, F-Pace, I-Pace, F-Type, XE, XF, XJ, Range Rover, RR Sport, RR Velar, RR Evoque, Discovery & Discovery Sport equipped with InControl Touch Pro |
|---|---|
| <p><b><u>Customer Voice:</u></b></p> <ul style="list-style-type: none"> <li>• Popping sound or crackling noise from the audio system while in use.</li> </ul> <p><b><u>Technical Description:</u></b></p> <ul style="list-style-type: none"> <li>• IMC module clipping sound due to large processing functions.</li> </ul> <p><b><u>Status:</u></b></p> <ul style="list-style-type: none"> <li>• IMC Software 19C contains additional improvements and was released on December 11, 2019 for PATHFINDER, January 9, 2020 for SDD and currently available wirelessly via TOPIx.</li> <li>• If you should encounter a further complaint after 19C software has been installed, please submit a TA case for guidance.</li> </ul> <p><b>A customer vehicle which was unresolved following the latest software release (North Carolina, Jaguar Raleigh) has now arrived back at Mahwah for further analysis and testing of an updated fix</b></p> | |

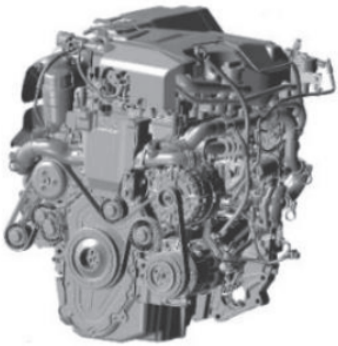
| Engine Speed Stability | 19MY – Onward Discovery Sport, RR Evoque, RR Velar, Defender, RR/RR Sport PHEV, XE, XF, F PACE, F TYPE, E PACE equipped with AJ20P4 |
|---|---|
| <p><u>Customer Complaint:</u></p> <ul style="list-style-type: none"> <li>There was a flashing D when slowing to a stop.</li> </ul> <p><u>Technical Description:</u></p> <ul style="list-style-type: none"> <li>Various contributing factors have been identified to improve idle quality.</li> </ul> <p><u>Status:</u></p> <ul style="list-style-type: none"> <li>Complete primary and secondary diagnosis for any DTCs that are stored.</li> <li>If no DTCs are stored, or if no other obvious root cause is identified, complete a PCM software update with Pathfinder 324 (released March 31, 2021) or later.</li> <li>Updated work instructions in the <b>TOPIx WSM section 303-14B: Electronic Engine controls – Ingenium I2 2.0L Petrol &gt; Diagnosis and Testing</b> will be published shortly.</li> </ul> | |
