# Special Service Message

**SSM 74857 - Suspended Campaign H291 - XCL / AJ20P - Ingenium 2.0 Petrol Coolant Pump (P2B61-73 / P26CB-72)**

**TECHNICAL BULLETIN**

Malfunction Indicator Lamp (MIL) Illuminated on the Instrument Panel Cluster (IPC)

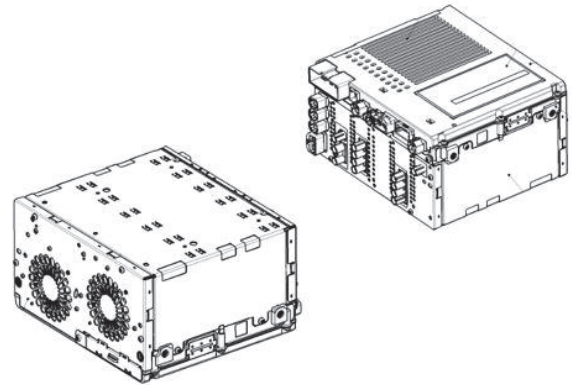
| No Audio Output or Loss of Audio | 19 – 20MY E-PACE, F-PACE, I-PACE, F-TYPE, XE, XF, XJ, Range Rover, RR Sport, RR Velar, RR Evoque, Discovery, Discovery Sport with InControl Touch Pro Audio System |
|---|---|
| <p><b><u>Customer Voice:</u></b></p> <ul style="list-style-type: none"><li>• Customer states there is no audio output from the speakers on all sources</li></ul> <p><b><u>Technical Description:</u></b></p> <ul style="list-style-type: none"><li>• IMC hardware failure</li></ul> <p><b><u>Status:</u></b></p> <ul style="list-style-type: none"><li>• Primarily reported on 19MY vehicles</li><li>• LR – SSM 74491 has been released on July 26<sup>th</sup> 2019</li><li>• JAG – SSM 74490 has been released on July 26<sup>th</sup> 2019</li><li>• Part stock has been confirmed clean.</li><li>• Permanent Corrective Action PCA to be completed by Dec 20<sup>th</sup> 2019.</li></ul> | |

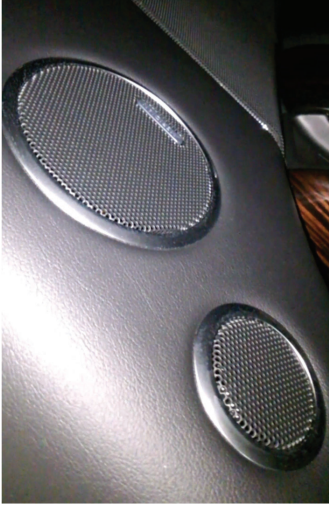
| Pop Noise From Audio Output | 16 – 20MY E-Pace, F-Pace, I-Pace, F-Type, XE, XF, XJ, Range Rover, RR Sport, RR Velar, RR Evoque, Discovery & Discovery Sport equipped with InControl Touch Pro |
|---|---|
| <p><b><u>Customer Voice:</u></b></p> <ul style="list-style-type: none"> <li>• Popping sound or crackling noise from the audio system while in use.</li> </ul> <p><b><u>Technical Description:</u></b></p> <ul style="list-style-type: none"> <li>• IMC module clipping sound due to large processing functions.</li> </ul> <p><b><u>Status:</u></b></p> <ul style="list-style-type: none"> <li>• IMC Software 19C contains additional improvements and was released on December 11, 2019 for PATHFINDER, January 9,2020 for SDD and currently available wirelessly via TOPIx.</li> <li>• If you should encounter a further complaint after 19C software has been installed, please submit a TA case for guidance.</li> </ul> <p><b>A customer vehicle which was unresolved following the latest software release (North Carolina, Jaguar Raleigh) has now arrived back at Mahwah for further analysis and testing of an updated fix</b></p> | |

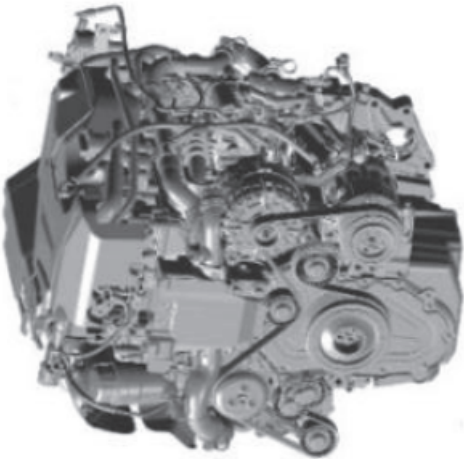
| Engine Speed Stability | |
|---|---|
| <p><u>Customer Complaint:</u></p> <ul style="list-style-type: none"> <li>There was a flashing D when slowing to a stop.</li> </ul> <p><u>Technical Description:</u></p> <ul style="list-style-type: none"> <li>Various contributing factors have been identified to improve idle quality.</li> </ul> <p><u>Status:</u></p> <ul style="list-style-type: none"> <li>Complete primary and secondary diagnosis for any DTCs that are stored.</li> <li>If no DTCs are stored, or if no other obvious root cause is identified, complete a PCM software update with Pathfinder 324 (released March 31, 2021) or later.</li> <li>Updated work instructions in the <b>TOPIX WSM section 303-14B: Electronic Engine controls – Ingenium I2 2.0L Petrol &gt; Diagnosis and Testing</b> will be published shortly.</li> </ul> | <p>19MY – Onward Discovery Sport, RR Evoque, RR Velar, Defender, RR/RR Sport PHEV, XE, XF, F PACE, F TYPE, E PACE equipped with AJ20P4</p> |
