JAGUAR  
LAND ROVER  
LOS ANGELES

Your 2020 Jaguar F-Type: (3 items)

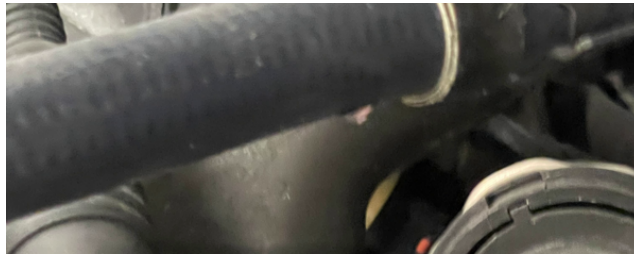
CUSTOMER STATES LOW  
COOLANT WARNING COMING ON.  
PLEASE ADVISE.

Comments: Topped up cooling system. Pressure tested cooling system to 15 psi. Inspected cooling system. recommend replacing leaking coolant hose from reservoir to top radiator hose.

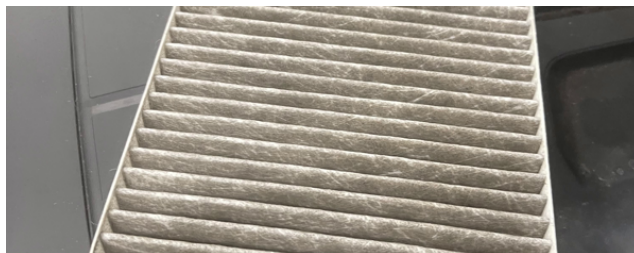
Inspect cabin air/HEPA micro filter(if  
equipped) at 15k or year intervals

Comments: Replace dirty cabin air/HEPA micro filter and clean air box assembly. To increase cabin air quality

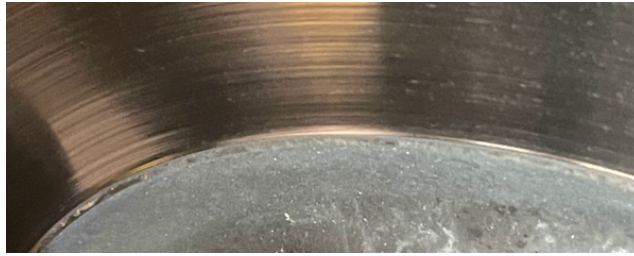
## Brake Linings Thickness - Rear

Comments: Replace rear pads, rotors and sensor. Rotors are worn and have grooves and hot spots.

REAR PADS

1 mm
