## Inspection Video

Multi Point Inspection

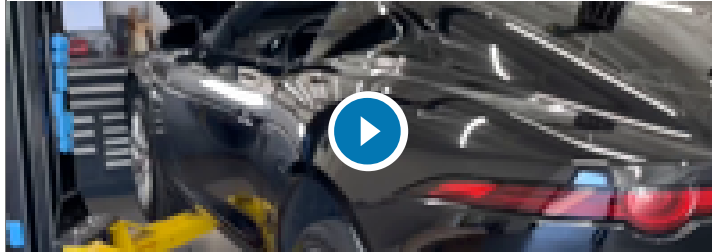
The technician was able to pressurize the cooling system and found that the coolant bypass hose is leaking, causing residue all over the engine. Additionally, the technician inspected the vehicle and found that the rear brake rotors and pads need replacement, as the rotors have been cut deeply and the pads are below minimum specifications. The technician also recommends an oil service due to the oil being low and dirty, as well as a cabin filter replacement, as the current filter is dirty and discolored.

- Pressurized the cooling system
- Identified a leaking coolant bypass hose

- Replace the rear brake rotors and pads
- Perform an oil service
- Replace the cabin filter
