## RETAILER BULLETIN

| SUBJECT: George vs. JLRNA: Revised Settlement with AC edits | | | | | | | | | | | | |

# TECHNICAL TOPICS

# TECHNICAL BULLETIN

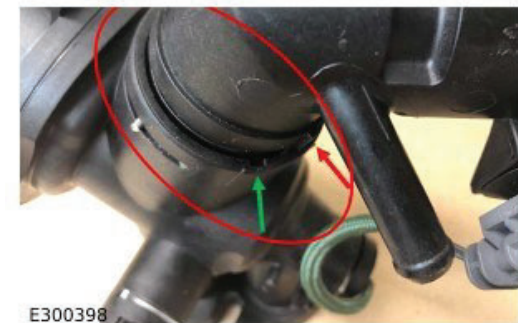
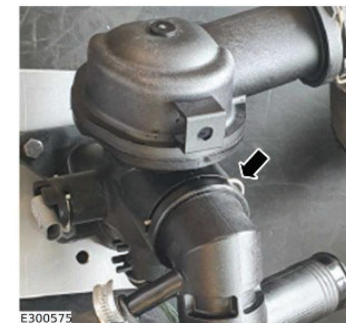
### AJ20-P4 engine- Coolant leak from Thermostat

- Thermostat coolant leak - Evident fluid leak from the engine compartment and the "Coolant Level Low" warning message may be on the cluster

- MIL might be associated with P0128 DTC
- Evidence of a leak from thermostat.
- No evident fresh leak but only dried up coolant deposit is seen on the body of the thermostat

- Check the coolant pipes on top of / around the thermostats for any leak / damage pipes which has possibility of leaking coolant to the thermostat body.
- New Pinpoint test has been added to TOPIx

Refer to TOPIx section 303-03a pinpoint test F

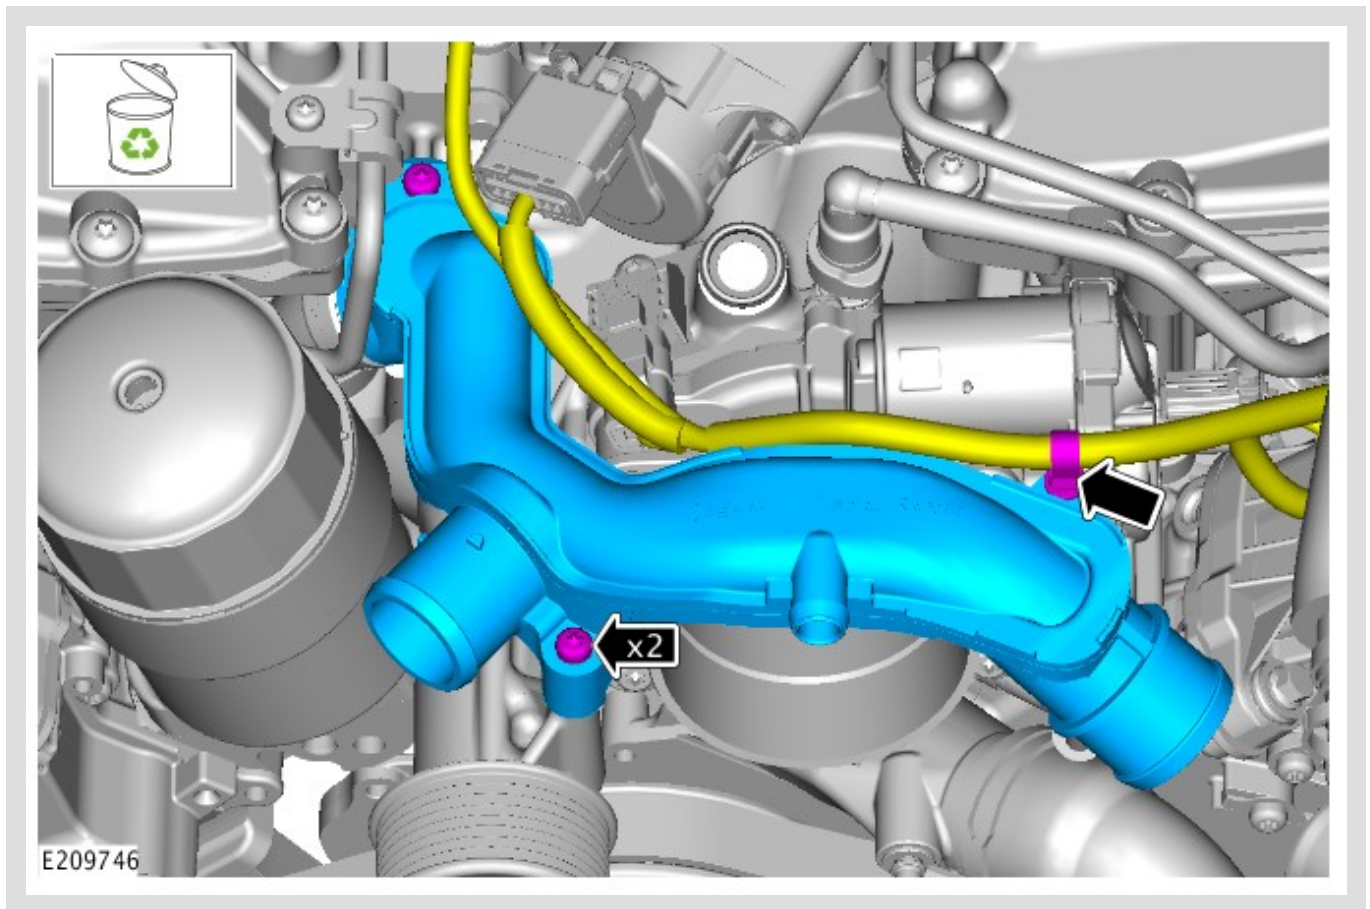
An 'engine overheat' message may be displayed on the Instrument Cluster and that coolant may be leaking from engine compartment area.

Remove and discard the upper coolant outlet pipe.

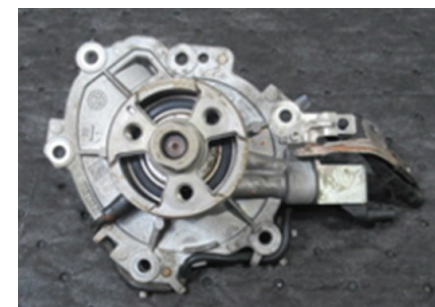
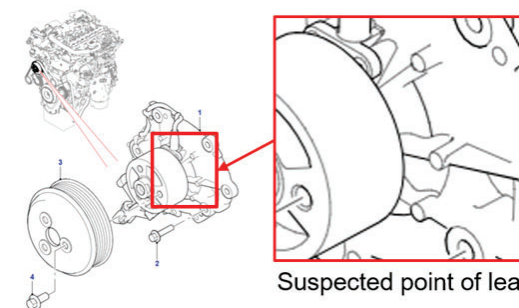
SSM 76161 / 76164

## LEAKING COOLANT PUMPS – 2.0L/P4

- Please inspect and take a photo of outer casting under a UV light, showing the whole component with the area of leak.
- If you have found a leak, raise an EPQR with the pictures and reference P373483 to the attention of Local Engineering. They will dispatch sample bottle.
- To correctly gather a sample:
  - Run engine for 10 minutes at idle once thermostat has opened.
  - Turn engine off for 30 minutes, use a clean syringe to collect the engine coolant sample from the engine coolant expansion tank.
- USE SAMPLE BOTTLE ONLY to take 4 ounce Coolant sample before repair.
- Retain removed water pump for collection via PRR.

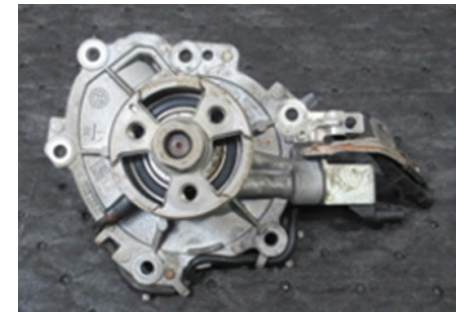
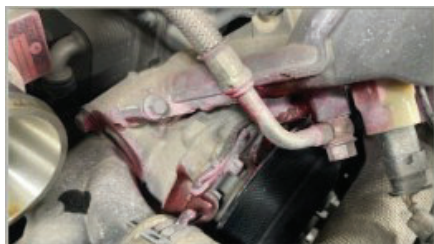
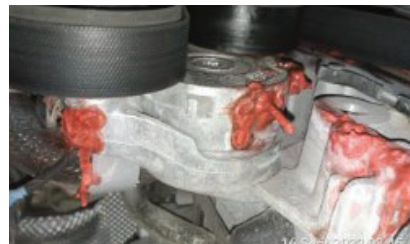
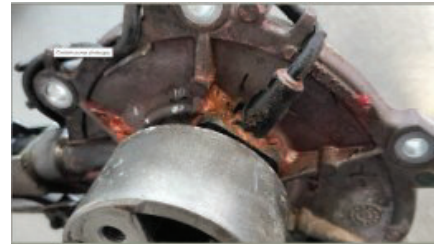
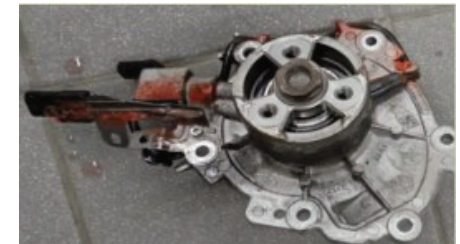
## LEAKING COOLANT PUMPS – 2.0L/P4

- The engine cooling pump has a visible coolant leak.

- Follow **TOPIX workflow**. It will direct you to:
  - Please inspect and take a photo of outer casting showing the whole component, with leak.
- Please raise a **FRED** for the attention of Local Engineering who will dispatch sample bottle.
- USE SAMPLE BOTTLE ONLY to take 4 ounce Coolant sample before repair.
- Dispatch coolant sample using FEDEX label provided.
- Retain removed water pump for collection via PRR.
- **This item will now be on the FRED list November 18th.**
