## Cement and concrete as an engineering material: An historic appraisal and case study analysis

Colin R. Gagg \*

The Open University, United Kingdom

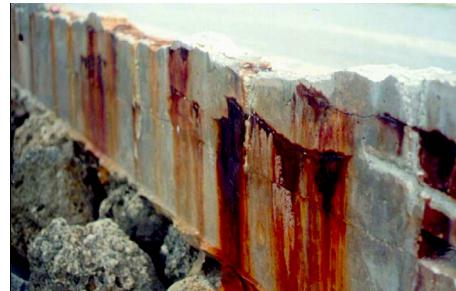
corrosion will become apparent as a result of surface spalling, delamination and staining (Fig. 18). When concrete corrosion has been identified, instigation of remedial work will be required to ensure continued integrity of the structure.

**Fig. 18.** Corrision staining of concrete sea wall (a); spalling concrete as a direct result of corrodng rebar on a bridge deck (b).

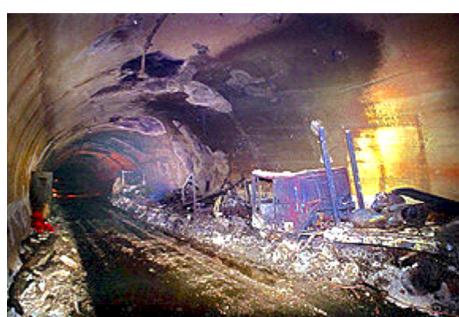
**Fig. 21.** Two examples of fire spalling of concrete: the channel tunnel (a); the Mont Blanc tunnel after the fire (b). In both cases, damage sustained by the concrete is clearly visible.

varying from 400 to 800 mm depending on the loading conditions. Where concrete lining was inappropriate, cast iron lining rings were used. On November 18, 1996, an England-bound train carrying expandable polystyrene caught fire 1 mile into the tunnel. The fire burned for 14 h, inflicting significant damage along a 480 m length of the tunnel lining structure. During the fire, large quantities of concrete had spalled off from the tunnel lining (Fig. 21a). This resulted in very fine concrete rubble collecting on the access walkway and the roof of the HGV wagons. The consistently falling off of the hot concrete debris endangered the life safety of the emergency personnel who were carrying out the rescue and fire fighting missions. Although there were no fatalities, 30 people were injured, and the England-bound rail tube was closed for 1 month for repairs. Subsequent forensic analysis, of the fire, highlighted the potential disaster of explosive spalling behaviour of high strength concrete (HSC) exposed to high temperatures [27,28]. Two possible ways of minimising the risk of extensive spalling of concrete lining for tunnels was highlighted:
