NO NAVIGATION SCREEN DISPLAYED WHEN "MAP/VOICE", "MENU" OR "DEST" SWITCH PRESSED (SCREEN CANNOT BE SWITCHED)

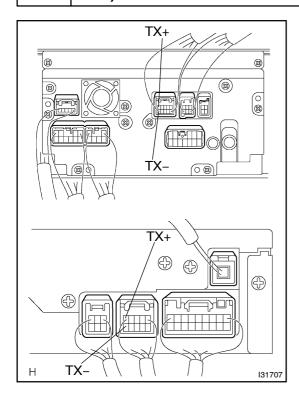
3 CHECK HARNESS AND CONNECTOR(RADIO RECEIVER ASSY-NAVIGATION ECU)

- (a) Disconnect the connector from the navigation ECU.
- (b) Disconnect the connector from the radio receiver assy.
- (c) Check continuity.
 - Check that the continuity between navigation ECU and radio receiver assy.

Tester connection	Specified condition
TX+ ⇔ TX+	Continuity
TX- ⇔ TX-	Continuity
TX+ ⇔ Body ground	No continuity
TX- ⇔ Body ground	No continuity

NG	REPAIR	OR	REPLACE	HARNESS	OR
	CONNEC	TOR
