SCREW MIGRATION IN TOTAL KNEE ARTHROPLASTY: CLINICAL REPORT

Fernando Fonseca¹, José Tomé², Manuel Barreto³

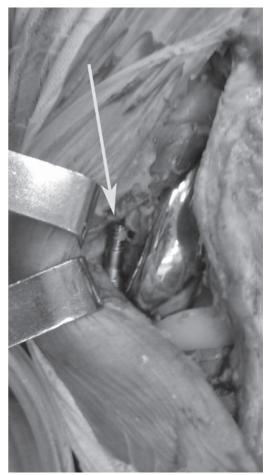
was in the medial parapatellar brace and that the femoral joint surface was complete and undamaged (Figure 2). There was no sign of dislocation, and therefore the strategy was changed. The polyethylene was then replaced and new locking screws were emplaced (Figures 3 and 4).

Figure 2 - Migrated screw

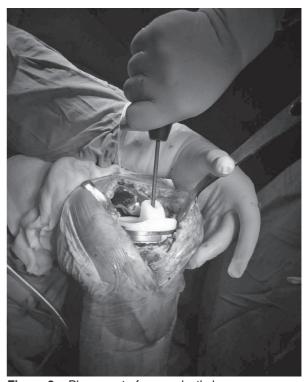
Figure 3 - Placement of new polyethylene

The cause of the migration is still unclear since, as can be seen from Figure 3, the screw remained inside the polyethylene. In the records from the initial operation, there had not been any reports of incidents, and the screw had been placed under tension in accordance with the standards defined by the manufacturer.

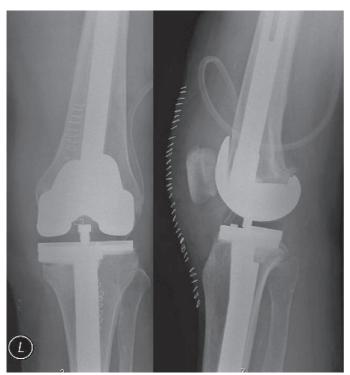
Figure 4 - Postoperative control
