A challenge to dam improvement for the protection of both salmon and human livelihood in Shiretoko, Japan's third Natural Heritage Site

Futoshi Nakamura · Eishige Komiyama

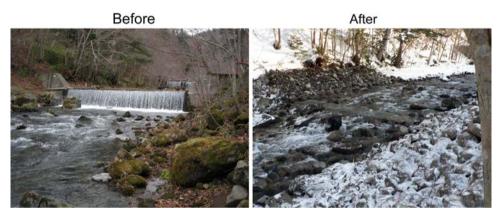
Fig. 6 Dam modification in Iwaubetsu Stream: before and after improvement. The channel slope was manufactured experimentally from natural rocks to meet three conditions: unimpeded upstream migration, a restored view worthy of a world natural heritage site, and

retention of the original erosion control function. The height of the dam was cut down by 1 m, and the channels *above* and *below* the dam were sloped with natural rocks. Rocks were fixed with wires. A field test using pink salmon confirmed passage over the modified dam

The RCWG decided to cut down the bulkhead of the dam by 1 m. The channels above and below the dam were sloped with natural rocks. Rocks were fixed with wires using a stone assembling technique, in an irregular arrangement to create a natural appearance. The bed slope

was designed to not impede upstream migration, to restore a view worthy of a world natural heritage site, and to retain the original erosion control function (Fig. 6).

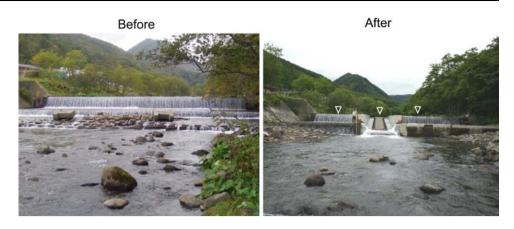
Fig. 10 Dam modification in Rausu Stream: before and after improvement. A slit was created at the center of the dam, and a fish ladder was built extending from the slit to upstream of the dam. Fish are able to find an entrance of the ladder easily if fish ladder extends upstream from the dam. Water drains not only into the fish ladder at the center but also through spillways on both sides as indicated by the *arrowheads*
