# RightShip Ship Inspection Program

RightShip Ship Inspection Report - 66070

| Vessel Name: | IMAVERE |
| IMO Number: | 9612325 |

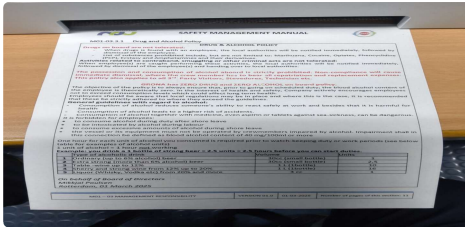
[Q210\\_1760597355467.jpg](#)

### 2.10 Are the limits of blood and breath alcohol contents in the drug and alcohol policy equal to, or less than the STCW mandatory alcohol limit? (V&M)

**Findings:** A zero-alcohol policy was implemented on board the vessels in the fleet. However, the same policy does allow ordering and serving alcohol on board (a stock list of light and strong alcoholic beverages was demonstrated). However, control of the distribution of alcohol available on board is not prescribed.

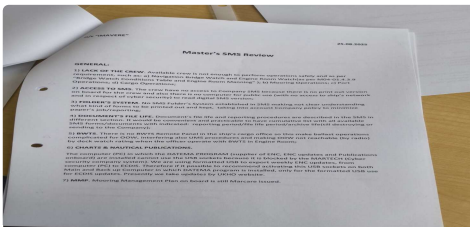
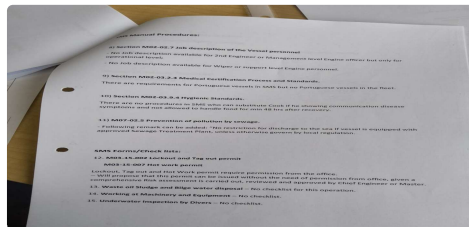
### 4.4 Does the master periodically review the effectiveness of the onboard Safety Management System, report the findings to shore based management and receive feedback from them? (M)

**Findings:** The Master SMS review does not specify the manuals and procedures of the Company SMS. The checklist for SMS review includes log books, records, audits, drills, and crew knowledge. Thus, evidence of SMS review could not be verified during the inspection.

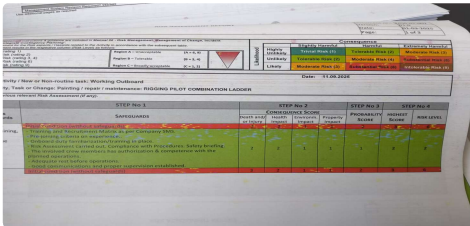
[Q407\\_1760603306895.jpg](#)

**4.7 Are procedures in place for the control of hot work, are they incorporated in the safety management system and is there documented evidence of compliance? (M)**

**Findings:** The risk assessment associated with the recent hot works carried out on 26/Aug/2025, 11/Jan/2025 were not included hazards of fire or explosion. Also, the Risk assessments were completed by a single person and not the team; additionally the risks consequences and likelihood were pre-entered by the company and could not be amended by the ship's staff.

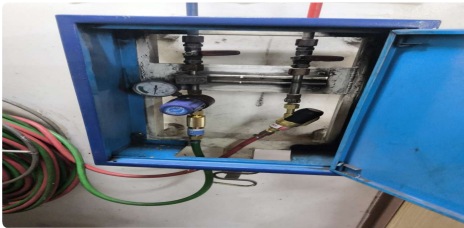
[Q417\\_1760609480744.jpg](#)

**4.17 Are the welding and gas-burning equipment, as well as the electric arc welding equipment, properly stored and maintained in good working order?**

**Findings:** The pressure gauge and regulator were not available at the Acetylene line workshop side cabinet. Also, welding hoses were over 5 years old and, as required by the technical report, needed replacement. Spares were ordered, and the crew was waiting for the delivery.

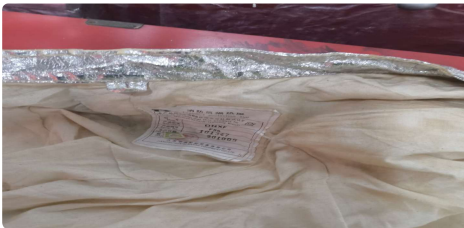
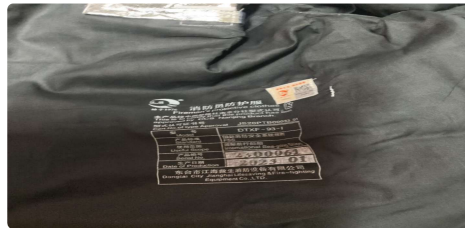
**4.30 Are firemen's outfits including their equipment, two-way portable radiotelephone apparatus for fire-fighter's communication and breathing apparatus in good condition, fit for purpose and available for instant use? (V & M)**

**Findings:** The Firemen's outfits available on board were not of the "Entry firefighting type" as required by EN469. The suits were made of light aluminium material and were suitable only for close-proximity firefighting. Therefore, the suits on board were not suitable for the entry and rescue of persons within the accommodation block, Engine Room space, etc., during the fire.

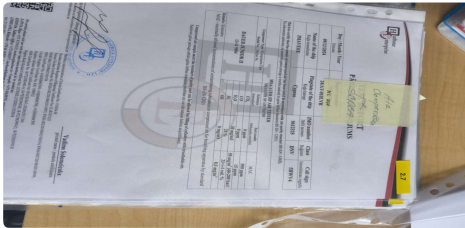
[Q431\\_1760604624942.jpg](#)

- 4.31 Is the operation and maintenance of the breathing apparatus air recharging system (where fitted) incorporated in the ship's safety management manual, and has the annual air quality check for breathing apparatus air recharging systems been carried out? (V & M)

**Findings:** The BA compressor air quality test was based on obsolete requirements of the industry and the latest requirements of EN12021:2014 (e.g., CO value, odour & taste missing).

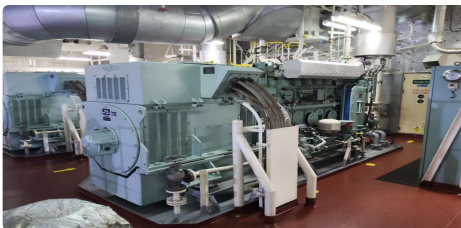
[Q1314\\_1760609196118.jpg](#)

**13.14 Are the major components of the auxiliary engines maintained as per manufacturer's recommendations and records of periodic maintenance kept? (V)**

**Findings:** All cylinders of Aux. DG No. 2 were overdue (over 2300 hours) for a plunger assembly check due to missing spares. Spares were on order.
