# RightShip Ship Inspection Program

### RightShip Ship Inspection Report - 70977

| Vessel Name: | KIRAN ISTANBUL |
| Inspection Completion Date: | 4/23/2026 12:00:00 AM |

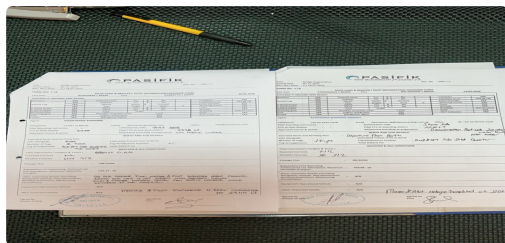
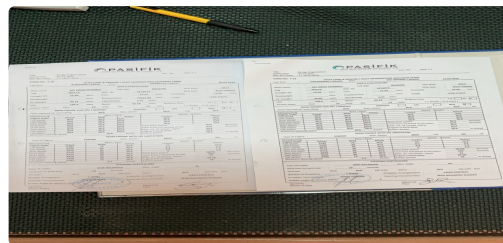
**3.6 Has the Master/Pilot information exchange been taking place effectively and is the standard pilot card being completed as required? (V)**

**Findings:** There was no records that the when Master/Pilot information exchange was completed and the time of the transfer of conn between the Master and Pilot.

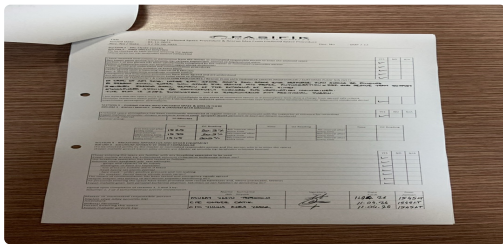
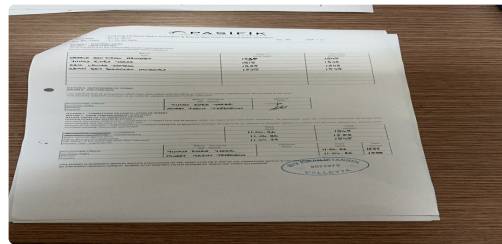
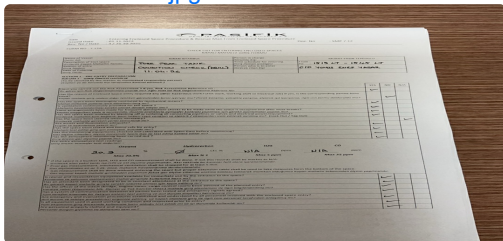
**4.5 Is the vessel provided with an enclosed space entry procedure, and is there documented evidence that it was followed, and is there evidence that the crew assigned to responsibilities requiring entry into enclosed spaces has attended a dedicated enclosed space entry course?**

**Findings:** The vessel was provided with three multi gas detector type xxxx. None of the interviewed senior officers were aware of the time required to clear the air from a 12m hose based on the pump airflow/suction capacity to ensure that the reading were a true representation of the atmosphere inside the space being measured. 2. There were no training records onboard to indicate that any of the crew members were trained/familiarized on the use of the multi gas detector onboard. 3.

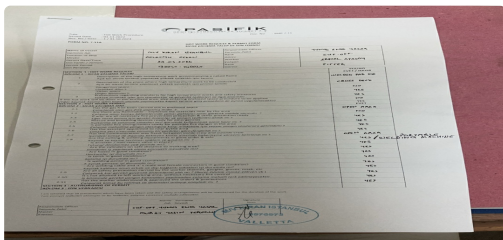
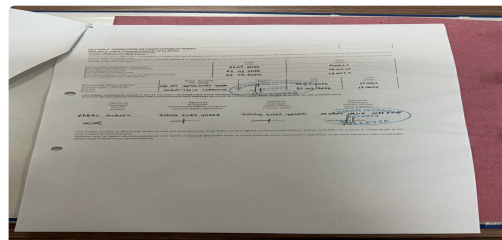
**4.7 Are procedures in place for the control of hot work, are they incorporated in the safety management system and is there documented evidence of compliance? (M)**

**Findings:** The most recent Hot work permit was sighted. The permit did contain a description of the work, did not list all the job, nor the tools used or the methods being employed.

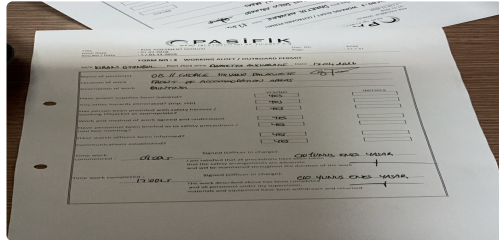
#### 4.11 Has a PPE Matrix for use of personal protective equipment been provided and is it being worn as required?

**Findings:** The use of the self retraceable fall arrestor was not included in the working aloft check list/permit. The crew member didn't utilize adequate personnel protective equipment during working aloft or in a great high.

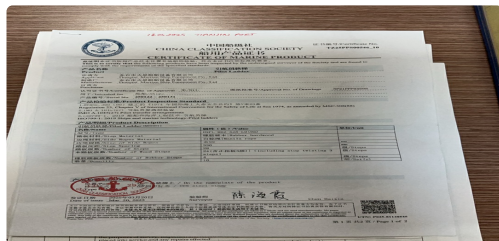
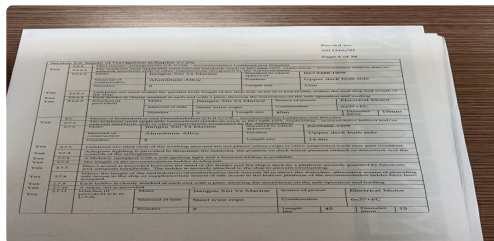
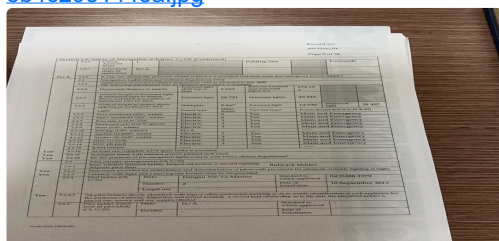
**4.37 Are pilot ladders used for pilot transfer in good condition, and inspected regularly, clearly identified with tags or with permanent marking and are maintenance records available and, are crew members capable of demonstrating proper rigging of the pilot-ladder arrangement?**

**Findings:** The Record of Approved Safety Equipment was not updated to reflect the material, manufacturer, and the standard to which the pilot ladder was made and tested.

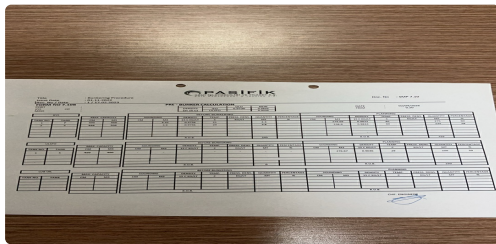
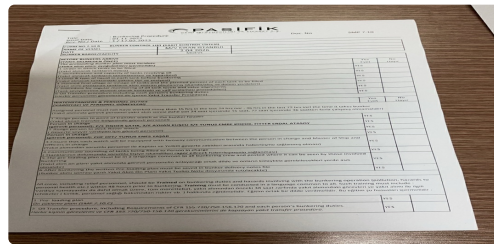
**Findings:** The vessel was utilizing Bunkering check list. However this check list didn't include the following: 1) vessel stability, list and trim during various stages of bunking. 2) Proper identification and Markings of the valves on bunker lines. 3) Emergency procedures. 4) A schematic diagram of the bunker system and proper valve line- up.

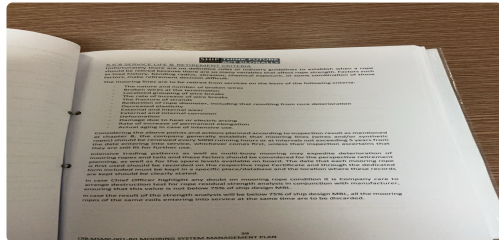
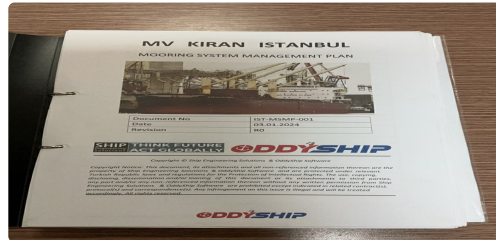
### 10.1 Has the company established guidelines and procedures for the inspection, maintenance and wear zone management of the mooring lines and are they being implemented? (V & M)

**Findings:** There was no spare mooring lines available on board.

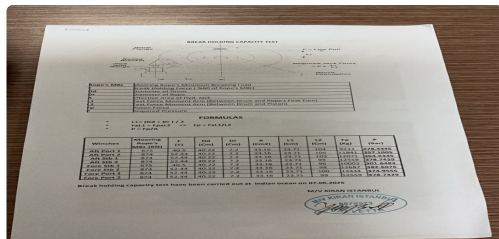
### 10.5 Is there a procedure for testing the winch brake rendering setting and is it being tested regularly? (V & M)

**Findings:** Break holding capacity test was calculated based on the mooring ropes MBL and not the SDMBL (ship design MBL). Furthermore, none of the crew members was aware of the SDMBL. It was not referenced in the mooring line management plan.
