# RightShip Ship Inspection Program

RightShip Ship Inspection Report - 67139

| Vessel Name: | AQUITANIA |
| IMO Number: | 9611278 |

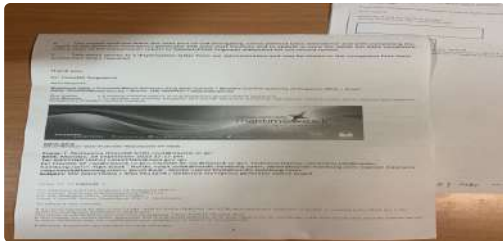
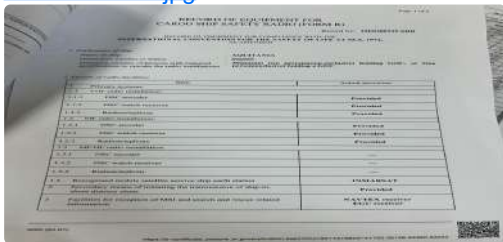
### 2.1 Is the latest Class Survey Status available and are all statutory certificates listed in the Class Survey Status valid, and is the vessel free of condition of class or significant recommendations? (M)

**Findings:** 1. The ship radio license stated the MF/HF was fitted on board with same as actual situation. However the safety radio certificate Form R indicates only MF was fitted. 2. The class of condition was mentioned "the ship emergency generator ESB auto start function was defective , however manual starting and manual putting on-load is possible , the vessel was allowed to operate until 29 October 2025" , a dispensation letter was issued from flag state.

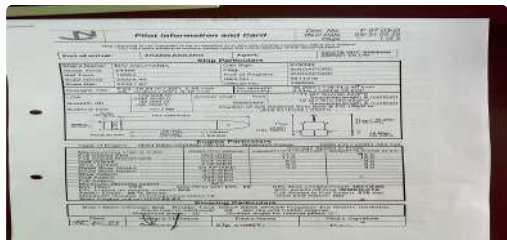
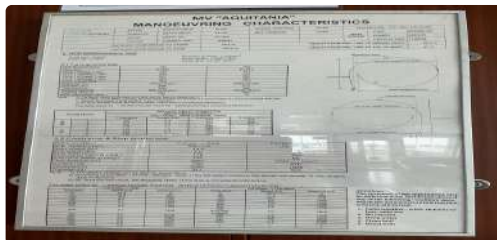
**3.3 Is the manoeuvring information for the vessel displayed on the bridge and are bridge logbooks, bell book, radar performance book, and Change of Watch at Sea check list being correctly maintained? (V)**

**Findings:** The Shapoli was fitted on board and engine power was limited from 6900kw to 4871kw, however the manoeuvring poster not mentioned and updated accordingly. That was rectified before close meeting

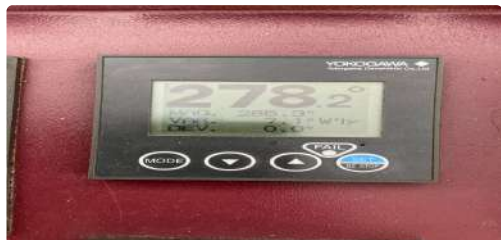
**3.13 Where fitted are the standard magnetic compass, gyro compass and Global Navigation Satellite System compass, operational, adjusted and properly maintained? (V & M)**

**Findings:** It was noted that the transmitting magnetic compass was fitted on the bridge, however the TMC outputs not be corrected for compass error.

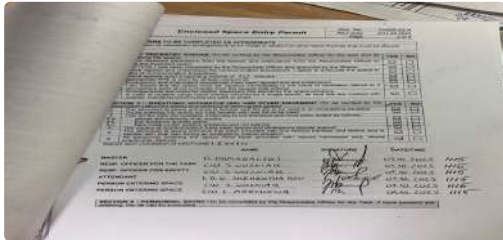
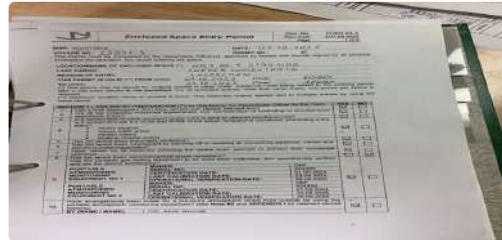
**4.5 Is the vessel provided with an enclosed space entry procedure, and is there documented evidence that it was followed, and is there evidence that the crew assigned to responsibilities requiring entry into enclosed spaces has attended a dedicated enclosed space entry course?**

**Findings:** The enclosed space entry permit on 01 October 2025 and valid at 1030LT to 1200LT, however the master or responsible officer signed at 1115LT, 45 minutes earlier than permit starts, other permits were reviewed a similar systematic timing problem was noted.

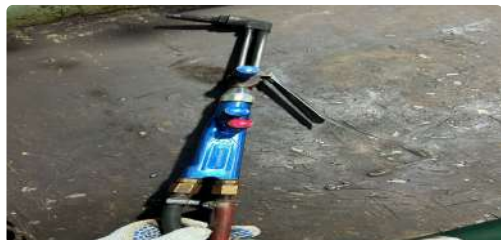
**4.17 Are the welding and gas-burning equipment, as well as the electric arc welding equipment, properly stored and maintained in good working order?**

**Findings:** It was observed that the worm screw driver was used to secure the hose and hose tail in engine room workshop

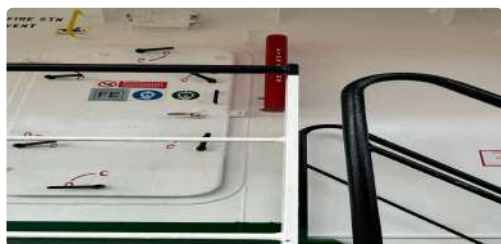
**4.22 Are IMO symbols to identify the location of life saving equipment, firefighting equipment and hazardous area displayed appropriately and in good condition? (V)**

**Findings:** There was no IMO sticker for P/S side fire control plan watertight box.

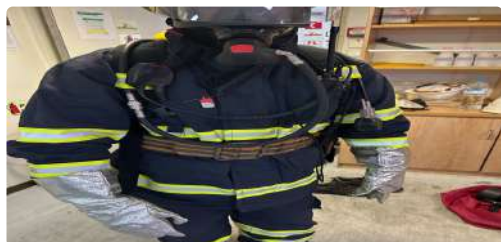
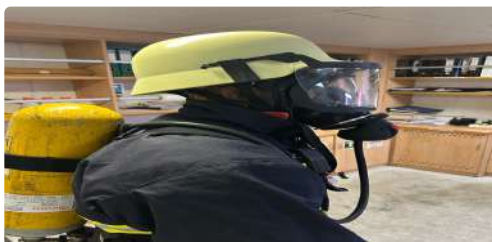
**4.30 Are firemen's outfits including their equipment, two-way portable radiotelephone apparatus for fire-fighter's communication and breathing apparatus in good condition, fit for purpose and available for instant use? (V & M)**

**Findings:** Donning fireman outfit was demonstrated by crew, it was observed that: 1. The fire fighter's ears and part of face still exposed 2. The cables of BA and communication apparatus were hanged outside of suit.

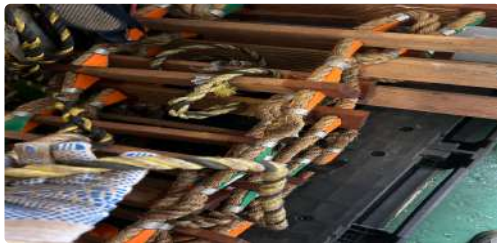
**4.37 Are pilot ladders used for pilot transfer in good condition and inspected regularly, clearly identified with tags or with permanent marking and are maintenance records available? (V)**

**Findings:** The inspector asked deck crew to demonstrate pilot ladder rigging, however the fiber rope was used to secure pilot ladder side instead of Manila rope

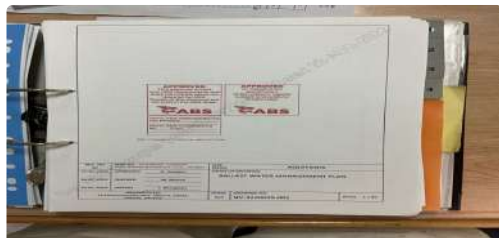
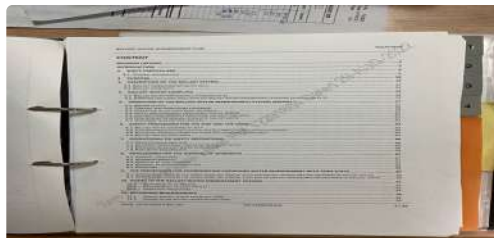
### 5.11 Is an approved ballast water and sediment management plan provided and complied with? (V)

**Findings:** The ballast water management plan which used on board was not updated according to MEPC.369 (80)-Changes to the new format of BWRB, and MEPC387(81) procedure from challenging water quality (CWP) .

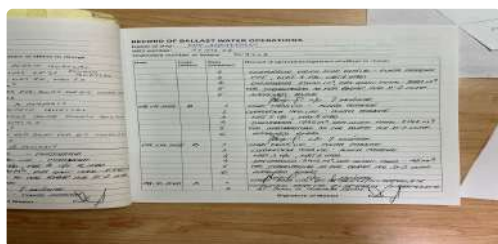
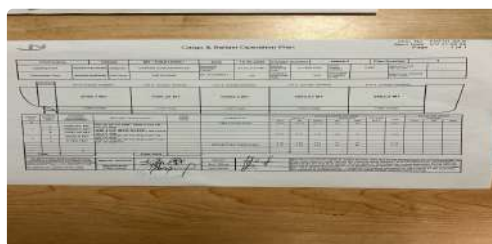
### 8B.7 Are the stresses, stability information and any limitations included in the cargo plan understood by the cargo watch officers and are conditions being monitored and maintained within design limits throughout cargo operations? (V)

**Findings:** There was no evidence to indicate that the stress and stability being monitored during cargo operation, the observed draft was left blank on cargo loading/discharging plan. Several plan was reviewed and a similar lake of records were noted.

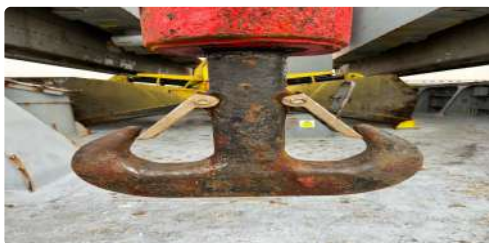
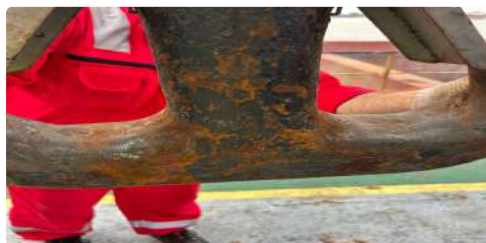
**9A.22 Are the loose gears of lifting appliances marked clearly and are the certificates of the loose gears available and traceable on board? (V)**

**Findings:** The deck crane loose gears used for lifting appliances are not marked clearly with its a batch mark or number as per certificate

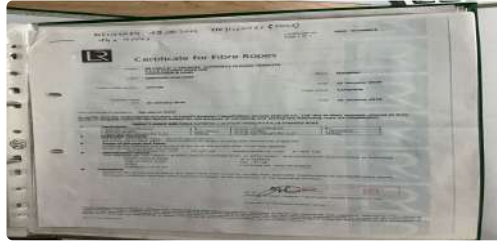
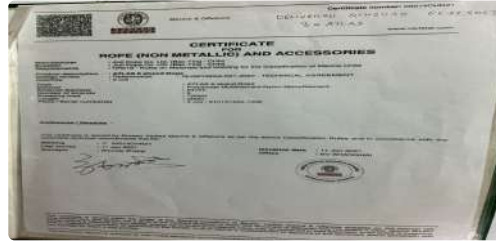
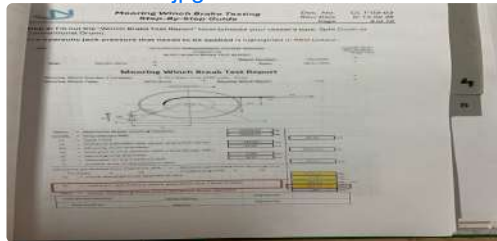
### 10.3 Are the certificates of mooring lines and mooring tails available on board? (V & M)

**Findings:** The ship's SDMBL was 490KN, however the breaking load was 790KN and 675KN of 4 mooring ropes used on board.

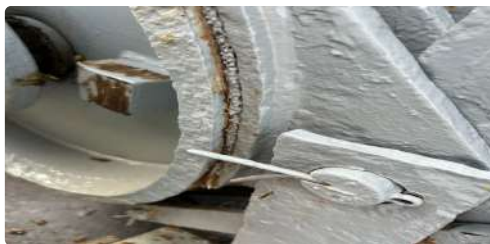
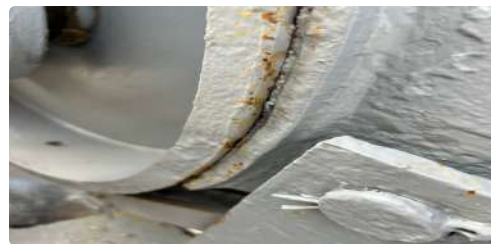
### 10.15 Do controls, linkages, operating levers, brake drums, brake linings and pins of winches appear to be in good order? (V)

**Findings:** There were 2 brake linings of poop deck mooring winch were uneven in thickness, with the ends about 9mm, and the middle part only about 3mm

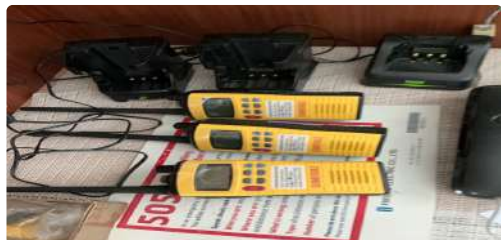
### 11.7 Are survival craft portable VHF radios in good order and charged? (V)

**Findings:** It was observed that three sets of portable VHF without wrist or neck strap as per resolution MSC.515(105) performance standard for survival craft portable Two-way VHF radiotelephone, which located in the bridge.

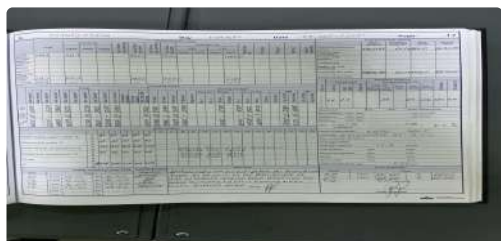
### 13.4 If the vessel has been certified for periodically unattended machinery spaces (UMS), is the machinery space being operated in that mode? (V)

**Findings:** The vessel has been certified for UMS mode, however since 29 Sep 2025 the engine room was manned due to the emergency generator defective. And following flag authority requirement.

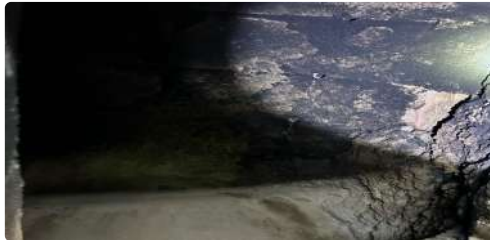
**Findings:** It was found that approximately 15cm X 10cm coatings inside of incinerator had become detached.

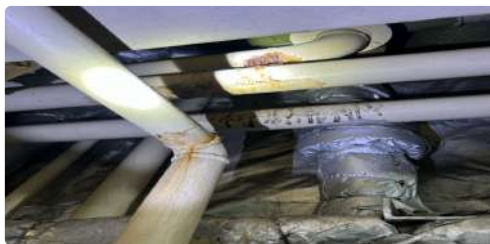
**13.34 Is the pipe work in the machinery space, including but not limited to steam, fuel, lubricating oil, sewage, drain and air lines well maintained, in good condition and free of any temporary repair? (V)**

**Findings:** It was observed that water dropping down from one of cooling pipe which rust and holed beside the No.2 auxiliary engine.

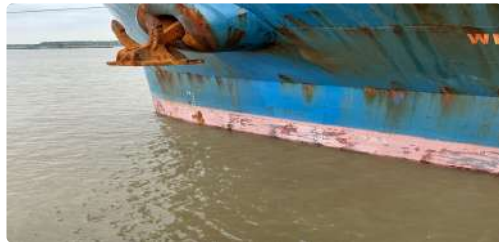
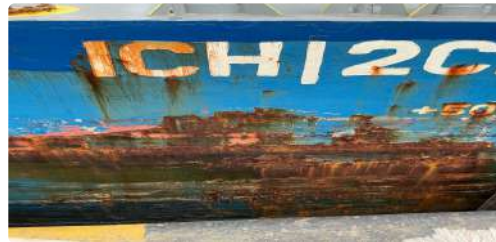
**14.2 Are the following permanent markings on the ship's hull, where applicable, plainly visible and painted in a contrasting colour? (V)** The vessel's name Port of registry Load lines Draft marks Thruster warnings Tug push points IMO number Bulbous bow mark

**Findings:** 1. The port side fwd draft mark from 8 -10 meters not visible. 2. It was observed that paint flake and rust scale on port side ship's hull approximately 1m x 2m between cargo hold 1&2.
