# RightShip Ship Inspection Program

### RightShip Ship Inspection Report - 76556

| Vessel Name: | DEVBULK GULTEN |
| Place of Inspection: | Brazil, Belem |

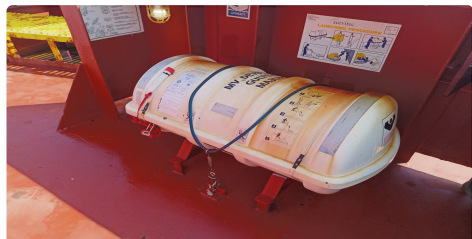
[Q419\\_IMG\\_20260805\\_094755\\_HDR.jpg](#)

**Findings:** The securing lashing wire of the forward liferaft was found covered with vinyl sheathing.

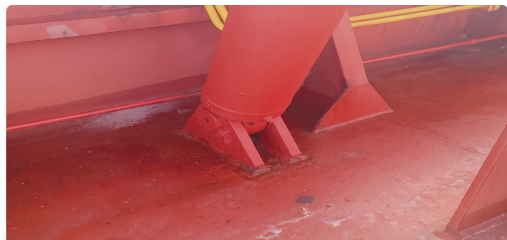
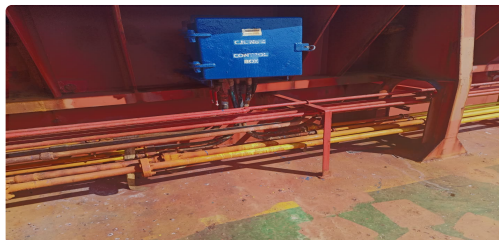
**Findings:** No hydraulic oil containment arrangements were provided beneath any of the hatch cover hydraulic cylinders or beneath the hatch cover hydraulic control stations.

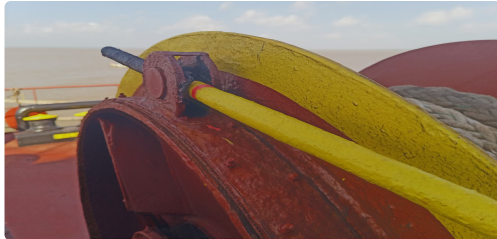
[Q1005\\_IMG\\_20260805\\_084930\\_HDR.jpg](#)

**Findings:** The port aft mooring winch, the inner brake adjustment indicator pointer was missing, and the brake setting position could not be identified.

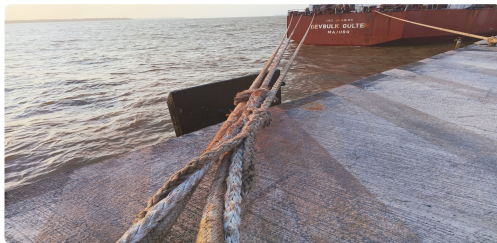
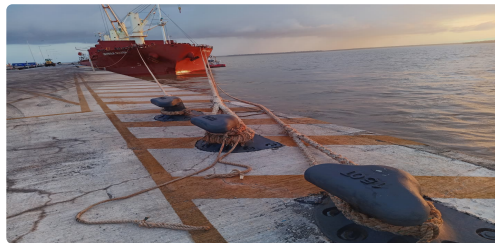
**Findings:** (1) The forward spring lines and one stern line were of different materials and had different construction.(2) The stern spring lines and forward head lines were observed slack.

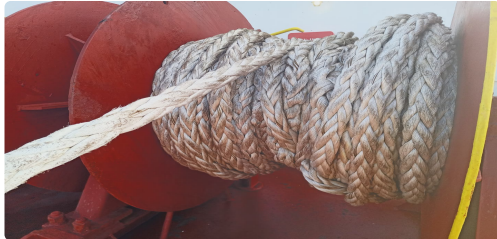
[Q1008\\_IMG\\_20260805\\_085051\\_HDR.jpg](#)

**Findings:** The mooring line on the outer drum of the starboard aft mooring winch was observed crossing over and being trapped beneath other turns of the mooring line on the drum.

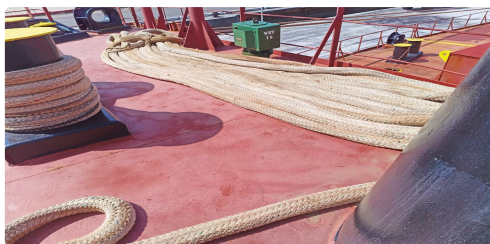
[Q1013\\_IMG\\_20260805\\_094821\\_HDR.jpg](#)

**Findings:** The mooring lines at the forward mooring station were stowed in direct contact with the deck.

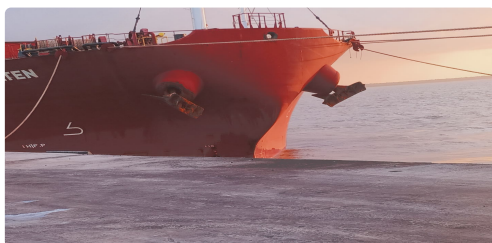
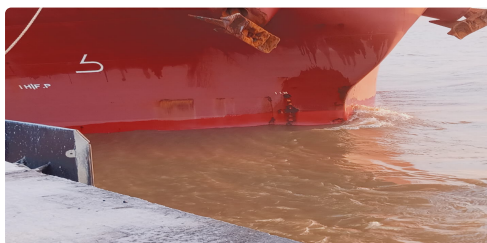
**Findings:** Both anchors were not fully housed and tightly secured in their respective hawse pipes while the vessel was alongside.

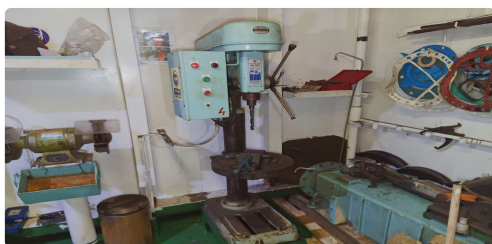
[Q1326\\_IMG\\_20260804\\_204816\\_HDR.jpg](#)

**Findings:** The bench drill was not fitted with a fixed protective guard and was not provided with a dedicated emergency stop. Only the ON/OFF switch was fitted.

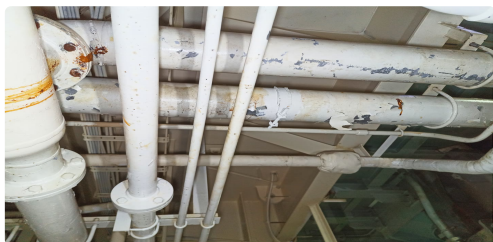
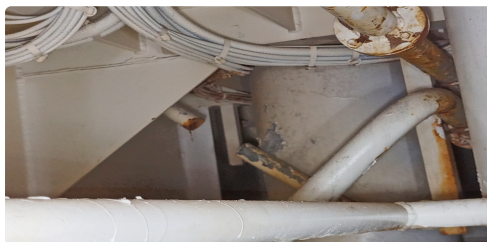
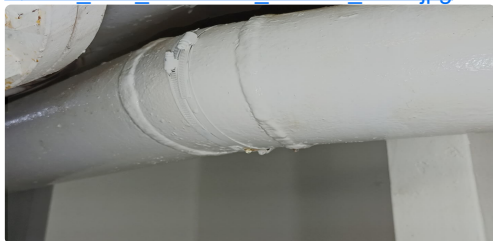
**Findings:** Two sections of the 6-inch main engine seawater cooling line were fitted with temporary soft patch repairs, with evidence of pinhole leakage observed. In the lower level of the engine room, a temporary soft patch repair was also fitted to the ballast stripping line. Additionally, approximately 50 cm of the port side grey water drain line was missing, leaving the line discontinuous.

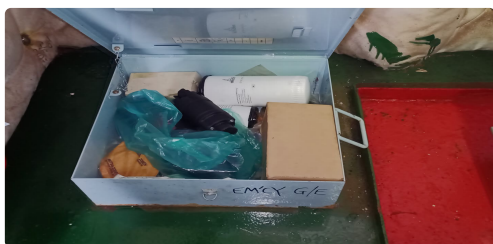
[Q1337\\_IMG\\_20260805\\_081830\\_HDR.jpg](#)

**Findings:** No evidence was available to demonstrate that the spare starter motor for the emergency generator had been periodically tested.

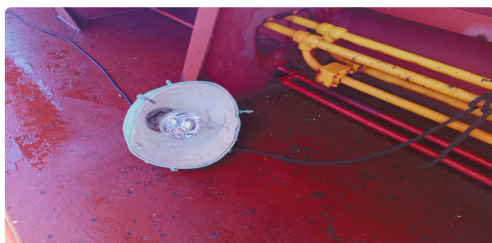
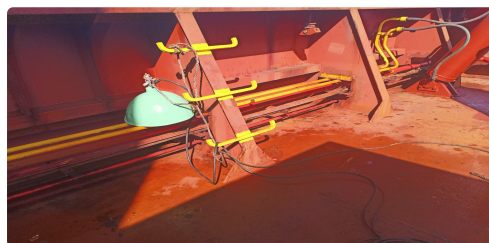
**Findings:** The lamp holder, drip shield and shade of the portable cargo lights on board were not made from non conductive material. There was no objective evidence of regular inspection and testing for the insulation of these portable cargo lights
