# RightShip Ship Inspection Program

### RightShip Ship Inspection Report - 75565

| Vessel Name: | DEVBULK DAMLA |
| IMO Number: | 9711717 |

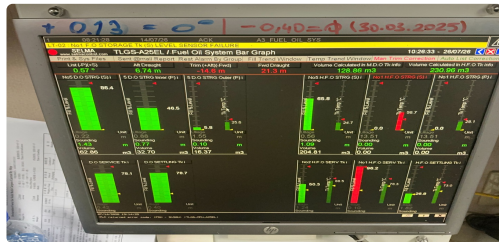
[Q525\\_d7c5d0f8-6326-405d-9eae-bc3349bf728e.jpg](#)

**Findings:** 1. No.1 F. O STORAGE Tk (S) Level sensor failure was found on the monitor screen in ship's office at the time of inspection. 2. The drafting gauging system located in the ship's office was found had inaccurate indication, the fore draft was shown as "21.3m" at the time of inspection.

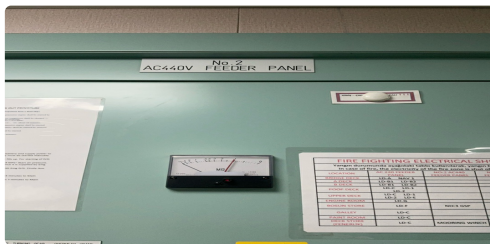
[Q1339\\_c6d70a61-44c1-42a8-a292-55883c27a788.jpg](#)

**Findings:** The insulation alarm setting valve No.2 AC 440V feeder panel was found set on 0.1 megohm at the time of inspection.
