# RightShip Inspection - Inspector Report

## DIANE, 9492086

Date of inspection **06 JUN 2026**  
Port of inspection **DONGGUAN**  
Type of inspection **STANDARD**  
Inspection ID **73476**

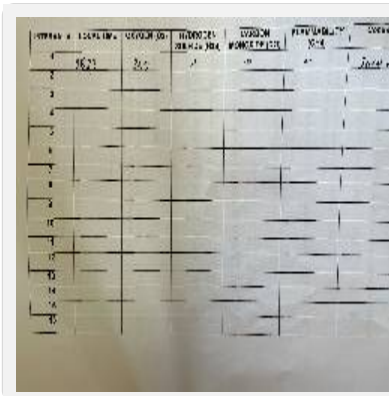
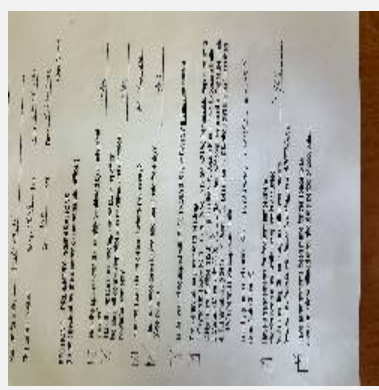
- 4.5 Is the vessel provided with an enclosed space entry procedure, and is there documented evidence that it was followed, and is there evidence that the crew assigned to responsibilities requiring entry into enclosed spaces has attended a dedicated enclosed space entry course? NO

It was observed that measuring the gas CO2 was not included in the company enclosed space entry permit/safety checklist during pre-entry atmosphere test and repeating test when the space occupied.

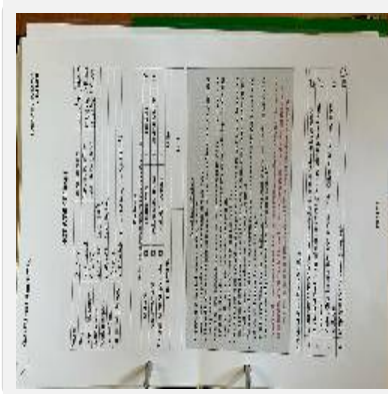
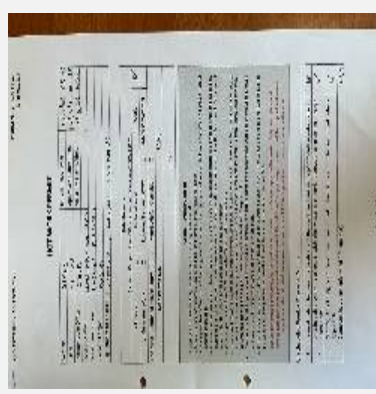
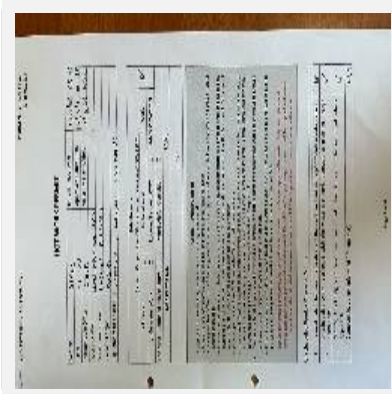
- 4.7 Are procedures in place for the control of hot work, are they incorporated in the safety management system and is there documented evidence of compliance? (M) NO

The last two hot work permits issued for replacing platform at weather deck port side on 13/May/2026 and at cross deck iwo No.4 CH port side on 14/May/2026 had not been approved by the company before the tasks commenced.

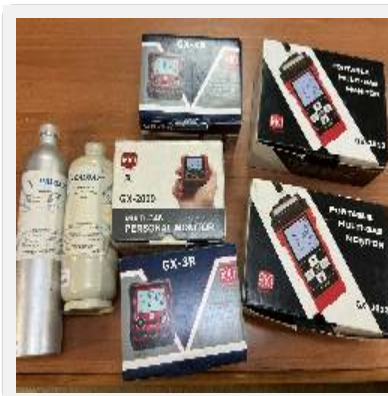
- 4.16 Are portable gas detectors suitable for atmosphere testing of enclosed spaces provided; in good condition; calibrated in accordance with the manufacturer's instructions, and are officers trained and competent with their operation?

Total five portable gas detectors were provided onboard for detecting four gases (O<sub>2</sub>/H<sub>2</sub>S/CO/CH<sub>4</sub>), but none of them could detect gas CO<sub>2</sub>.

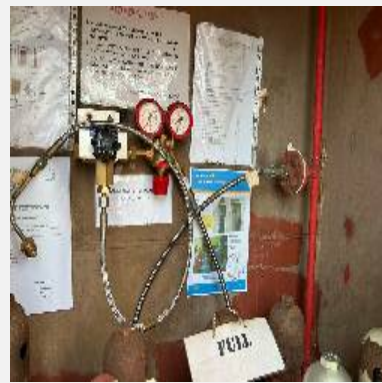
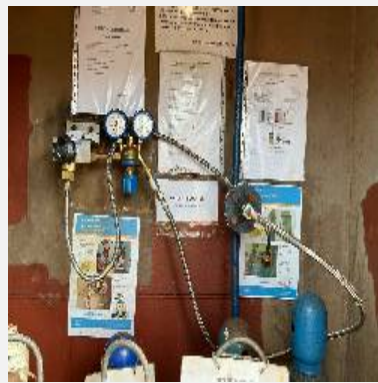
- 4.17 Is the welding and gas-burning equipment, as well as the electric arc welding equipment, properly stored and maintained in good working order?

It was observed that the flanges were used for OX/AC gas distribution lines in their storage rooms at poop deck.

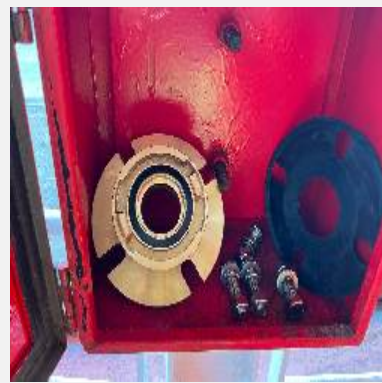
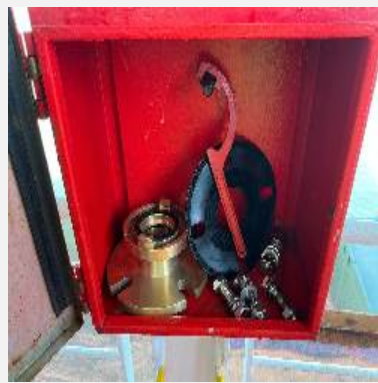
- 4.25 Are the International Shore Connection fitting arrangements clearly marked and well maintained and are the crew aware of their location?

No suitable bolt spanner was provided for the International Shore Connection deployed near both side accommodation ladder.

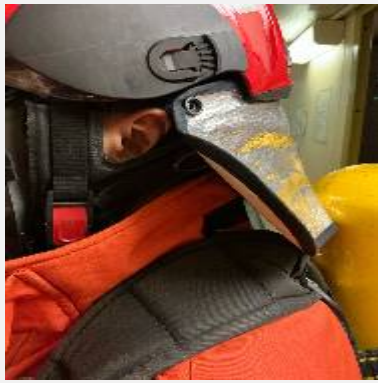
- 4.30 Are firemen's outfits including their equipment, two-way portable radiotelephone apparatus for fire-fighter's communication and breathing apparatus in good condition, fit for purpose and available for instant use?

The fireman's outfits in the fireman store at upper deck could not provide full protection from the heat and flames in fire scenario as parts of the ear, face and neck of the fireman were exposed with exposed areas approximately 3x5cm, 1x3cm and 2x5cm respectively.

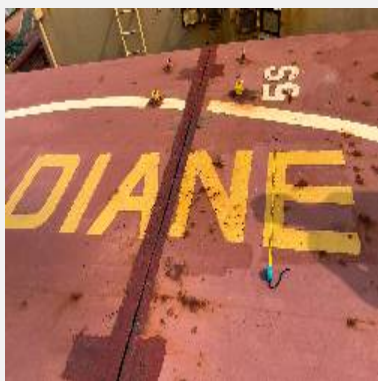
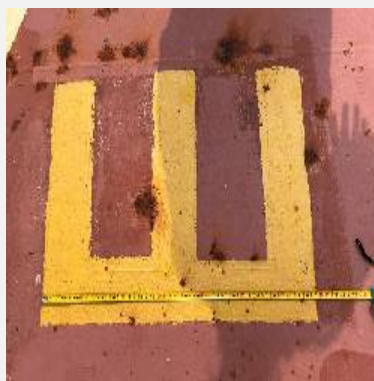
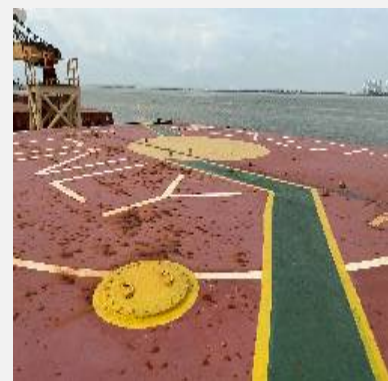
- 4.39 If the vessel is provided with a helicopter operating area, does the area comply with the requirements of ICS guidelines, and is there a safe access from the hatch cover to deck? NO

The height of the ship's name marked on the helicopter winching area was only 68cm, while it should be 1.5m as required.

No.5 CH hatch cover was designated as helicopter winch only area.

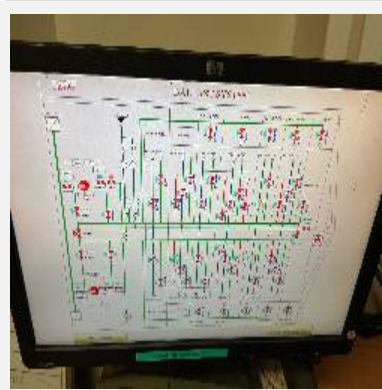
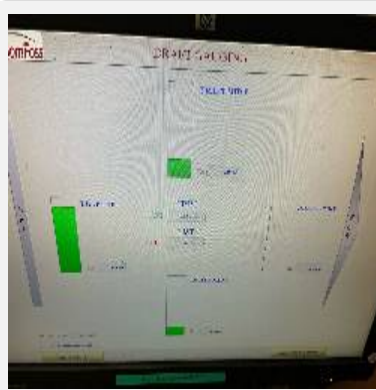
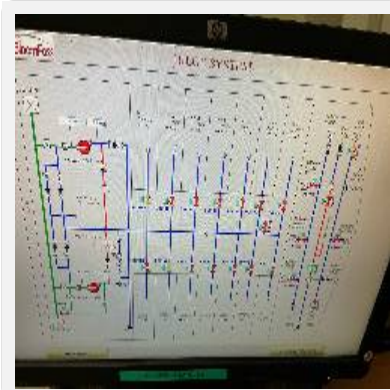
- 5.25 Are the ballast pumping systems, including their associated instruments, controls, valves, pipework, and the control panel (including pressure gauges, draft gauges, and the remote control system), in good working order and is there recorded evidence of regular inspection? NO

Below were observed on the computer remote control system in the deck office: 1. Ballast stripping valves of No.3 WBT-P (Valve No. BWV123), No.3 WBT-S (Valve No. BWV124) and main ballast valves of No.4 CH heavy weather ballast hold (Valves No. BWV120 & BWV126) were indicating yellow (opening or closing), actually they were fully shut and should be indicated red. 2. Ballast valves of No.6 CH heavy weather ballast hold (in port use) (Valve No. BWV110) was indicating green (open), actually it was fully shut and should be indicated red. 3. No.6 CH starboard side bilge valve (Valve No. BGV105) and No.7 CH port side bilge valve (Valve No. BGV102) was indicating yellow (opening or closing), actually they were fully shut and should be indicated red. 4. Remote draft indicated were forward -1.174m and mid-ship (S) 2.588m, actually they were approximately 13.4m when observed locally.

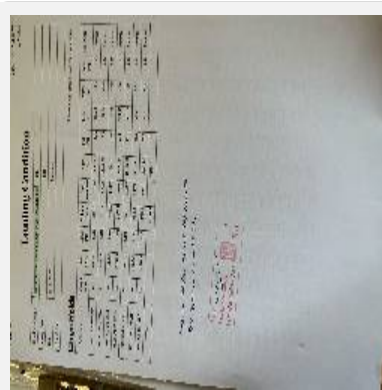
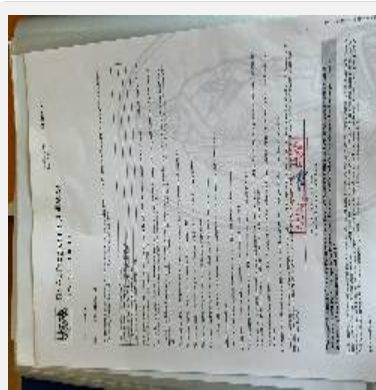
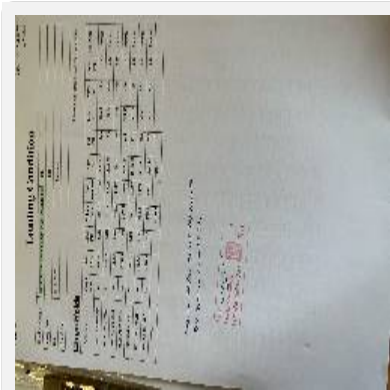
8B.6 Is a Class-approved loading computer or programme in use and has its operational accuracy been regularly tested? (V)

The loading computer last operational accuracy test verified by the class surveyor was on 11/Oct/2024 which had been over one year.

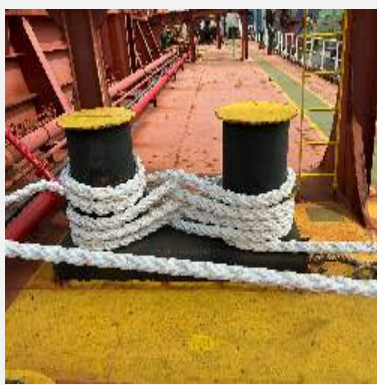
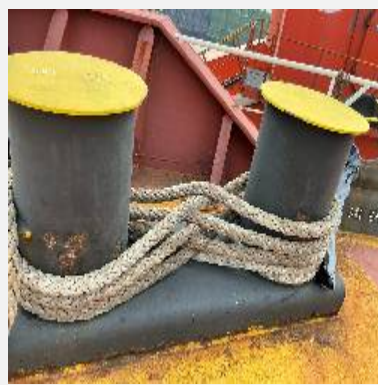
10.14 Are appropriate stoppers in use and are the mooring ropes turned up to bitts correctly? (V)

The fore breast line and fore spring line at forecastle deck were not turned up to the bitts correctly as only one turn was taken directly around the first post of the bitts before the rope laid up in a figure eight around the bitts.

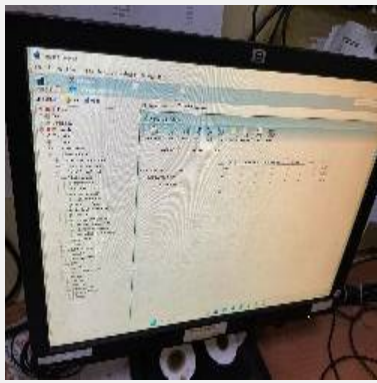
13.11 Is an effective and up to date planned maintenance system available and being followed on board the vessel? (V &amp; M)

A computerized PMS (Danaos) was fitted onboard and all officer/engineers used the system for routine maintenance, but none of them had received any familiarisation training.

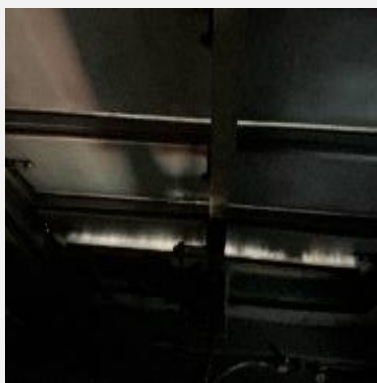
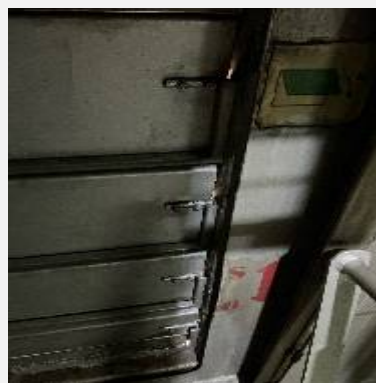
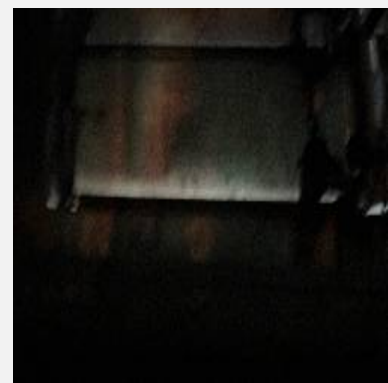
13.18 Are engine room emergency stops for ventilation fans and the closing mechanism of ventilation supply and exhaust ducts clearly marked, in working condition, and do records indicate that they have been regularly tested? (V)

Several gaps between 2-5mm were observed on the funnel louvre vents when fully closed.

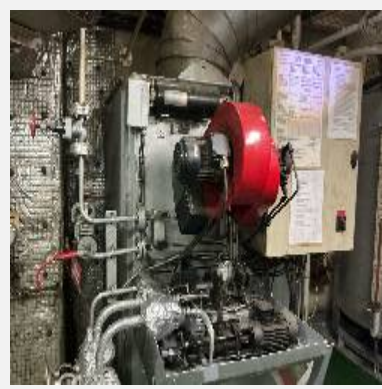
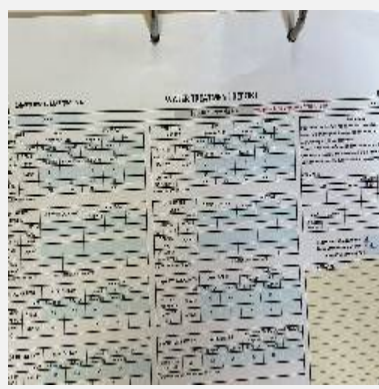
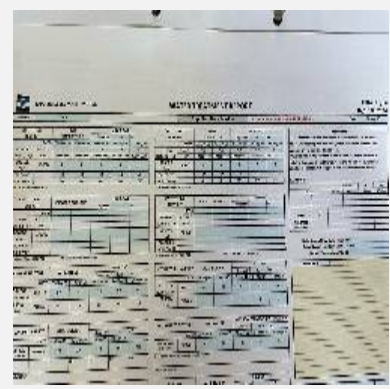
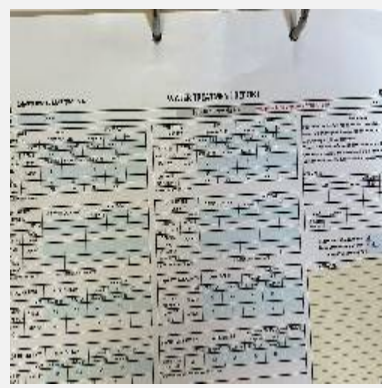
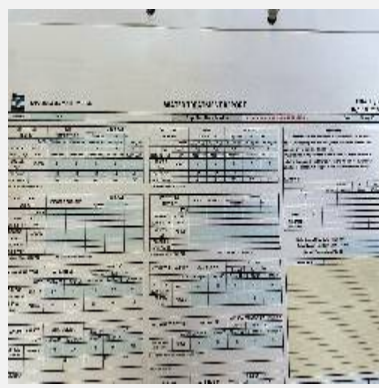
13.33 Is the following machinery/equipment, where applicable, in good order and well maintained? (V) Shaft generator and emergency generator Boilers, including waste heat and domestic boilers (Boilers should be operated in automatic mode where the automated boilers are installed) Boiler safety system and instrumentation Boiler water safety system Main and emergency air compressors Purifiers and fuel oil handling equipment Stern tube sealing arrangements Incinerator Sewage system Air condition and heating system Refrigeration plant Accommodation service systems (i.e., Calorifiers, Portable water equipment, heating etc) Any other items of machinery, including stand-by machinery. Burners, tubes, uptakes, exhaust manifolds and spark arrestors. Engine control console including the control and monitoring system Steering gear system Battery maintenance and renewal.

The incinerator in the engine room funnel was found out of order due to FX series PLC communication cable failed. Note: Spare parts requisition had been sent to office on 08/May/2026, but was not received before the closing meeting.
