# RightShip Ship Inspection Program

RightShip Ship Inspection Report - 66703

| Vessel Name: | PATAGONIA |
| Inspection Completion Date: | 10/23/2025 12:00:00 AM |

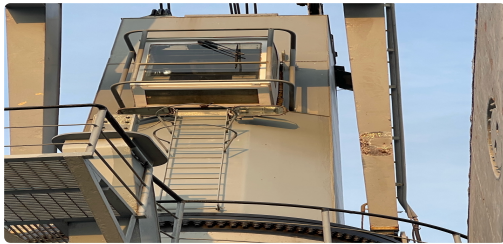
### 2.1 Is the latest Class Survey Status available and are all statutory certificates listed in the Class Survey Status valid, and is the vessel free of condition of class or significant recommendations? (M)

**Findings:** The class status report dated 20 October 2025 was reviewed and a Condition of Installation was found recorded as follows: - The left arm of jib deck crane No. 4 must be permanently repaired at the owner's earliest convenience, but not later than the due date indicated below. (Due date: 12 January 2026)

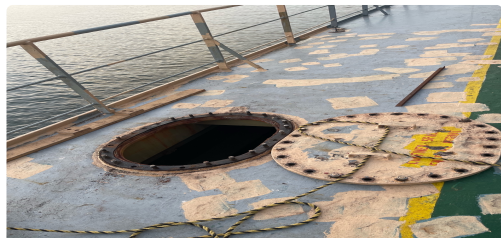
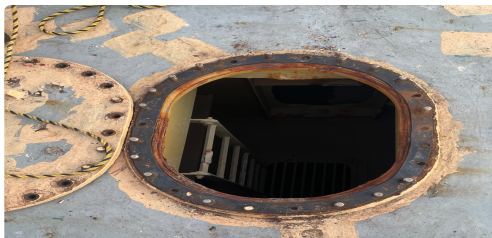
### 5.26 Are bunker and ballast tank manholes maintained in good condition?

**Findings:** During the inspection of the starboard side water ballast tank No. 2, it was observed that the access manhole lid had nine (9) damaged and missing fastening bolts that were not fitted in their position to secure the lid

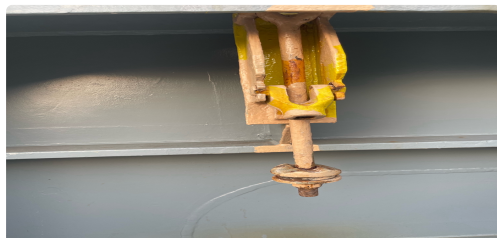
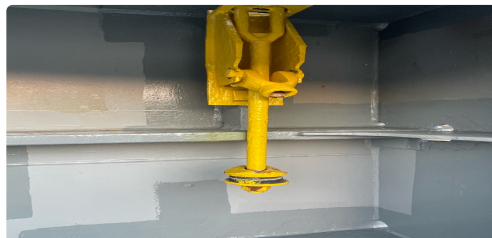
### 9A.6 Are quick-acting cleats and crutches all in place and in good working condition with the rubber washers flexible and free from paint and crack? (V)

**Findings:** Three (3) quick-acting cleats of the hatch covers of the cargo holds No 1, 3 and 5 (Starboard side) their washers were not free of paint

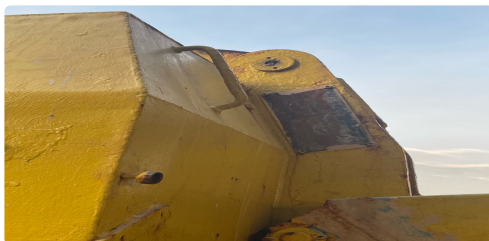
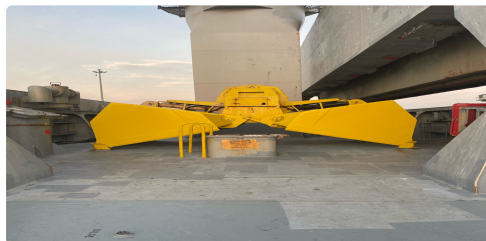
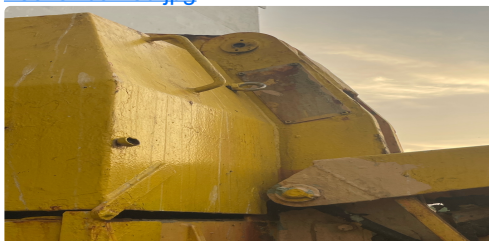
**9A.21 Are the ship's grabs being maintained as per manufacturer recommendation and have the maintenance requirements been incorporated in the PMS? (V)**

**Findings:** The capacity of grabs used for the loading and discharging of bulk cargoes utilising the ship's cranes, and the weight of the grab was not readable on the name plate attached to the grabs due to the weather exposure and paint applied during the maintenance

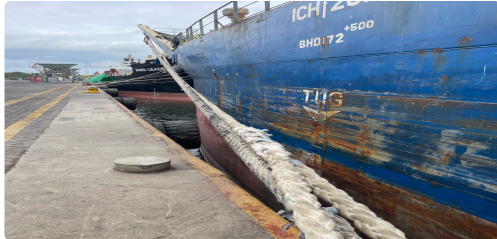
### 10.6 Are mooring lines correctly deployed and tended? (V)

**Findings:** It was noted that the vessel used mooring ropes of different material like high grade synthetic compound with polyester and polypropylene, nylon and polyester (Atlas, polypropilen ropes) and all of them with different LDBF and diameters from 68 to 100 tons, and 67 to 72 mm, as per their certificates on board

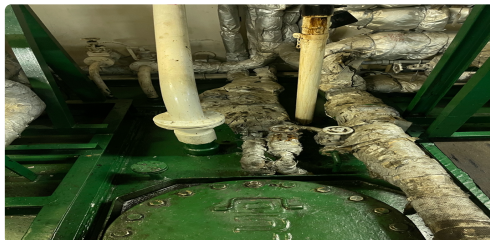
### 13.20 Is lagging and insulation, free of any significant oil impregnation ? (V)

**Findings:** The purifier room pipe system the lagging of a section approximately of 800 mm in length was soaked with oil. This observation was corrected before the inspector left the vessel

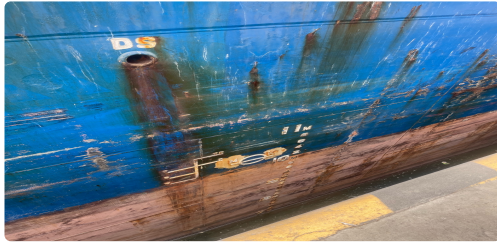
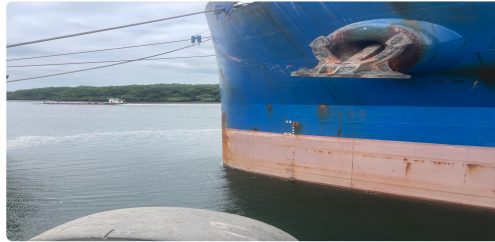
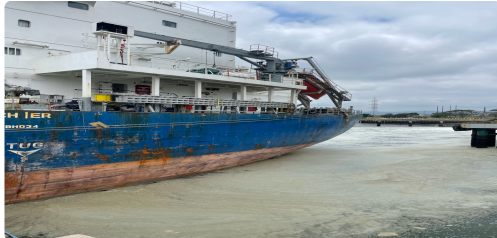
**14.2 Are the following permanent markings on the ship's hull, where applicable, plainly visible and painted in a contrasting colour? (V)**The vessel's namePort of registryLoad linesDraft marksThruster warningsTug push pointsIMO numberBulbous bow mark

**Findings:** The port side hull forward, midship and aft draft marks were not visible had lost their constrasting paint

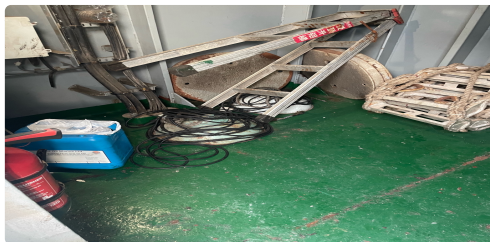
**14.10 Are portable and fixed cargo lights used for illumination of cargo holds inspected regularly and maintained in good condition? (V)**

**Findings:** The portable cargo lights for illumination of cargo holds were not nonconductive, and had a voltage of 200V

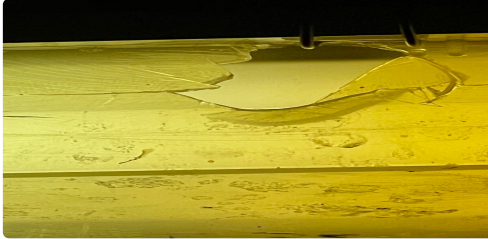
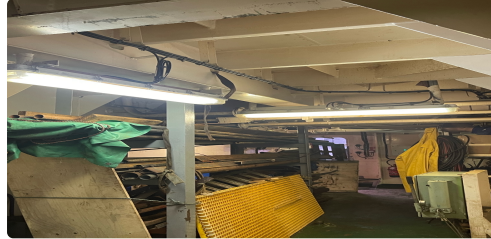
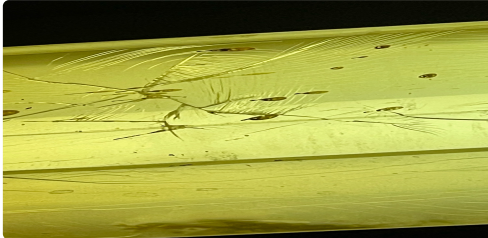
**14.13 Are the stores located inside the accommodation and on the weather decks clean and tidy? (V)**

**Findings:** Two (2) lights in the bosun store (Internal forecastle) their plastic covers were found broken and holed
