# RightShip Ship Inspection Program

### RightShip Ship Inspection Report - 71992

A bulk carrier that is carrying solid bulk cargo

| Vessel Name: | RUBY STAR |

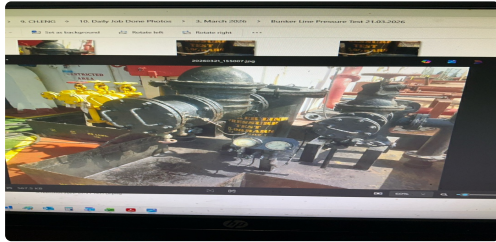
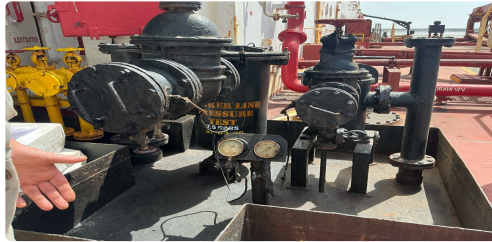
**7A.2 Are bunker transfer systems hydrostatically tested to their Maximum Allowable Working Pressure (MAWP) on an annual basis and to 1.5 times their MAWP at least twice within any five years period?**

**Findings:** MAWP of bunker transfer system was carried out onboard on 21 Mar 2026 at 7.5 bar, the pressure testing was carried out using compressed air which is not acceptable form of pressure testing the line.

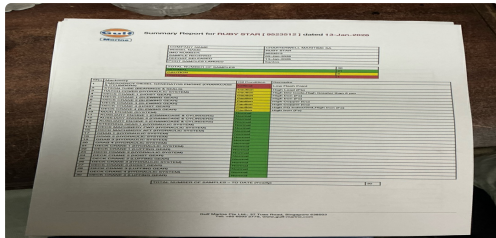
**7A.5 Are there procedures for the analysis of fuel, lubricating and hydraulic oils, and are oil sampling requirements aligned with equipment manufacturer's recommendations? (V & M)**

**Findings:** Emergency diesel generator crankcase fuel oil analysis report indicated oil condition as critical , as per the chief engineer the oil was changed and was sent for sampling , results for the renewed oil were awaited from shore .

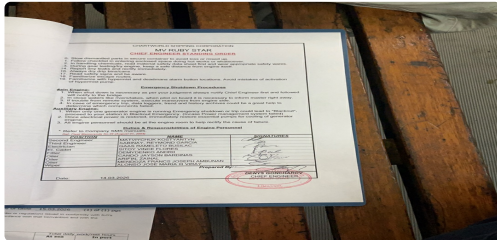
**13.3 Has the Chief Engineer prepared specific standing orders, night and day orders, and have these orders been read, understood, and signed by the watch standing engineers, engine crew, and electrical engineer, where applicable? (V & M)**

**Findings:** Relevant engineers had signed the chief engineer standing order , the date for the orders were found to be missing. Vessel was certified to be operated in UMS operation , precautions during UMS operations was not identified in the standing orders issued by the chief engineer .

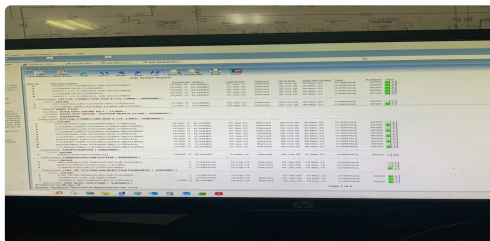
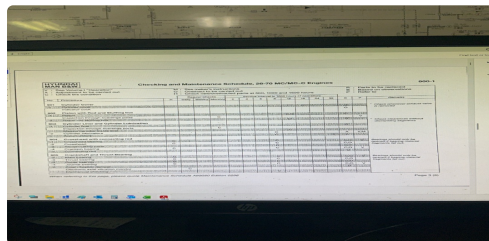
**13.13 Is the main engine maintained as per manufacturer's recommendations and records of periodic maintenance kept? (V)**

**Findings:** Vessel had Man B&W engines installed onboard . The maintenance schedule for main engine in PMS was not align as per manufacturer guidelines. Piston overhaul was 16000 hr in PMS as directed 12000 hr by manufacturer.

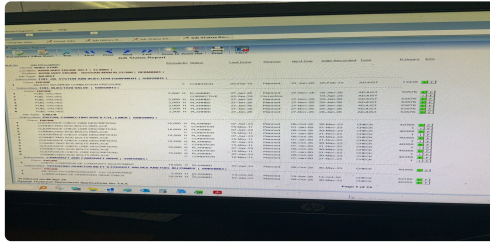
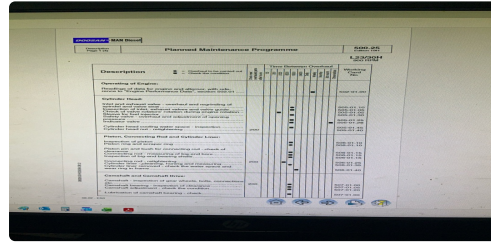
### 13.14 Are the auxiliary engines maintained as per manufacturer's recommendations and records of periodic maintenance kept?(V)

**Findings:** Auxiliary engines onboard were Doosan , the maintenance schedule in PMS was not in line with manufacturer guidelines . Camshaft and camshaft drive was 16000 hrs overhaul interval in PMS as directed 12000 hrs by manufacturer .
