# RightShip Ship Inspection Program

RightShip Ship Inspection Report - 64977

| Vessel Name: | NORDIC MALMOE |
| Place of Inspection: | Indonesia, Bahodopi |

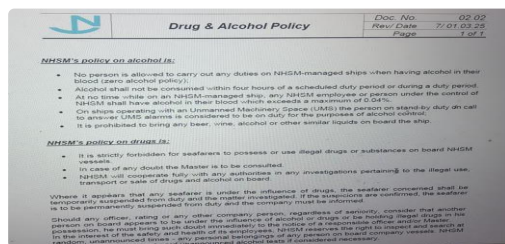
[Q209\\_1752474777627.jpg](https://www.rightship.com/attachments/2023/07/01/23/02_09_Drug_and_Alcohol_Policy.pdf)

**Findings:** The company's drug policy did not cover the vendors and contractors.

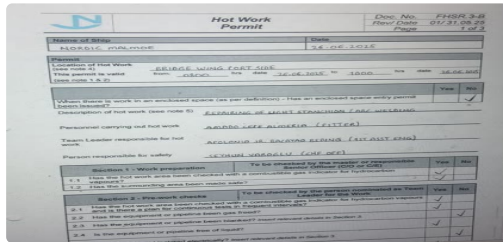
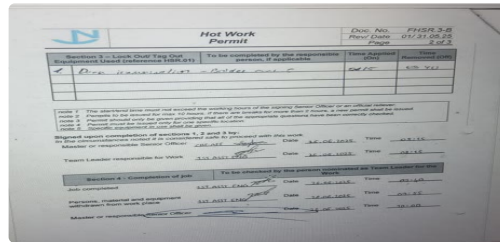
**Findings:** The hot work permit dated 26th June 2025 for welding on light stancion on port side bridge wing was valid from 08:00LT to 10:10 LT However, the Master signed the permit only at 08:15 LT,well after the permit validity period had already commenced.

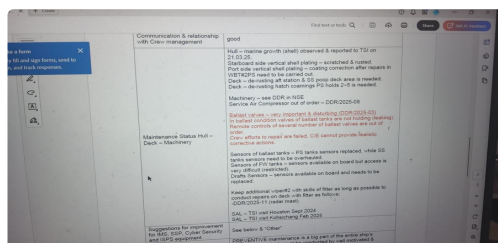
[Q525\\_1752475676791.jpg](#)

**Findings:** 1) All the draft level monitors in the ship's offices were unreliable, showing significant differences from the actual draft. 2) The operating time of the ballast valve was not being recorded as per the manufacturer guidance for the optimum opening and closing times for each valves.

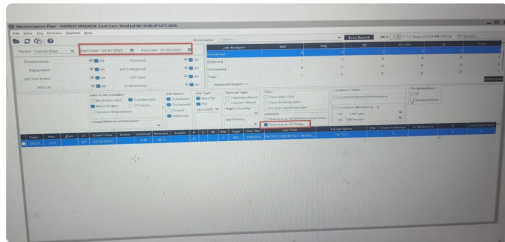
[Q602\\_1752475520090.jpg](#)

**Findings:** 1) The fresh water tank port side had due for the 6-monthly inspection on 22nd May 2025 2) There was no evidence that the company had included a procedure for the regular inspection of the cofferdam onboard, and no inspection report was available.

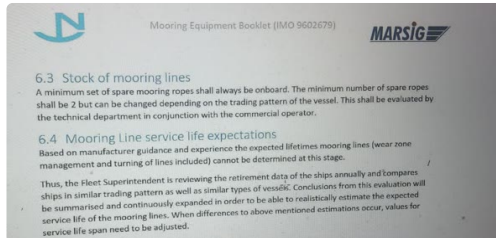
[Q1001\\_1752475423410.jpg](#)

**Findings:** There was no evidence that the personnel assigned the responsibility for rope inspections was properly trained to recognise rope damage.

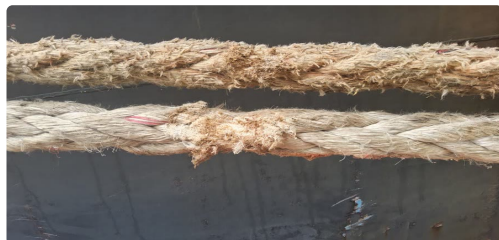
[Q1004\\_1752558482269.jpg](#)

**Findings:** 1) One of the starboard side aft spring lines were found with significant abrasion about 10cm in length. 2) One of the forward starboard-side outer mooring lines was found with significant abrasion approximately 10 cm in length. | The ship's design minimum breaking load (SDMBL) was 480 KN. However, 15 of the in use mooring ropes and 5 of the spare mooring ropes on board had a Line design breaking force ranging from 674 KN to 1020 KN , which exceeded 105% of the ship's design minimum breaking load.
