# RightShip Ship Inspection Program

RightShip Ship Inspection Report - 68760

| Vessel Name: | NORDIC MALMOE |
| IMO Number: | 9602679 |

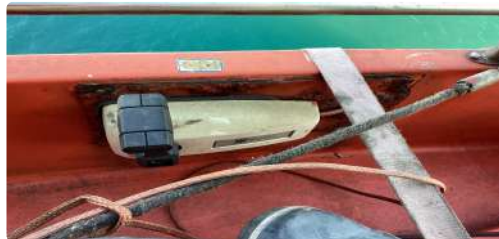
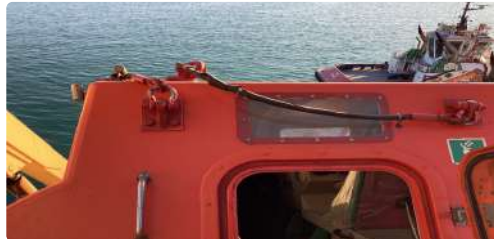
### 4.18 Are the lifeboats, rescue boat and davit-launched life raft, their equipment and launching arrangements being serviced periodically in good condition, and are the crew familiar with the launching procedure and operation? (V & M)

**Findings:** 1) The hanging sling wires of the free-fall lifeboat were found sheathed with plastic, and the rescue boat sling wires were observed covered with wrapping tape. The actual condition of the wires could not be visually verified. 2) The steel panel on the starboard side of the rescue boat, which the engine control lever was fitted, was found significantly corroded and broken on the top corner around its securing bolt.

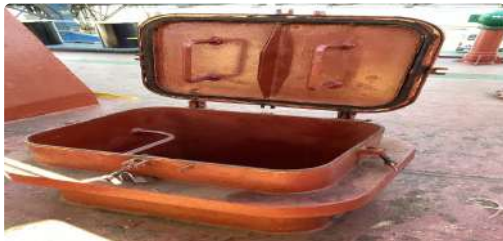
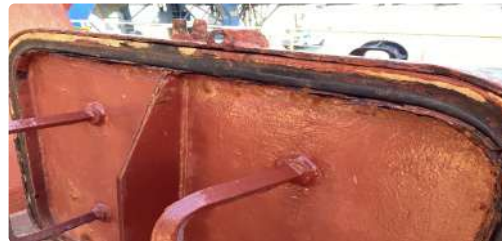
**6.4 Are the access points to cargo holds, ballast tanks, and void spaces including vertical ladders, spiral ladders, rungs, stations, and platforms being maintained and in good order? (V)**

**Findings:** The inner rim of the seal retaining channel of No.4 cargo hold access hatch was found significantly corroded with spot wastage.

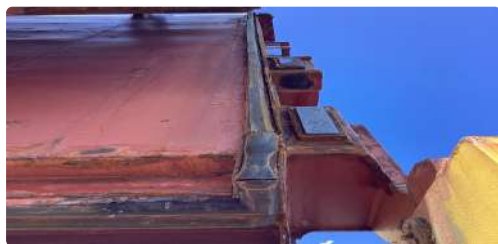
**9A.9 Are the side and cross-joint rubber seals in good condition? (V)**

**Findings:** Short rubber seal inserts, approximately 50 cm in length, were observed fitted on the side ends of the third panel of No.4 hatch cover, on both port and starboard sides.

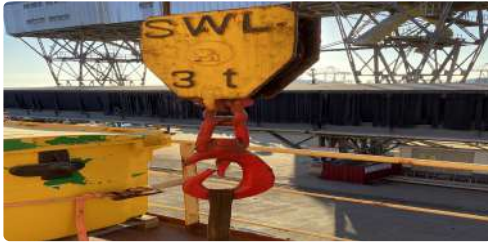
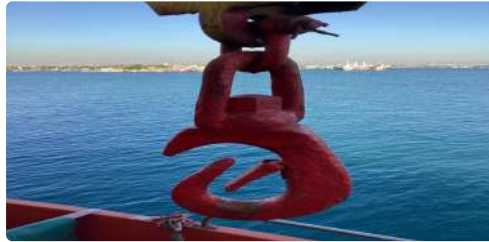
**9A.22 Are the loose gears of lifting appliances marked clearly and are the certificates of the loose gears available and traceable on board? (V)**

**Findings:** The hook swivels of the vessel's general-use cranes on the 3rd Deck, port and starboard sides, were found non-functional, with worn connection surfaces and seized swivels. In addition, the safety clutch of the starboard side general-use crane was non-functional due to spring failure.

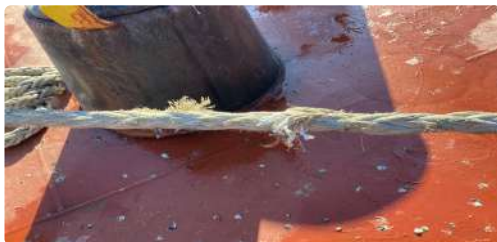
**10.4 Do mooring lines and mooring tails comply with industry guidelines and are they in good order? (V & M)**

**Findings:** One of the mooring ropes on the forward mooring winch starboard side was found with severe strand cuts, while the other rope exhibited multiple yarn cuts due to repeated contact with the rope access hatch on the forecastle deck.

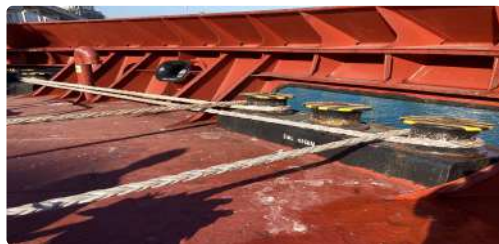
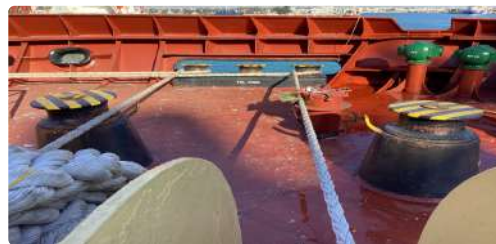
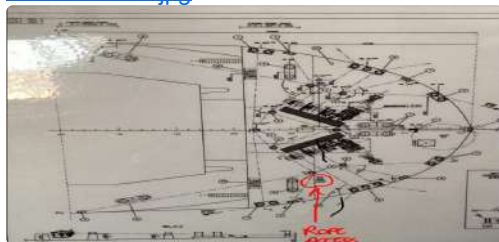
### 10.6 Are mooring lines correctly deployed and tended? (V)

**Findings:** 1) Two mooring ropes from the forward starboard mooring winches were found led around the roller fairleads with an approximate 270 degrees change in direction, resulting in the ropes crossing and contacting themselves. 2) Two -elevated hatches- (access to the rope store from forecastle deck) were found fitted in way of the tension drums and fairleads of the two forward mooring winches. As observed, the hatches were not located as indicated in the mooring line management plan and preventing proper line-up of these two mooring ropes.

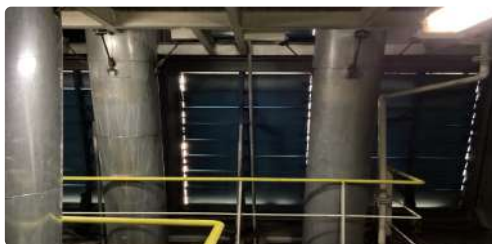
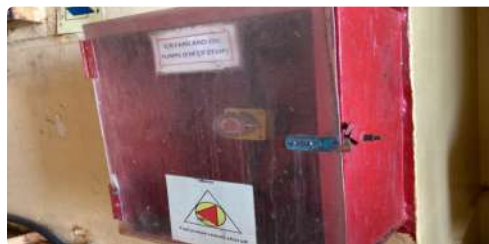
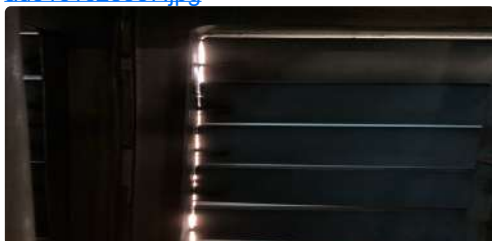
**13.18 Are engine room emergency stops for ventilation fans and the closing mechanism of ventilation supply and exhaust ducts clearly marked, in working condition, and do records indicate that they have been regularly tested? (V)**

**Findings:** 1) The emergency stop button for the engine room ventilation was located inside a box on the upper deck, aft of the superstructure. The hinges and securing pin of the box were seized, preventing prompt access to the emergency stop. 2) Three funnel dampers were fitted side by side, and their remote operation was tested during the inspection. It was observed that excessive gaps of approximately 10 mm were present at the middle funnel damper, between three (3) of the damper louvre panels and the frame.

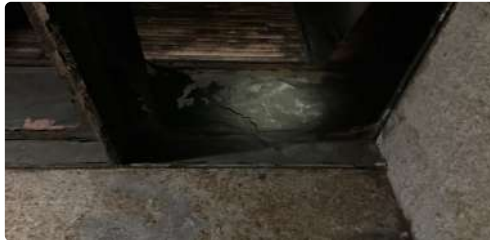
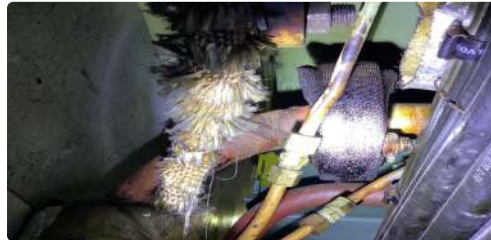
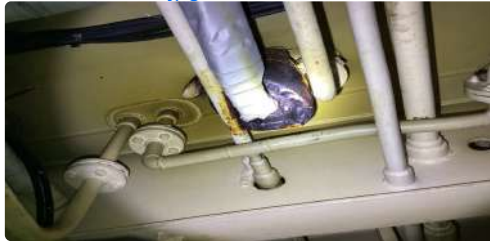
**13.20 Is lagging and insulation, free of any significant oil impregnation ? (V)**

**Findings:** 1) The fire insulation inside Engine Room Fan Room No.2, located within the funnel casing at the starboard side of the boiler platform, was found peeled off over approximately 25% of its area, with localized wastage observed in several spots. 2) The lagging on the fuel injector piping located at the local manoeuvring platform of the main engine, over an extent of 1 meter, and the fuel oil piping at the purifier compartment ceiling, over a similar length in total in localized areas, were found soaked with fuel oil.

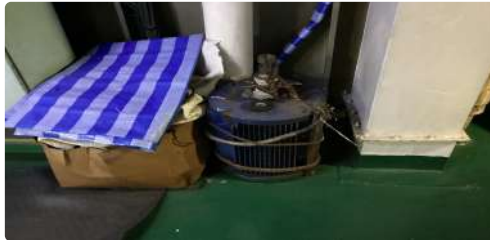
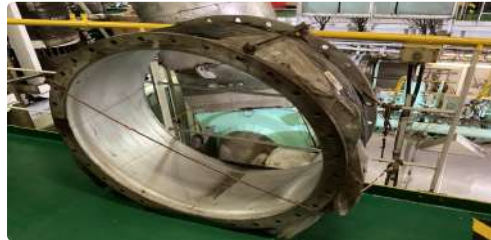
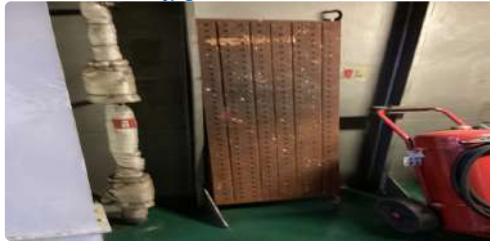
**13.28 Are all spare parts and loose gear in the machinery spaces, stores and steering compartment properly secured? (V)**

**Findings:** - The spare turbocharger compensator was found secured to the ship's railings by nylon ropes on the 1st platform of the engine room. - A spare electric motor was found secured with nylon ropes on the boiler platform of the funnel casing. - A steel platform was found leaned against the bulkhead without any securing arrangement on the boiler platform of the funnel casing.

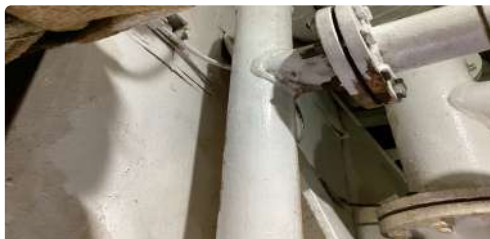
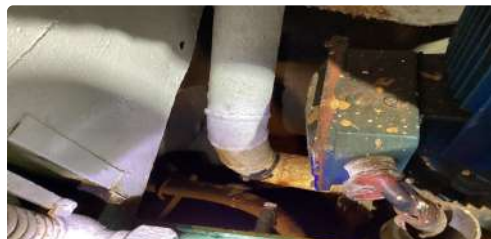
**13.34 Is the pipe work in the machinery space, including but not limited to steam, fuel, lubricating oil, sewage, drain and air lines well maintained, in good condition and free of any temporary repair? (V)**

**Findings:** The 4-inch diameter seawater pipeline from the ejector pump, located at the engine room bilge level on the starboard side, was found temporarily repaired by means of a pipe clamp. In addition, a minor leakage was observed from the elbow above the repaired section.

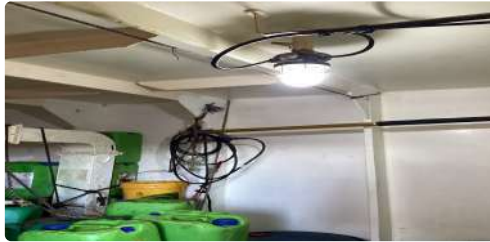
**14.12 Are the explosion-proof lights in paint lockers, acetylene stores or similar spaces in good condition? (V)**

**Findings:** The deck store adjacent to the No.4 crane housing on the main deck was found to be used as a chemical store, containing flammable substances. A proper ventilation was provided however the compartment was not fitted with explosion-proof lighting.
