# RightShip Inspection - Inspector Report

## STAR TRADER, 9461142

Date of inspection **29 MAR 2026**  
Port of inspection **SINGAPORE**  
Type of inspection **STANDARD**  
Inspection ID **72267**

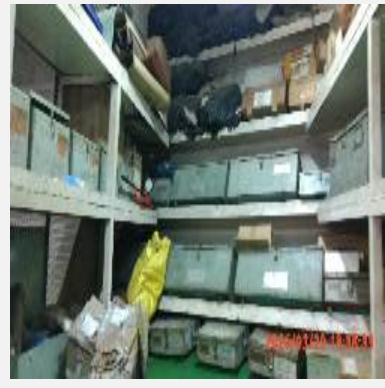
[Q1328\\_100\\_2576.JPG](#)

- 13.28 Are all spare parts and loose gear in the machinery spaces, stores and steering compartment properly secured? (V)

The vessel's manager did not identified potentially hazardous manual handling operations, including the development and implementation of procedures for storing, securing and manual handling of spare parts and steel plates.

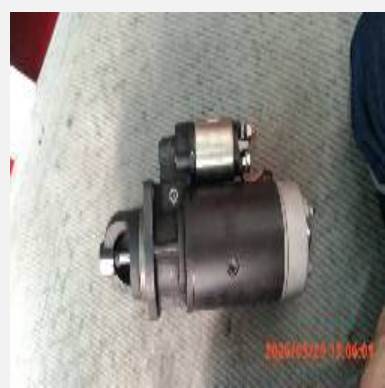
[Q1337\\_100\\_2408.JPG](#)

There was no objective evidence that spare starter motor for emergency generator was tested every quarter.

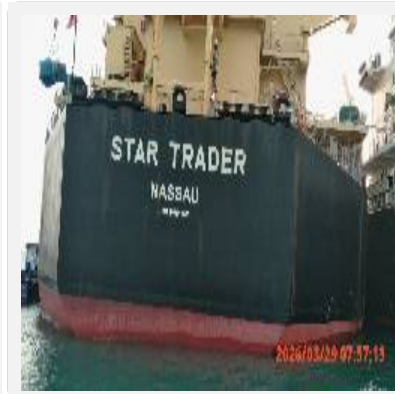
[Q1402\\_100\\_2331.JPG](#)

14.2 Are the following permanent markings on the ship's hull, where applicable, plainly visible and painted in a contrasting colour? (V) The vessel's name Port of registry Load lines Draft marks Thruster warnings Tug push points IMO number Bulbous bow mark

Load line marked midship(S) was faded and not clearly painted in contrasting colours.

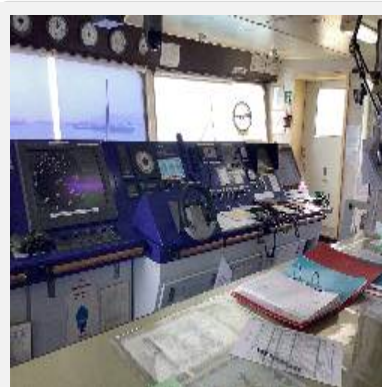
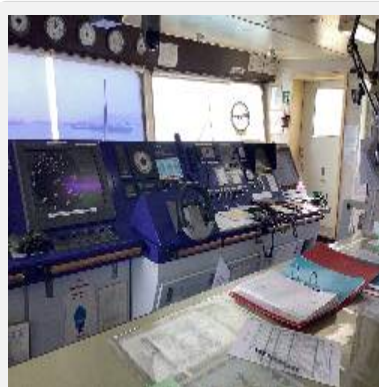
EPL(Electrical) was fitted. On board management manual was provided.

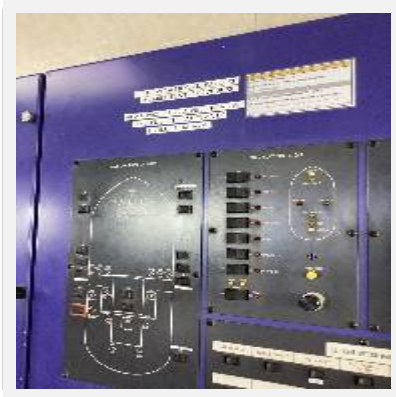
[Q311\\_97ee3f40-c761-41eb-945e-ce11fa616573.jpg](#)

The navigation lights power failure alarm was tested by pulling out a fuse.

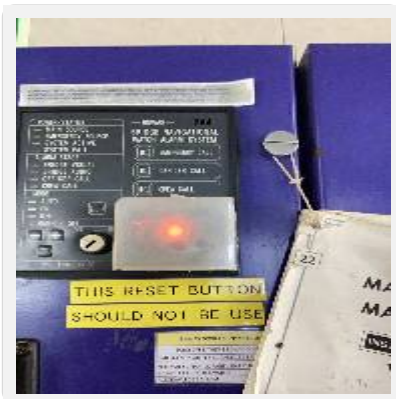
[Q312\\_d002bb7c-9058-4270-a2c1-a17704a12764.jpg](#)

BNWAS power failure alarm was tested.

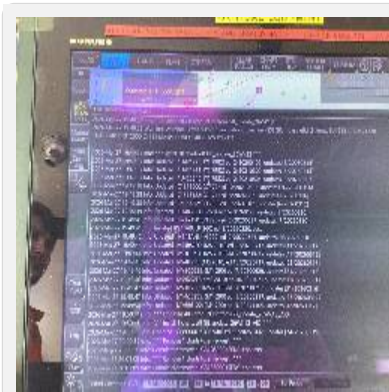
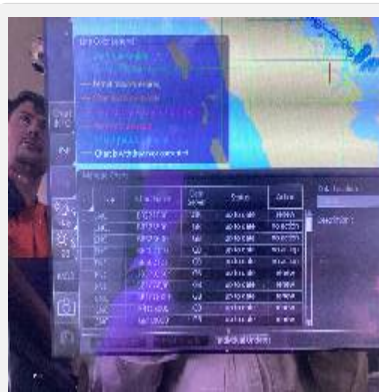
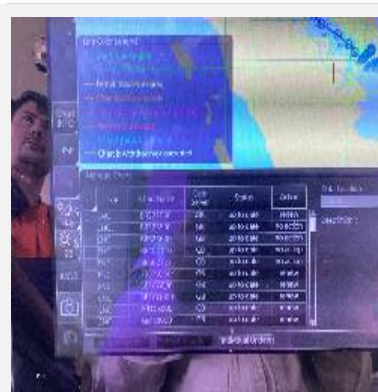
Nautical publications were available as soft copies and some as hard copies.

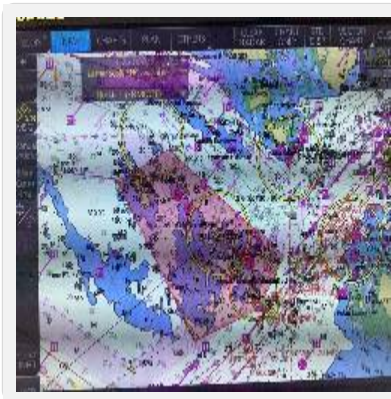
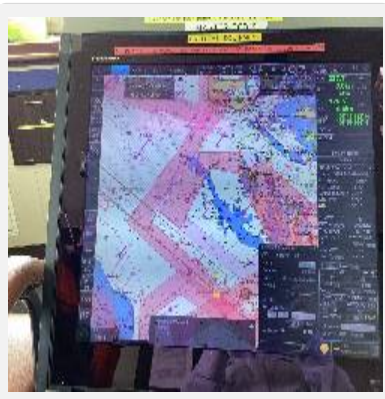
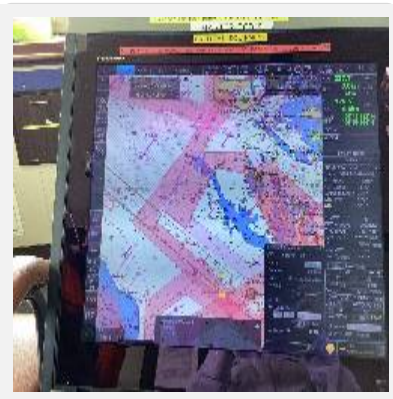
AIO was fitted.

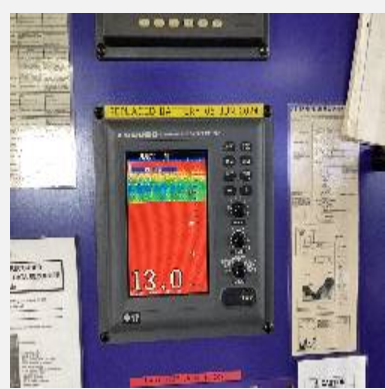
[Q322\\_99f3ff08-f171-4f8a-9470-8abd91af2a.jpg](#)

Echo sounder shallow water alarm was tested.

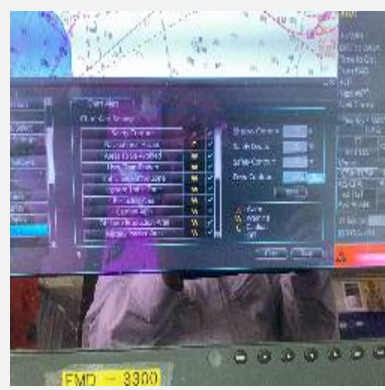
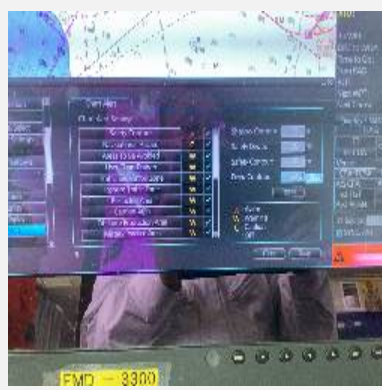
A software was in use for making the berth-to-berth passage plans.

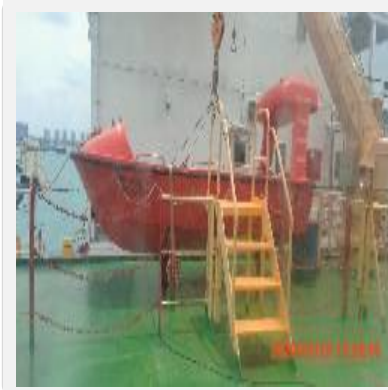
[Q418\\_100\\_2360.JPG](#)

Free fall lifeboat engine and rescue boat engine were tested. Davit for launching rescue boat and life rafts was swung under emergency power.

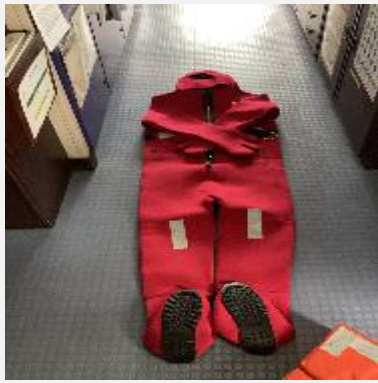
[Q421\\_82de0ae1-0ba8-49dd-8546-14479c51571b.jpg](#)

Immersion suits leak test was carried out by external agency on 23 May 2025.

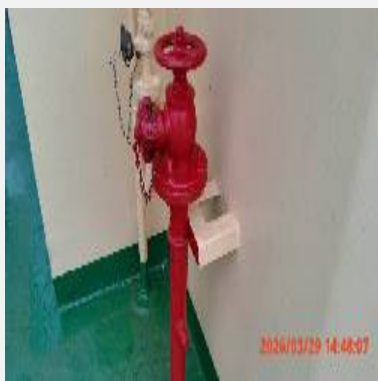
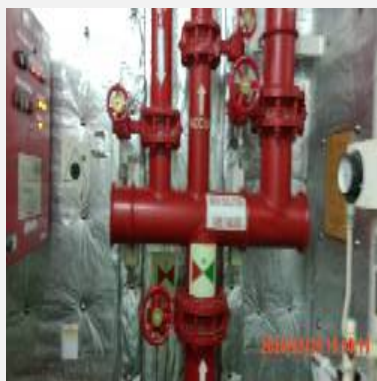
Main fire line isolation valve located inside fire control station was lubricated.

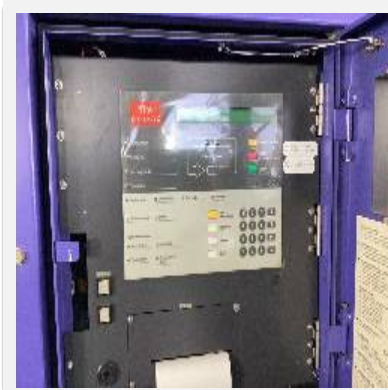
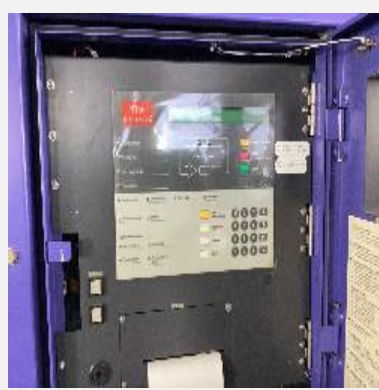
Weekly test record for sensor was maintained.

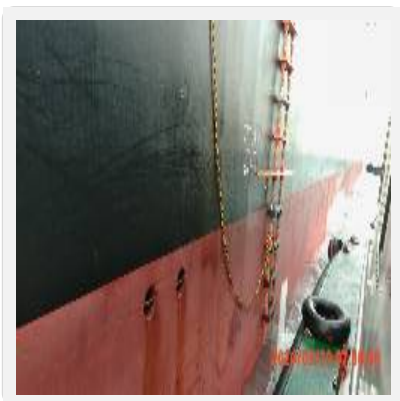
[Q435\\_100\\_2337.JPG](#)

Pilot ladder was used at anchorage.

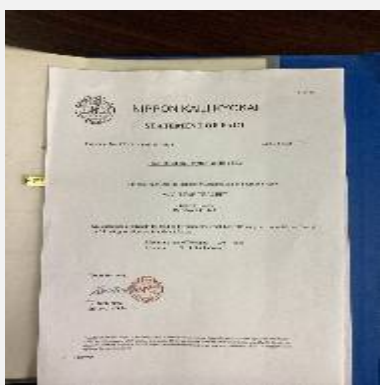
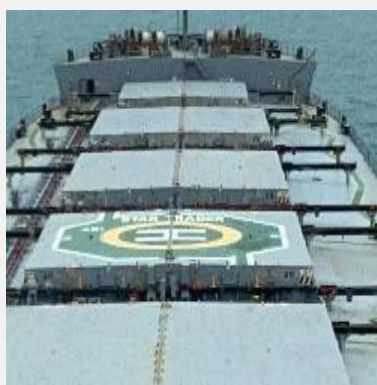
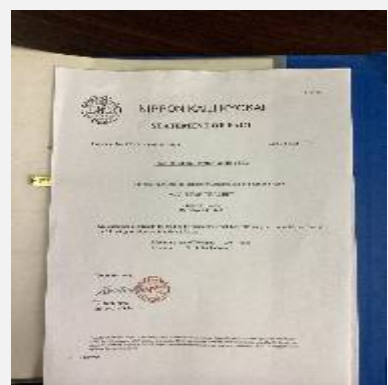
No. 4 hatch cover was the helideck.

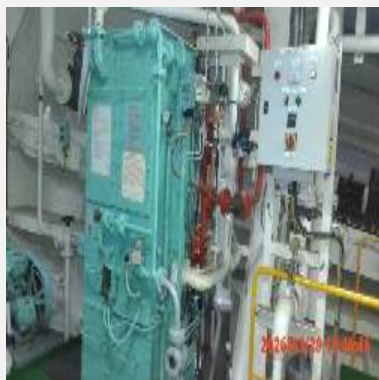
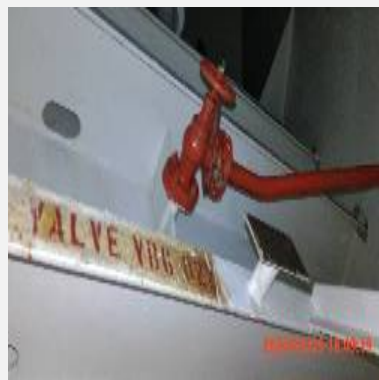
The 15 ppm alarm and automatic stopping device of the oily water separator were tested.

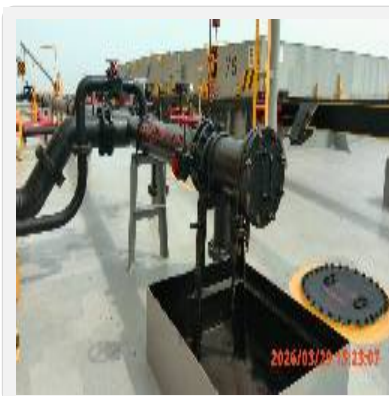
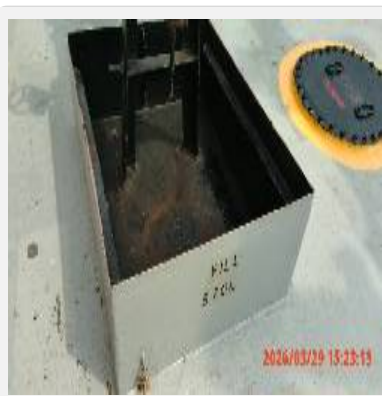
7A.1 Is adequate manifold spill containment provided under the bunker manifolds, and are they clean and empty? (V)

YES

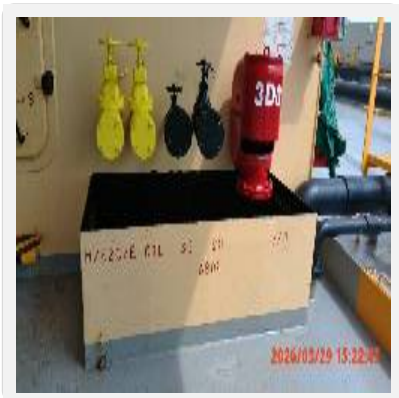
[Q7a04\\_100\\_2451.JPG](#)

7A.4 Are save-alls fitted around all fuel, diesel, and lubricating oil tank vents; are they clean and empty, and is the drain plug secured with a strap chain to a save-all? (V)

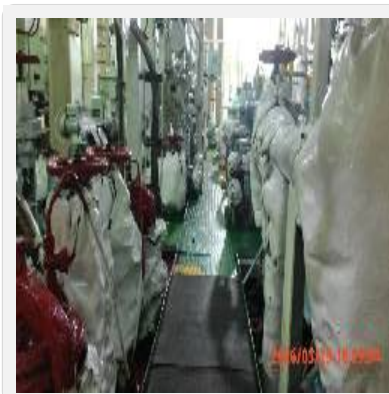
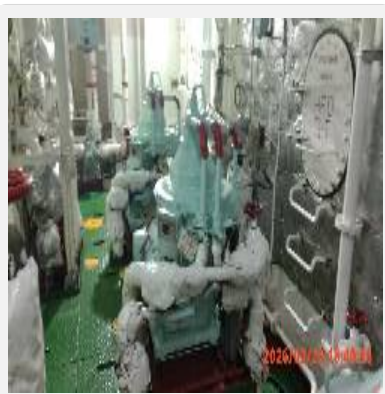
7A.12 Are purifier rooms and fuel and lubricating oil handling areas ventilated, free of oil leaks and clean?

YES

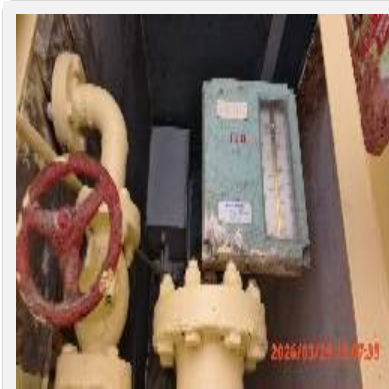
[Q7a13\\_100\\_2410.JPG](#)

7A.13 Is the reserve fuel tank of the emergency generator filled with sufficient fuel of a suitable type for at least 18 hours operation?

YES

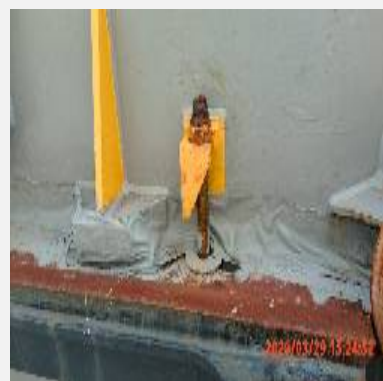
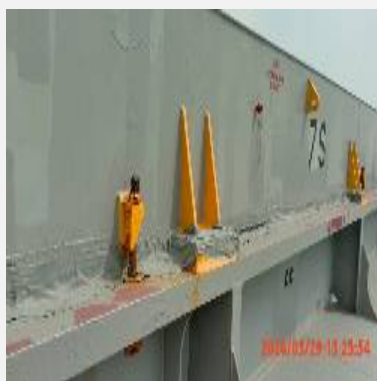
- 9A.6 Are quick-acting cleats and crutches all in place and in good working condition with the rubber washers flexible and free from paint and cracks? (V)

YES

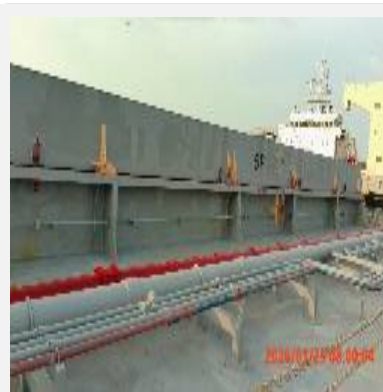
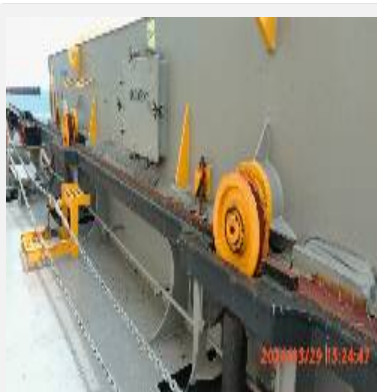
- 9A.13 Are the following parts of the hatch covers, where applicable, all in good order and do they appear to be well maintained?<ul><li>Wheels/bearings or trackway</li><li>Hydraulic system including hoses</li><li>Chains</li><li>Link pin and safety pin</li><li>Cargo holds' ventilator on the side and end of hatch panel</li></ul>

YES

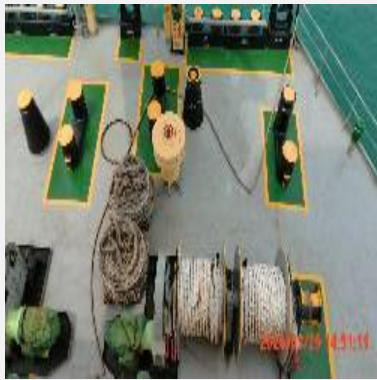
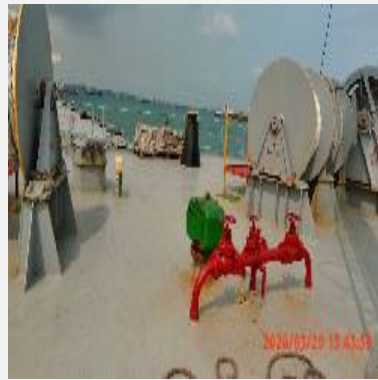
- 10.1 Has the company established guidelines and procedures for the inspection, maintenance and wear zone management of the mooring lines and are they being implemented? (V & M)

Five spare mooring ropes were carried on board.

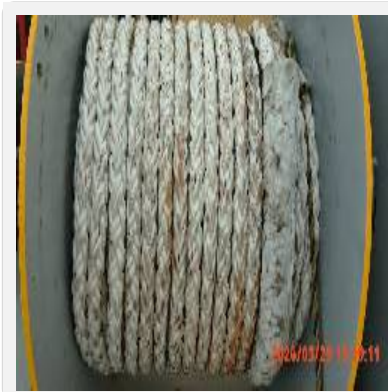
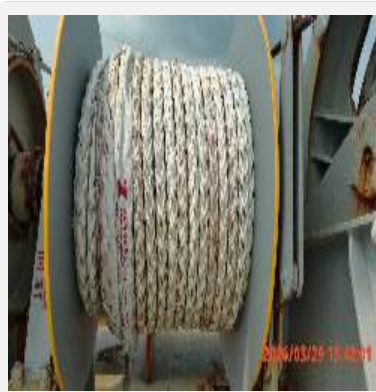
- 10.4 Do mooring lines and mooring tails comply with industry guidelines and are they in good order? (V & M)

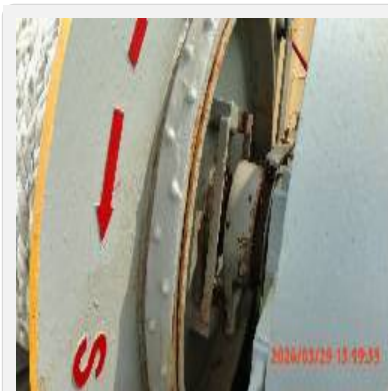
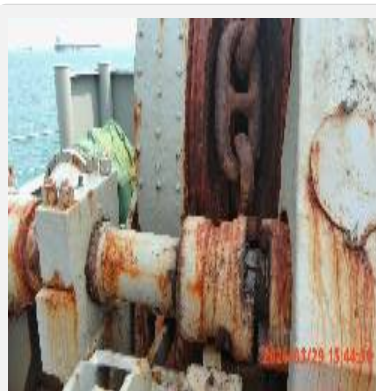
10.15 Are the controls, linkages, operating levers, brake drums, brake linings, and pins of the winches, as well as the working access arrangement to the winches, in good working order?

YES

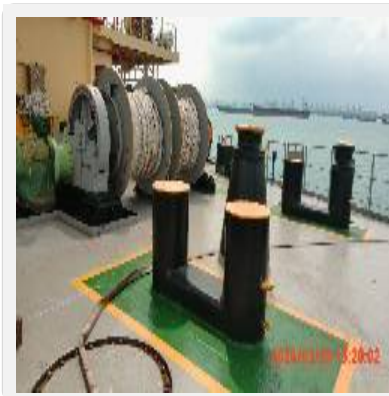
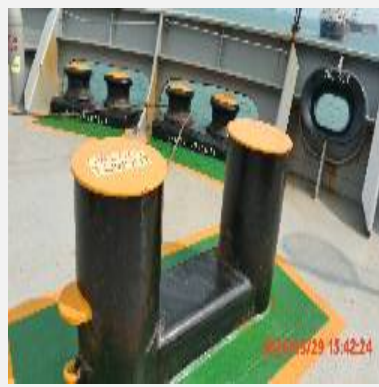
10.16 Are the pedestal fairleads, roller fairleads and other rollers free of grooving, well-greased and free to turn? (V)

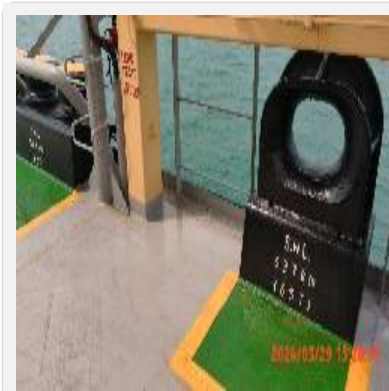
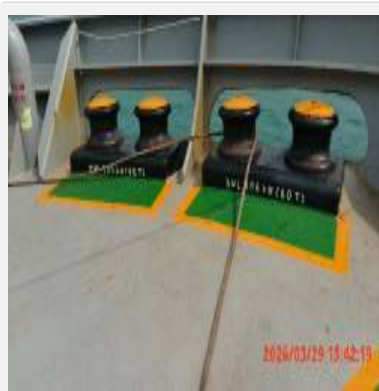
10.17 Are the fairleads, rollers, bitts, chocks and other items of mooring equipment clearly marked with the relevant SWL? (V)

YES

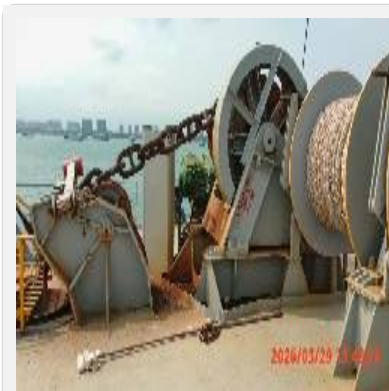
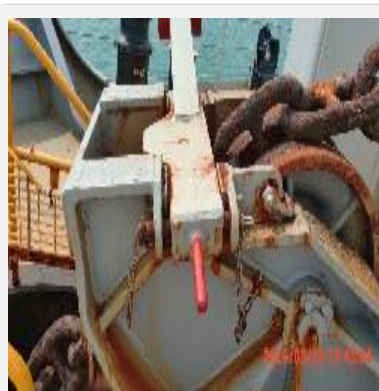
10.18 Are the windlasses, anchors, locking bars, and cables, as well as the working access arrangement, in good working order and are they maintained as part of the plan maintenance system? (V)

YES

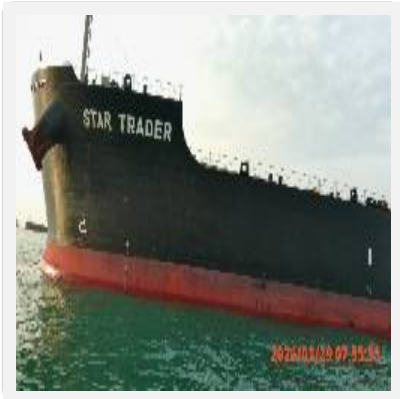
[Q1019\\_100\\_2323.JPG](#)

10.19 Have the anchors been tightly secured in the hawse pipe? (V)

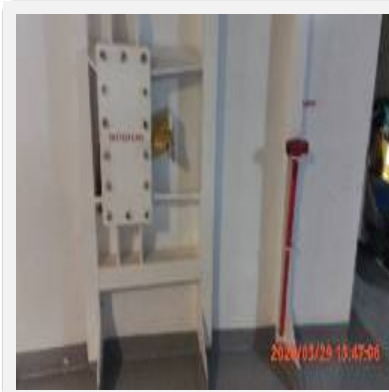
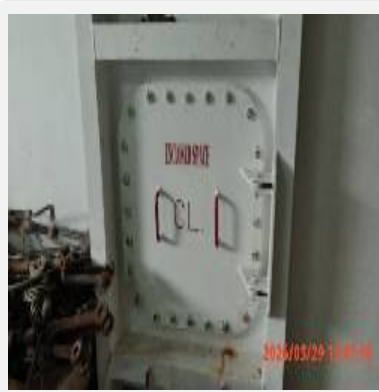
10.20 Are the chain locker doors firmly battened down and are the bitter end securing arrangements located outside the chain locker and accessible? (V)

YES

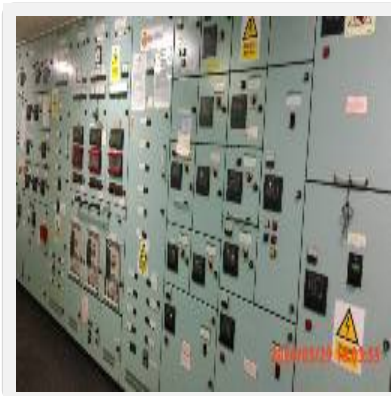
[Q1304\\_100\\_2545.JPG](#)

The engineer's calling alarm system was tested.

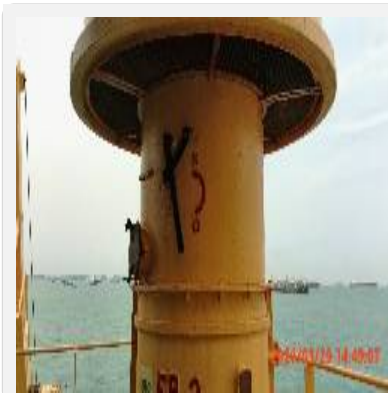
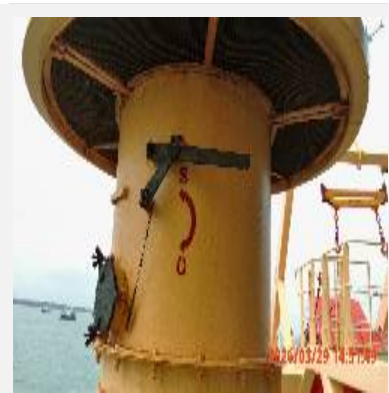
Funnel fire dampers and engine room blowers fire dampers were tested,

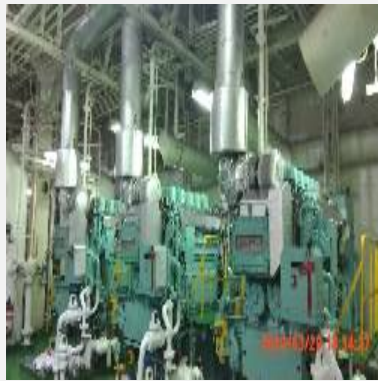
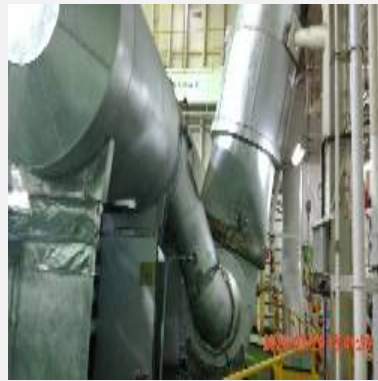
The main engine and auxiliary engine fuel leak off alarms were tested.

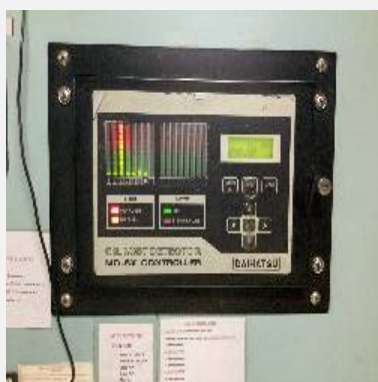
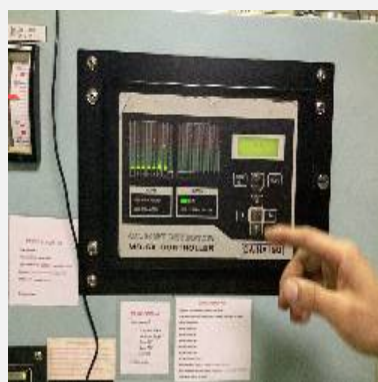
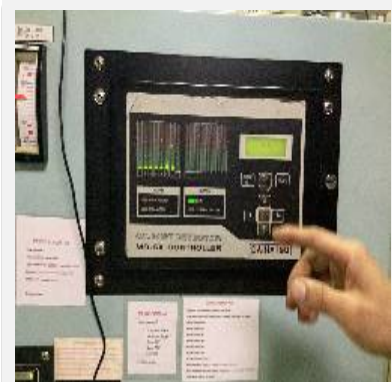
The main engine crankcase oil mist detector was tested.

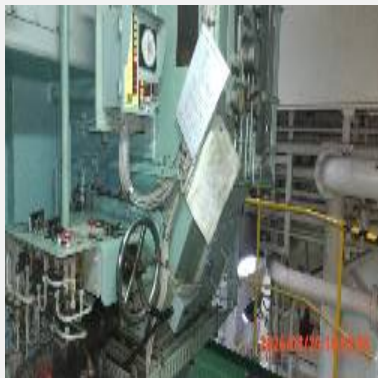
[Q1335\\_100\\_2631.JPG](#)

The most recent training for main engine from the local manoeuvring control was carried out on 17 Feb 2026.

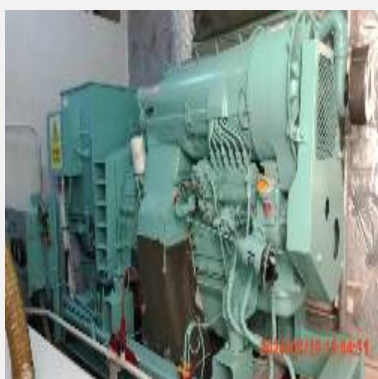
[Q1336\\_100\\_2403.JPG](#)

Emergency generator was tested by two batteries.

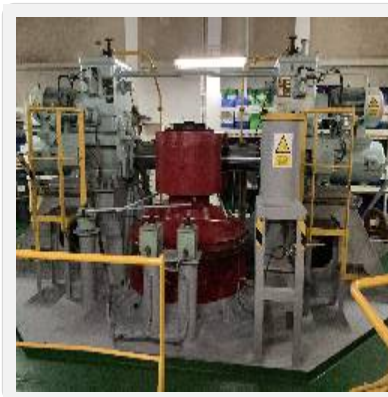
[Q1340\\_57d9af7f-28a6-4b7c-aabb-6e5670fa02e2.jpg](#)

Emergency steering was tested.

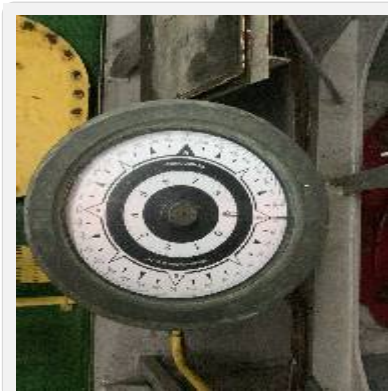
[Q1342\\_571d6587-e540-448c-93cd-42ed17e3b297.jpg](#)

13.42 Is a heading indicator and communication system provided in the steering gear room and are they in good order? (V)

YES

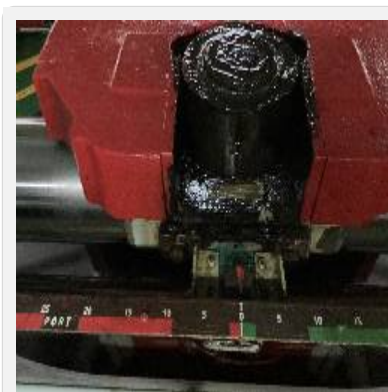
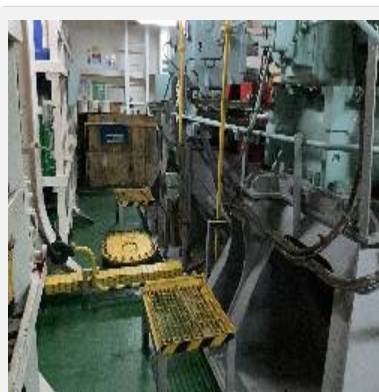
13.43 Is the rudder angle indicator at the emergency steering position in good order, and is the display clearly legible? (V)

YES

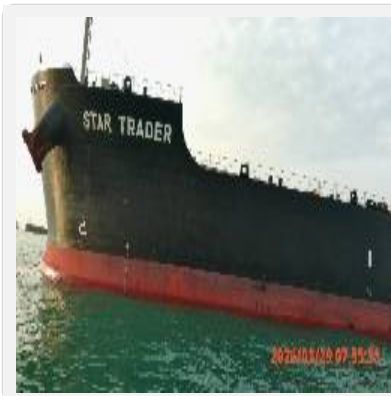
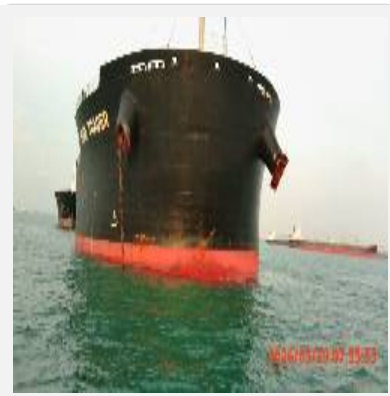
14.1 Is the ship's hull clean, free of significant corrosion, extensive coating breakdown and marine growth? (V)

YES

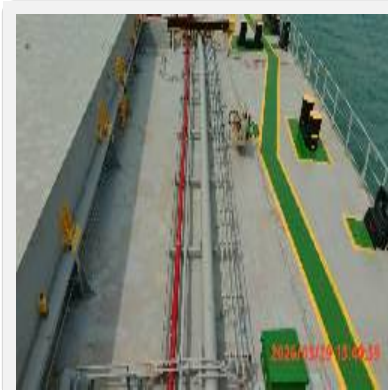
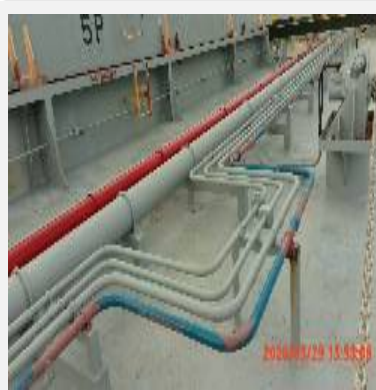
14.4 Are the pipes on deck free of significant corrosion, pitting, soft patches, leakage or temporary repair and maintained in good condition? (V)

YES

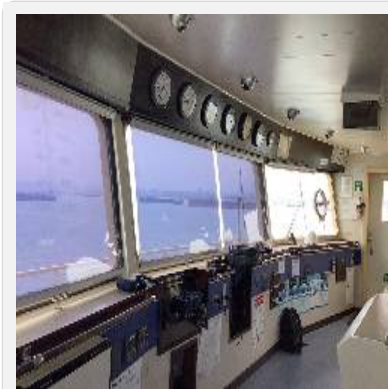
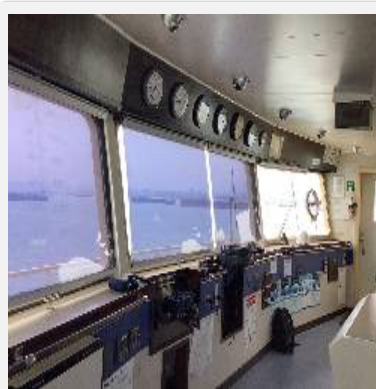
14.5 Are all watertight doors (where fitted), fire doors, weathertight doors, portholes and wheelhouse windows maintained in good order? (V)

YES

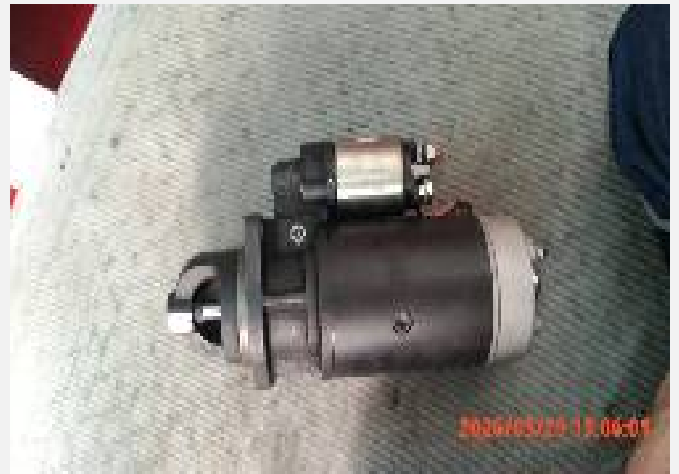
13.37 If the starting source of the emergency generator relies on a single starter motor, has a spare starter motor been provided? (V)

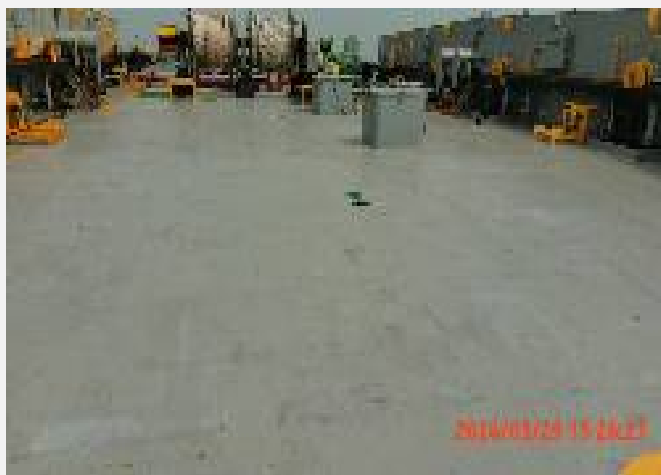
14.3 Are the weather decks free of loose rust scale and maintained in a satisfactory condition? (V)

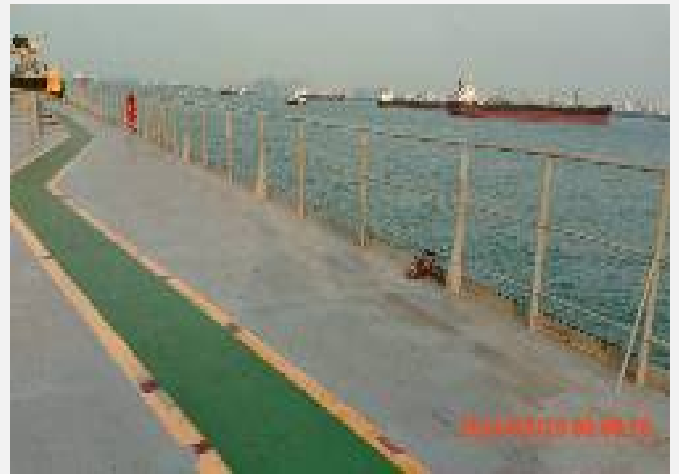
14.19 Are the ship's guard rails, walkways, and access ladders, as well as the steps and railings, maintained and in good working order, and are the securing arrangements for deck cargoes on the deck also maintained and in satisfactory condition?(V)
